# Engine Component CBM using Flexible ET Arrays for Crack Depth Measurement

31 March 2015

Neil Goldfine, Mark Windoloski, Vlad Tsukernik, Yanko Sheiretov, Stuart Chaplan, and Zach Thomas  
JENTEK Sensors, Inc.; Waltham, MA 02453-7013

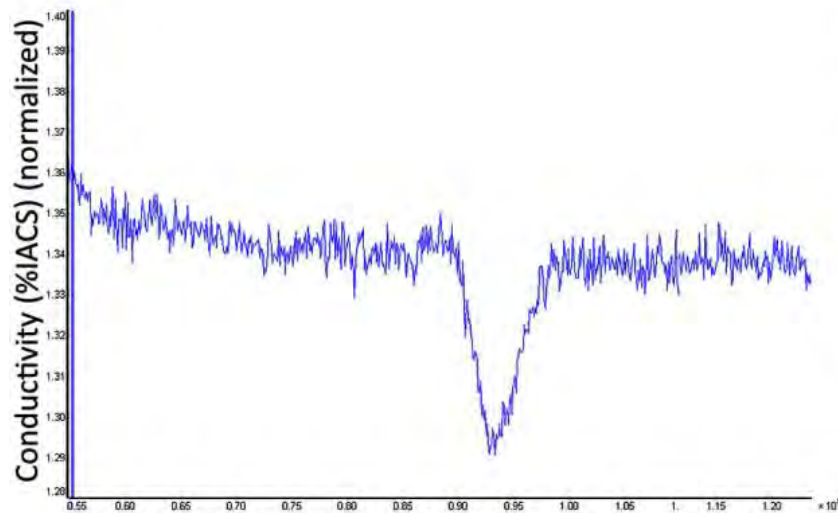
7000 Series Crack response

**100 samples per second**

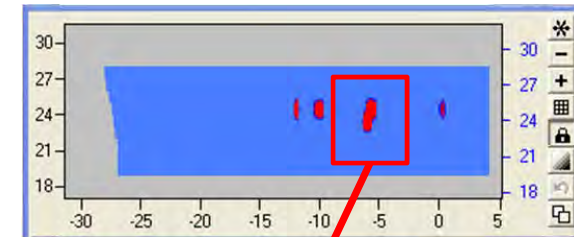
## C-Scan Image

42-mil Crack

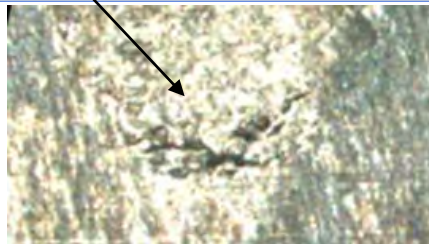
Convex Side

Concave Side

42-mil Crack

75-mil Crack Cluster  
(Maximum Crack  
Length 50 mils)

- Training Set Blade with “Known Cracks”
- Cracks verified using acetate replicas
- On similar blades, MWM-Arrays detected cracks that were **not found by the OEM optical method**
- **These are tight cracks in regions with fretting damage**

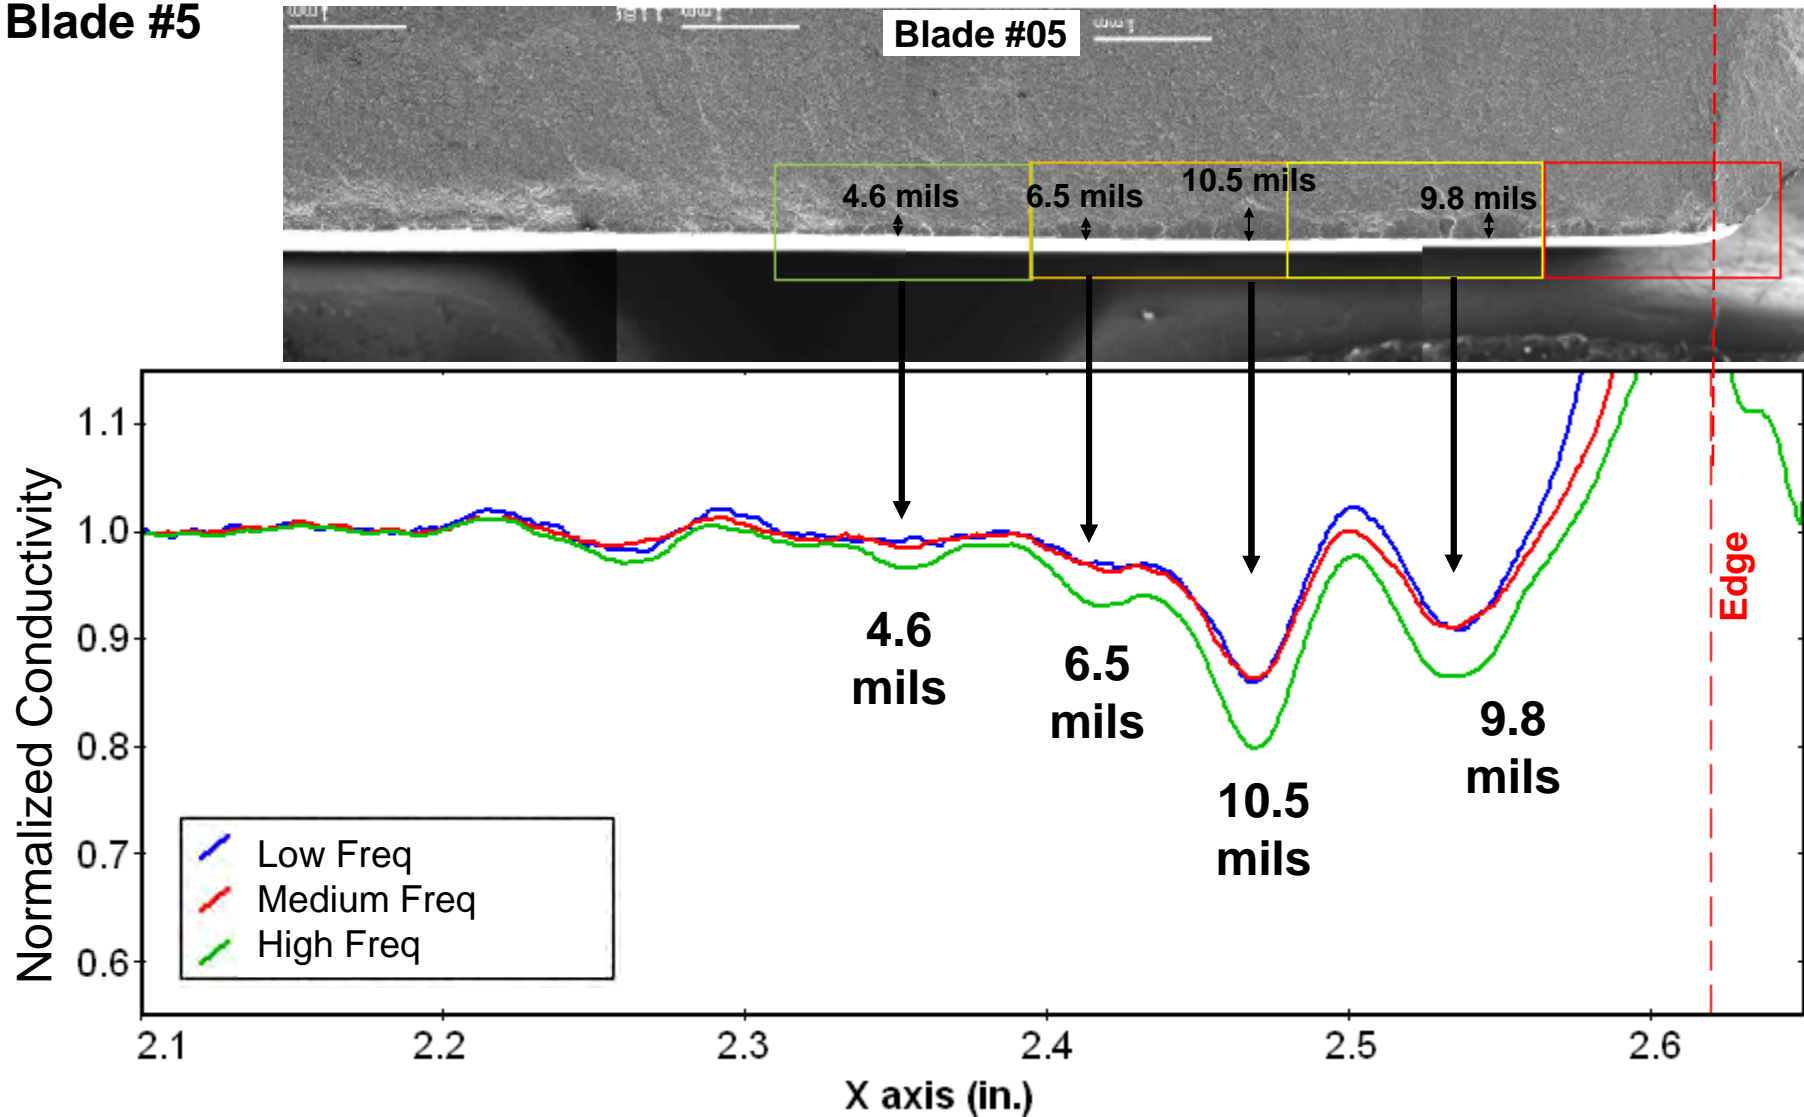
Blade #5

# Case Study 2b: MWM-Array Conductivity Response

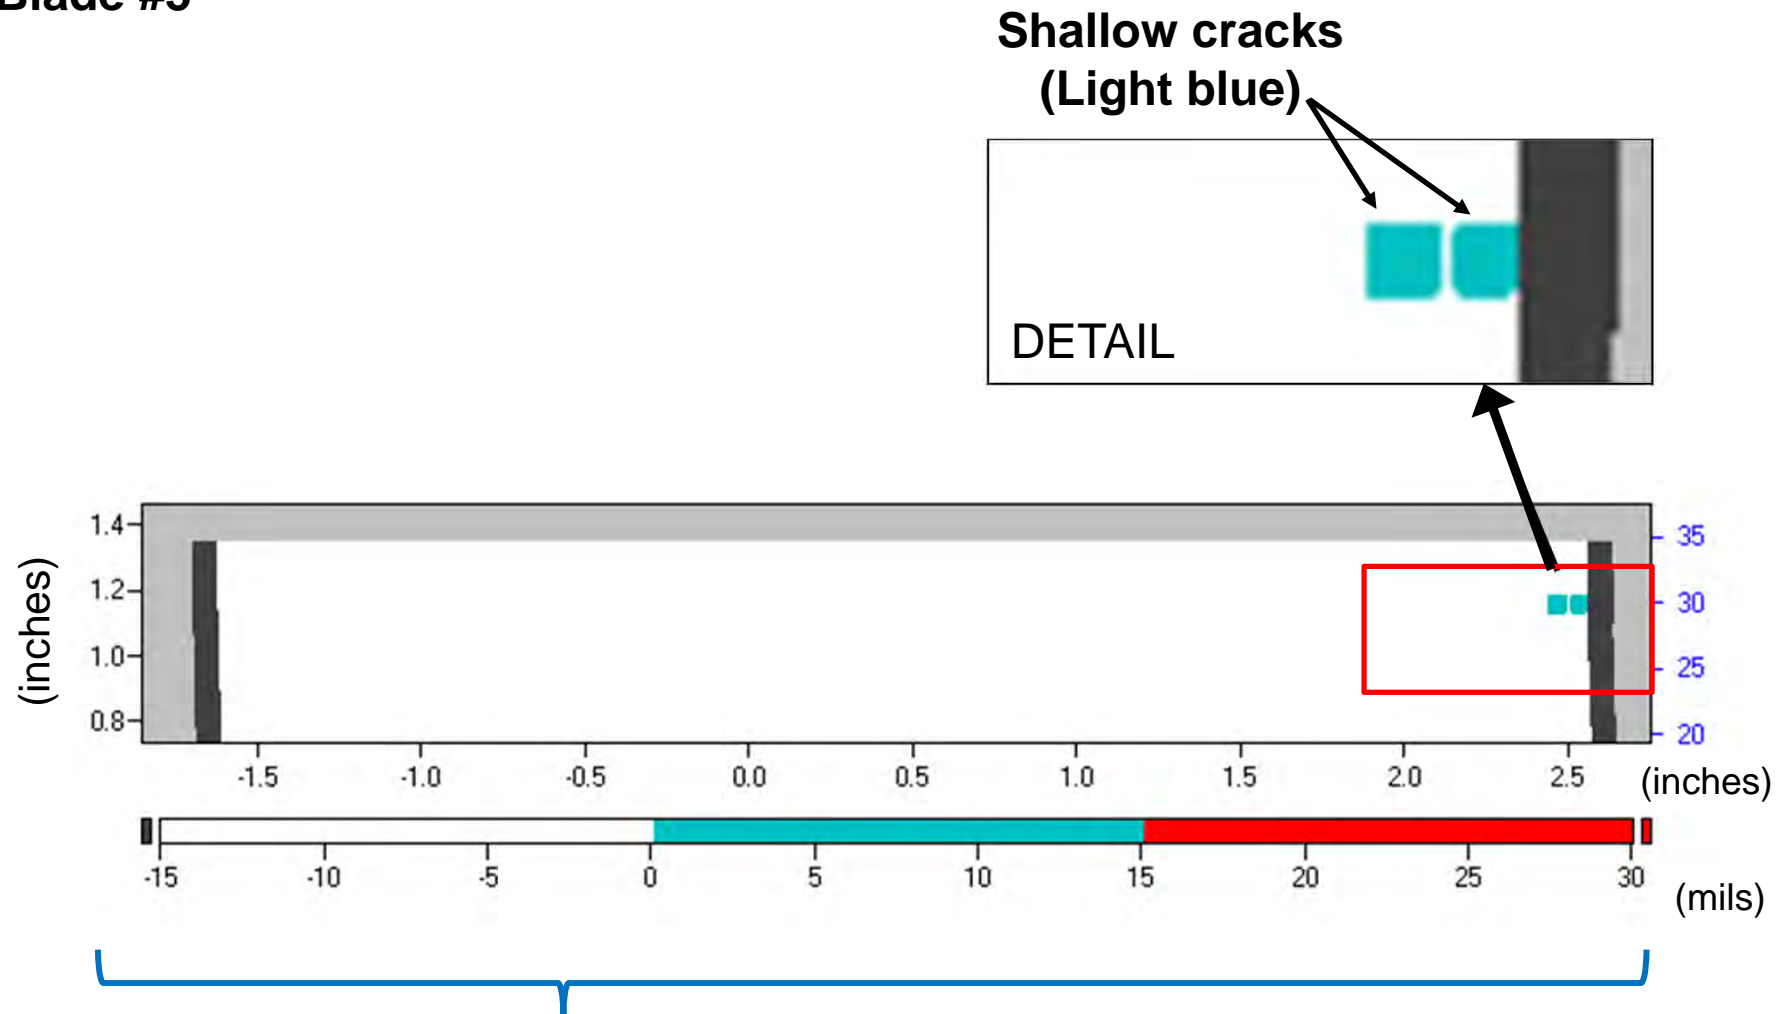
## Blade #5

*Entire image encompasses one complete side of dovetail*

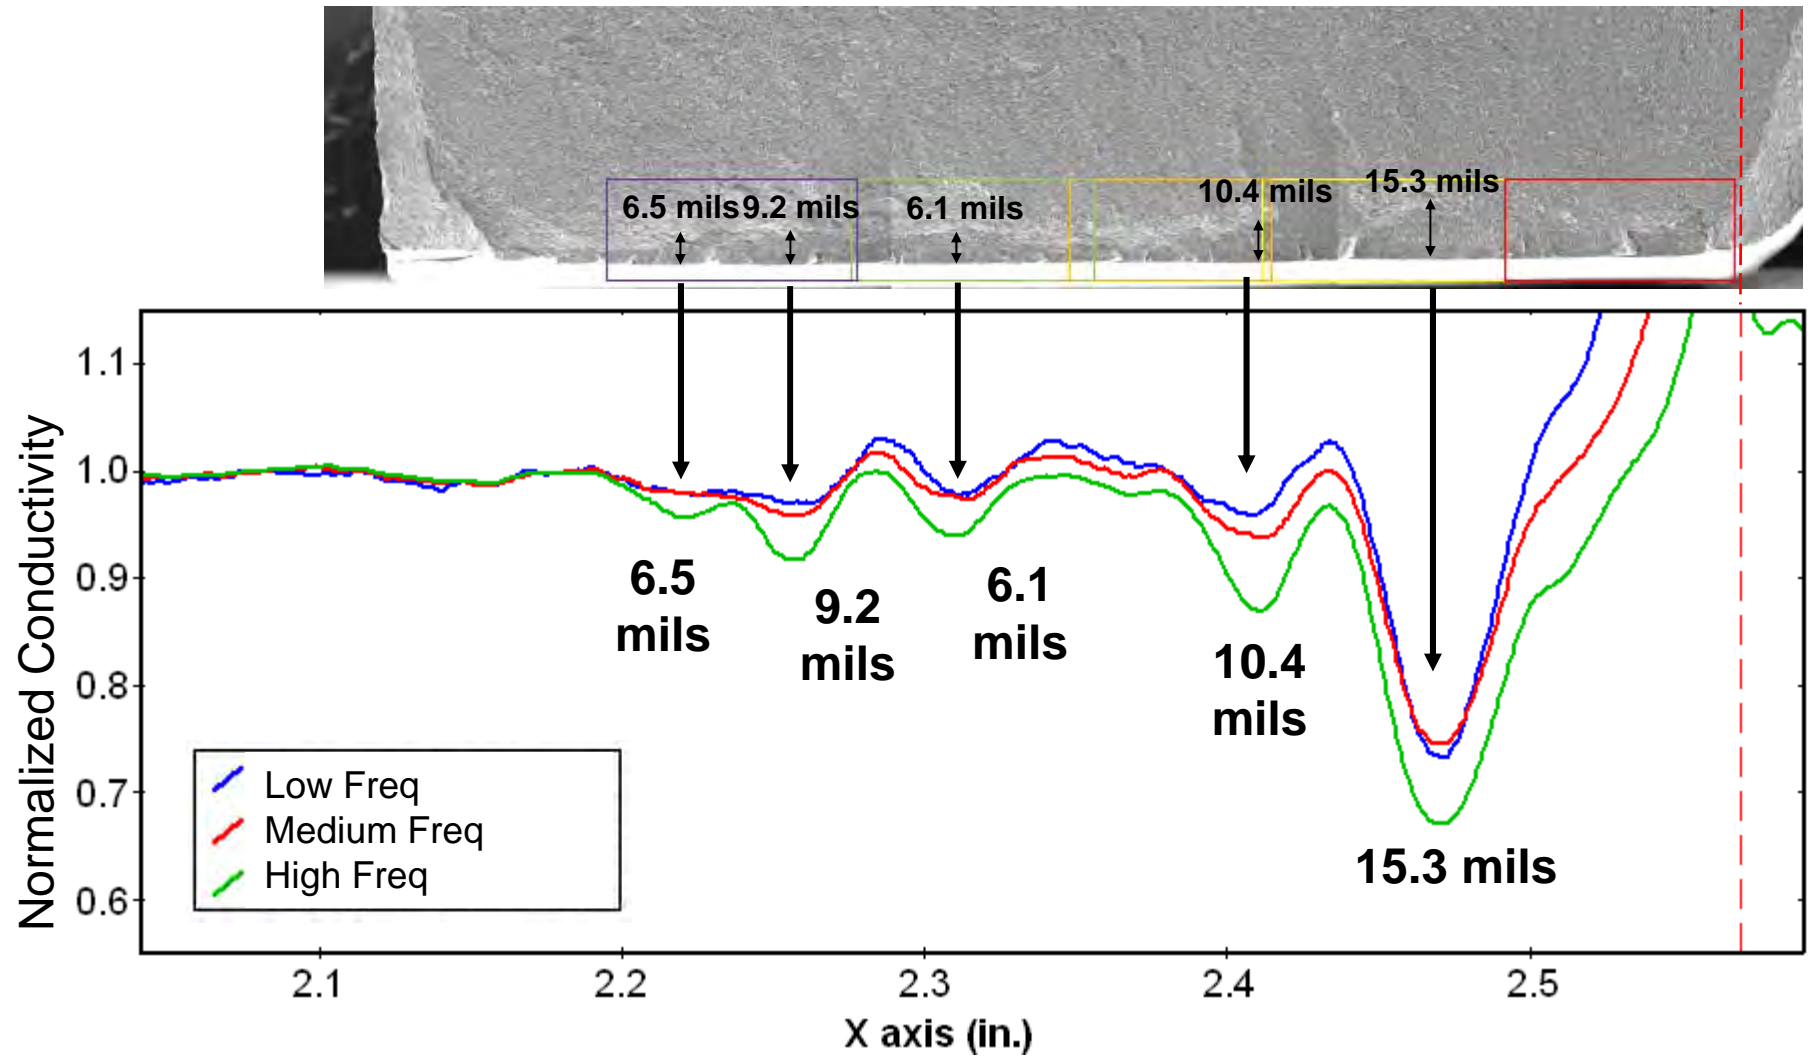
Blade #13

# Case Study 2b: MWM-Array Conductivity Response

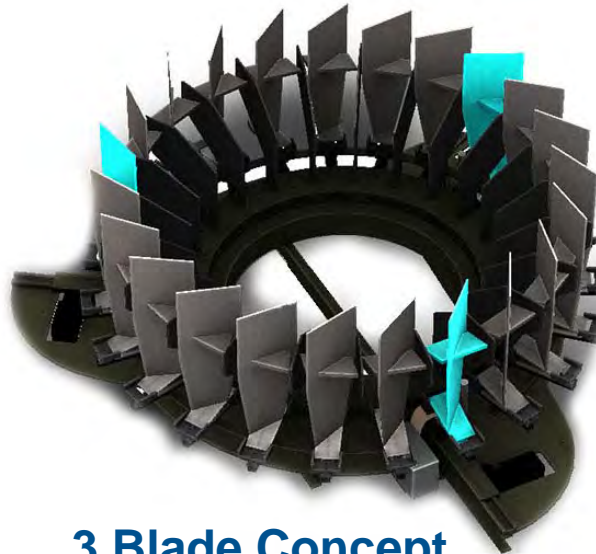
**3 Blade Concept**

*Scan up to 6 blades at once*

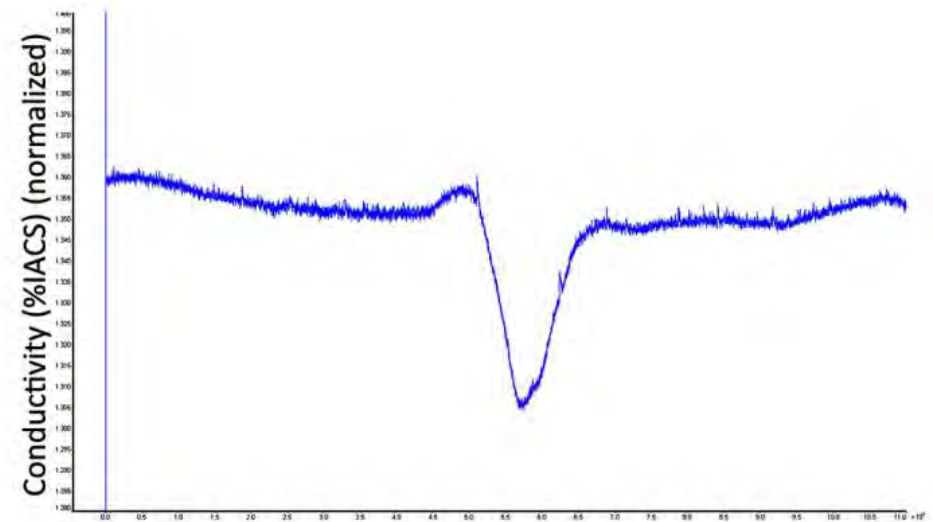
8200 Crack Response

**1,300 samples per second**

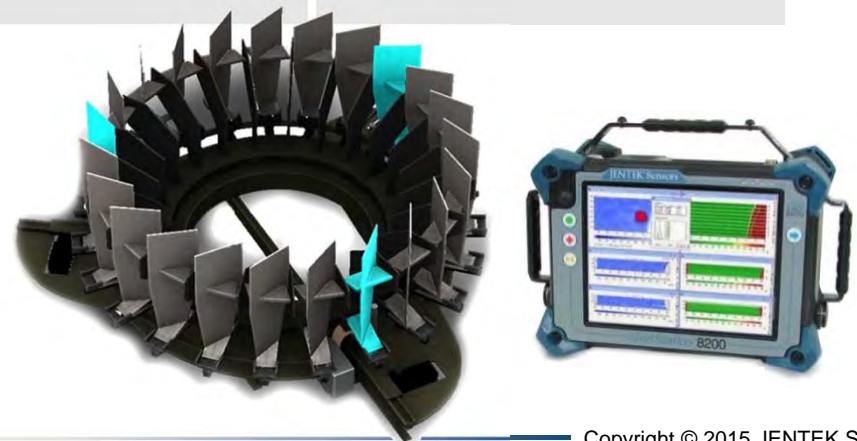
7000 System, 37 channels	8200 System, 119 channels
Scan time	90 seconds per blade	9 seconds
Rotation time	30 seconds per blade	30 seconds
Total Time 1 array	1 hour	20 minutes
Total Time 2 arrays	N/A	10 minutes
Total Time 3 arrays	N/A	7 minutes
