Mapping & Tracking Properties of Next Generation Space Vehicle Materials

JENTEK Sensors, Inc.

Eric Madaras, Buzz Wincheski,
NASA Langley Research Center

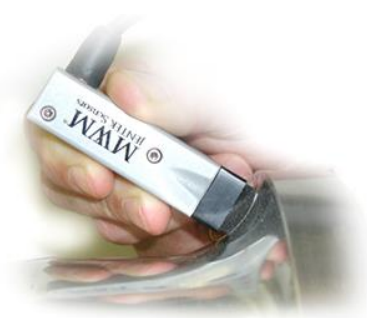
MWM FS33

Single-channel MWM sensor

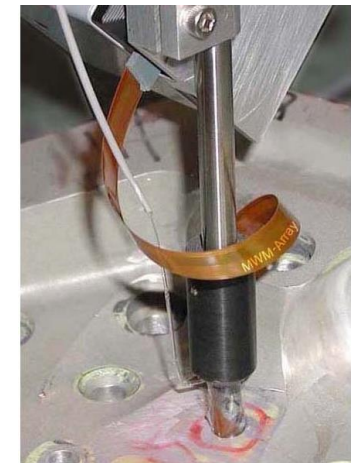
MWM-Array FA43

Multi-channel MWM-Array sensor

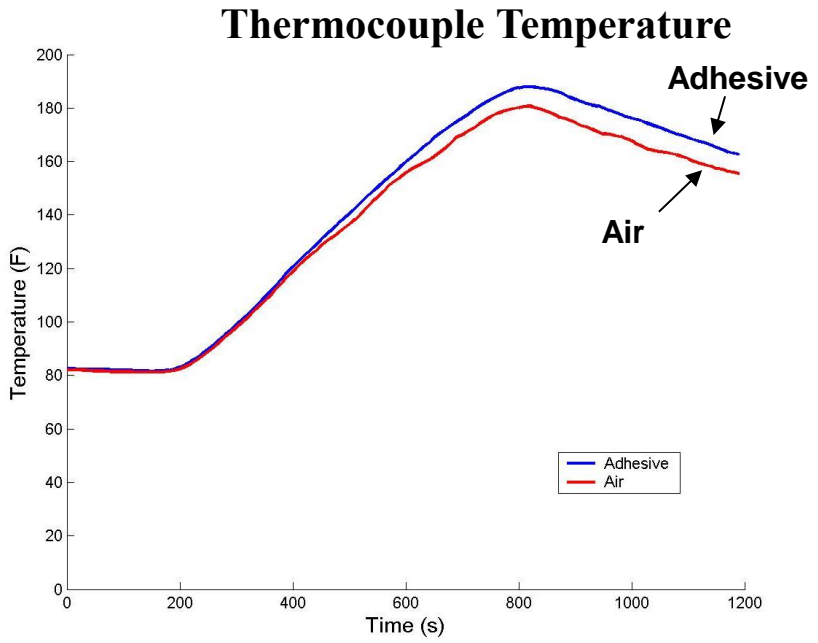
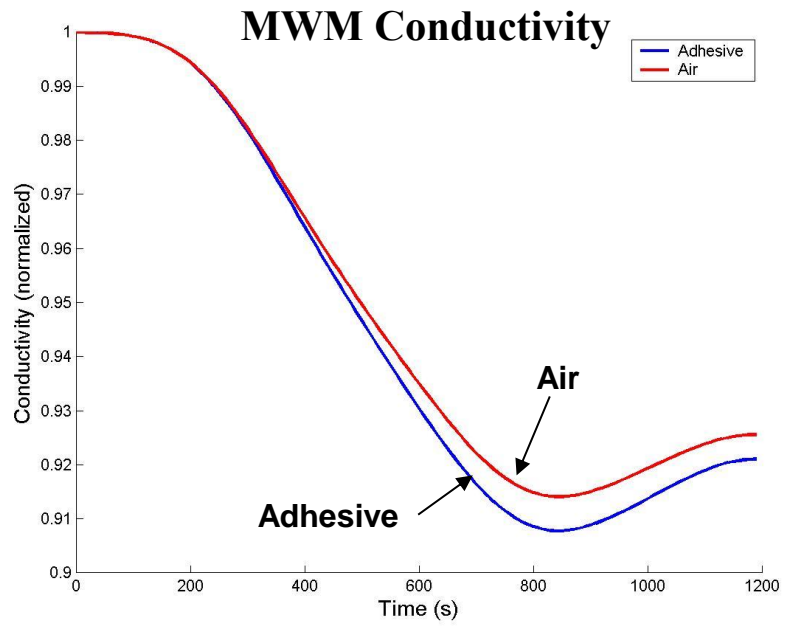
Magneto-Thermography Capability Demonstration: Metal-Metal Joint (JENTEK IR&D Project)

- Hot plate provides heat
- The temperature difference along the upper plate part over the adhesive and the part over air simulates a disbond
- Differences in temp. lead to differences in material conductivity
- Conductivities of both upper plate areas are measured using mounted MWM-Array sensor

$$\sigma = \frac{\sigma_0}{1 + k_c(T - T_0)}$$

k_c = thermal coefficient of resistance (/K)

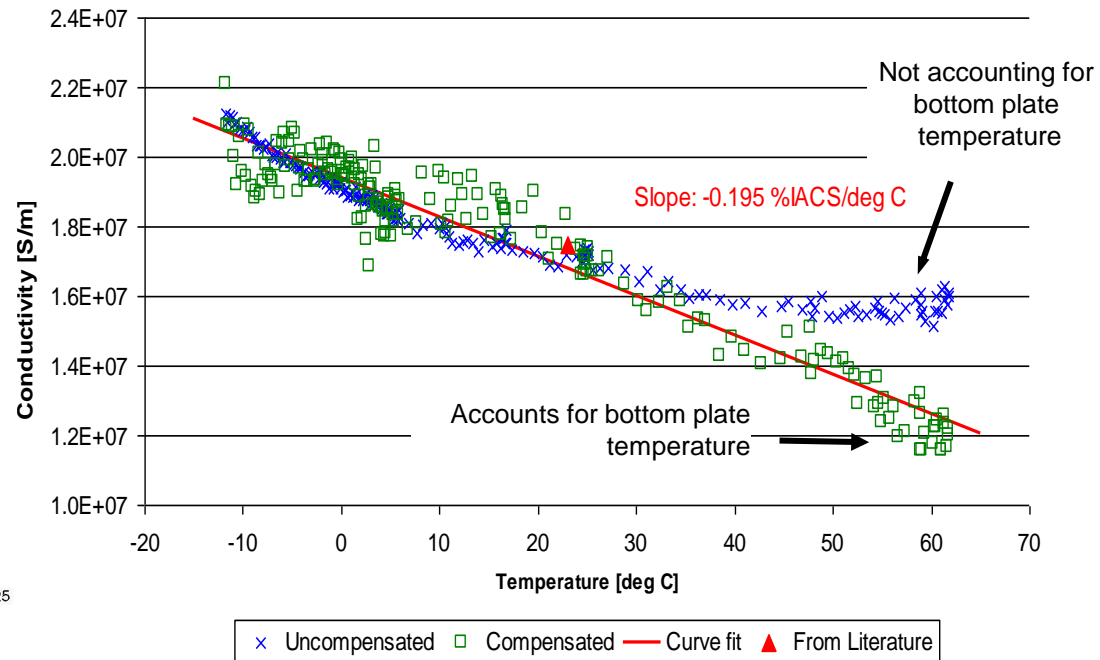
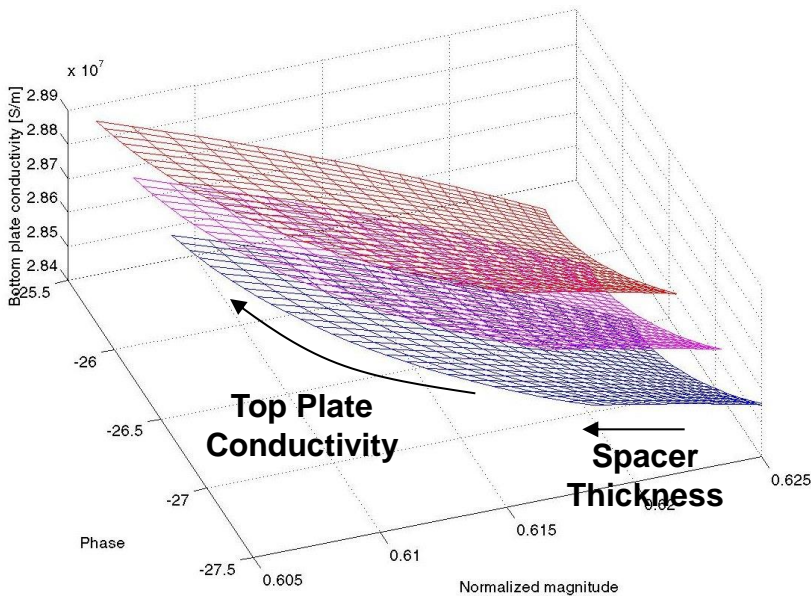
Through-Wall Temperature Monitoring

Need: Non-invasive through-wall temperature measurement at inaccessible locations

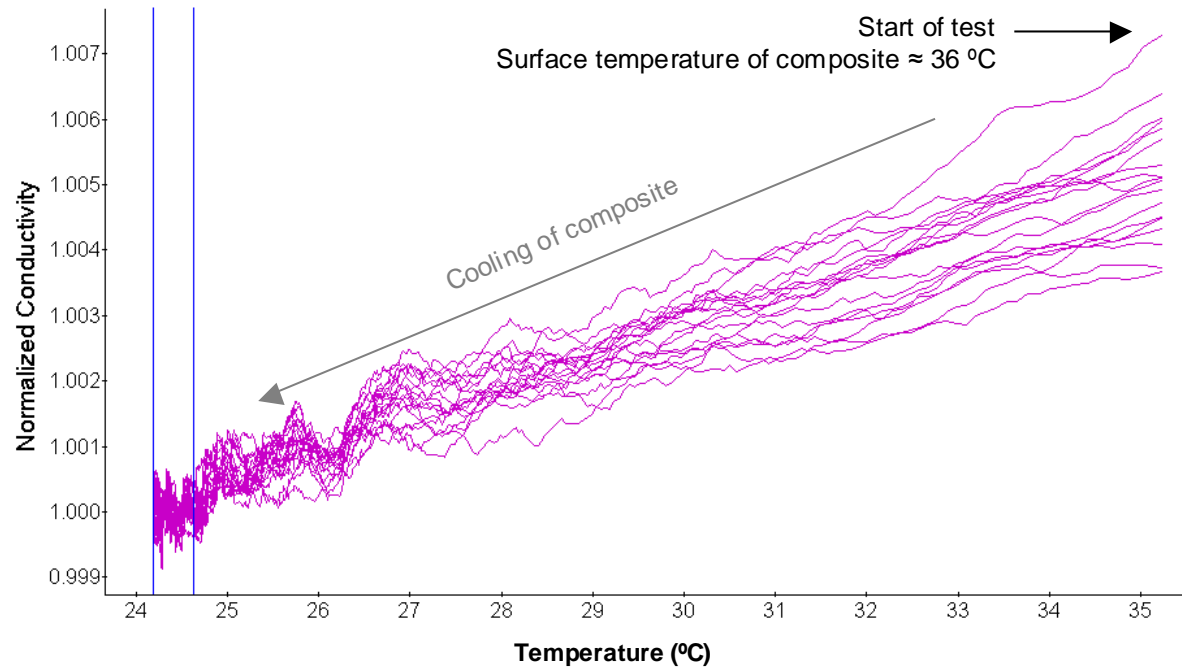
Composite Fiber Temperature Monitoring

Magneto-Thermography Feasibility Tests

Measured Temperature of Buried Fibers

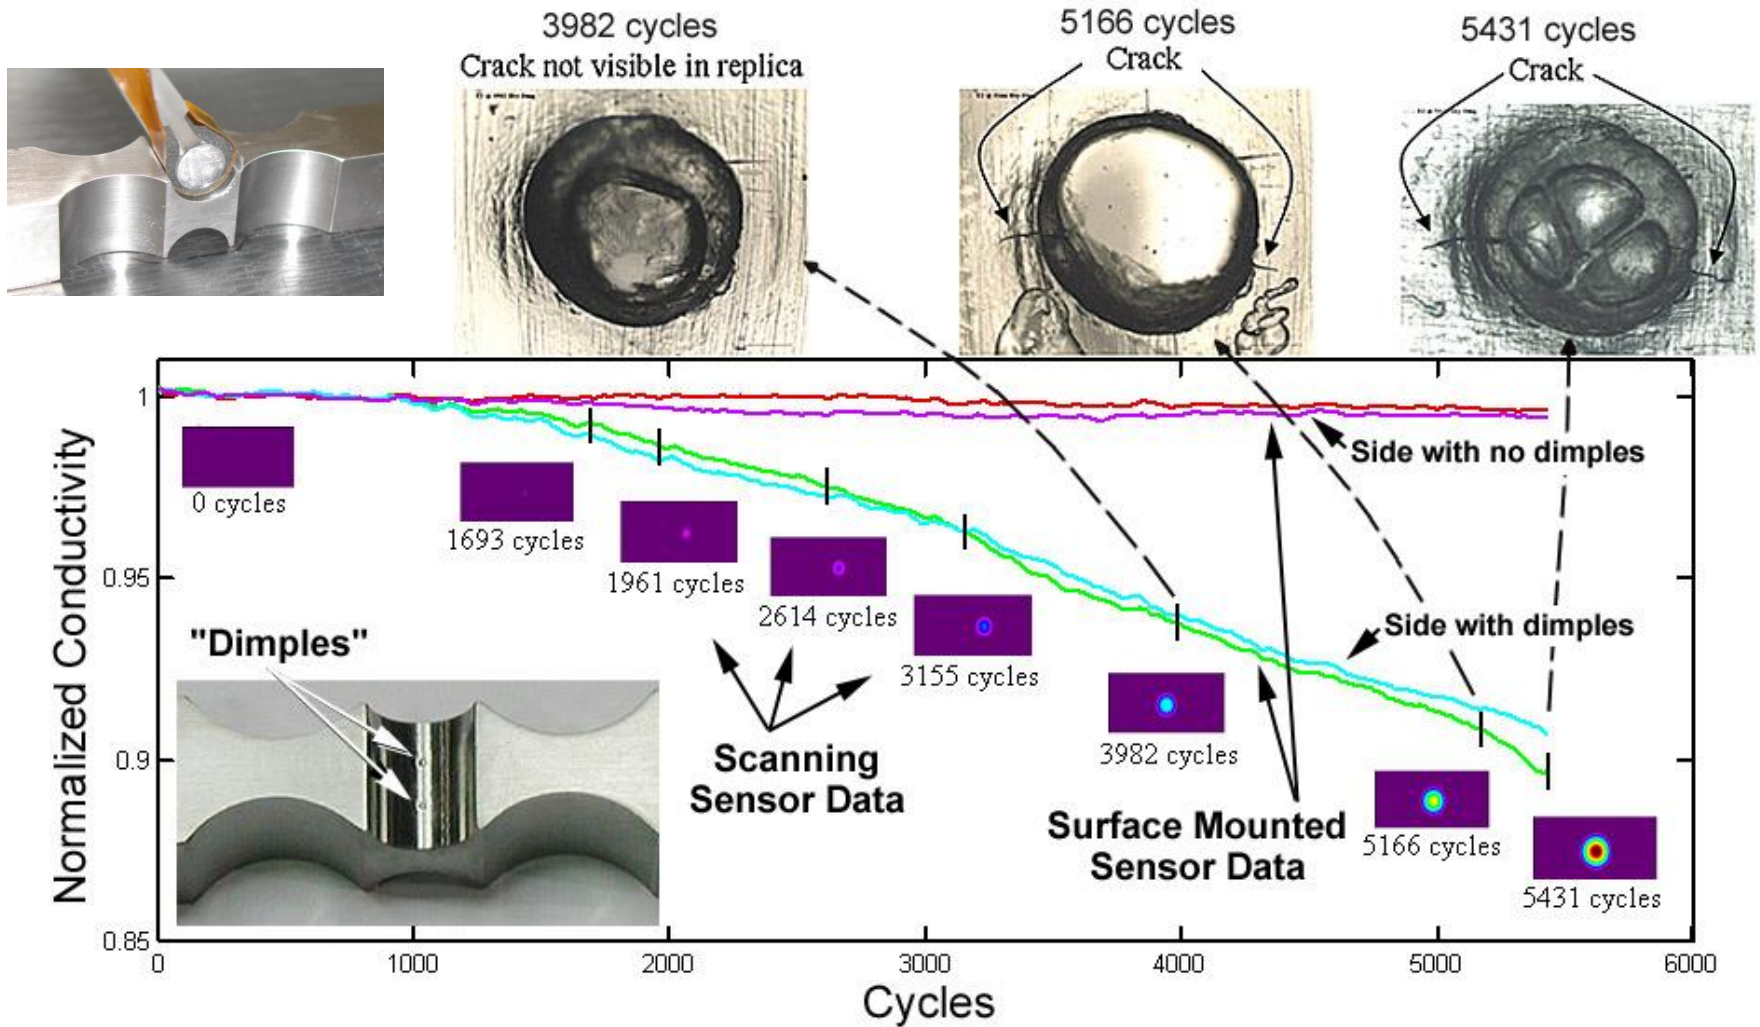
Mapping and Tracking of Crack Initiation and Growth at “Dings” in Ti-6Al-4V

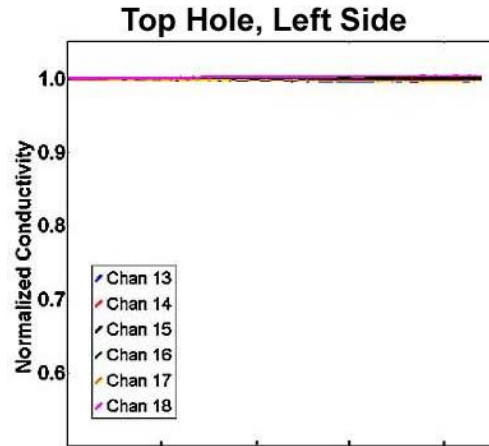
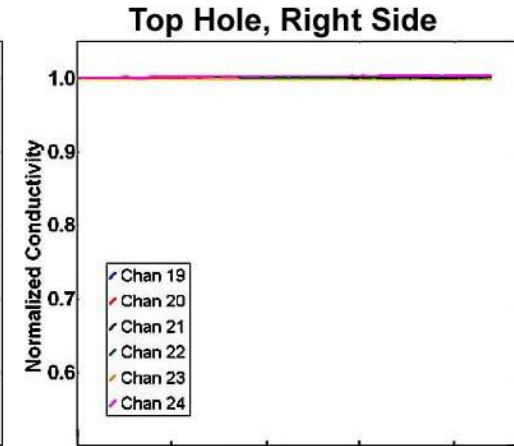
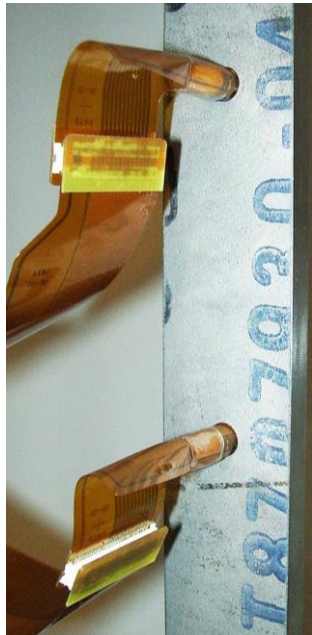
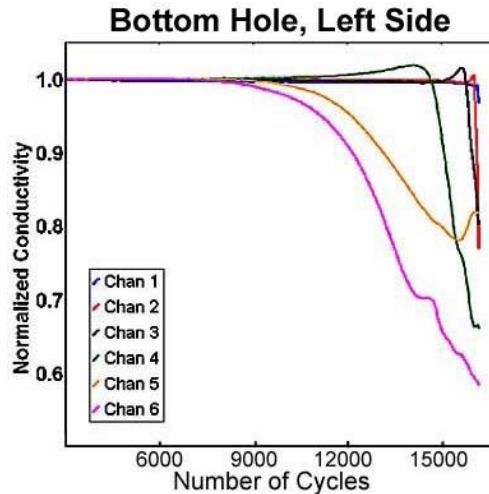
Generation of “Real Crack” Specimens

MWM-Array
FA75

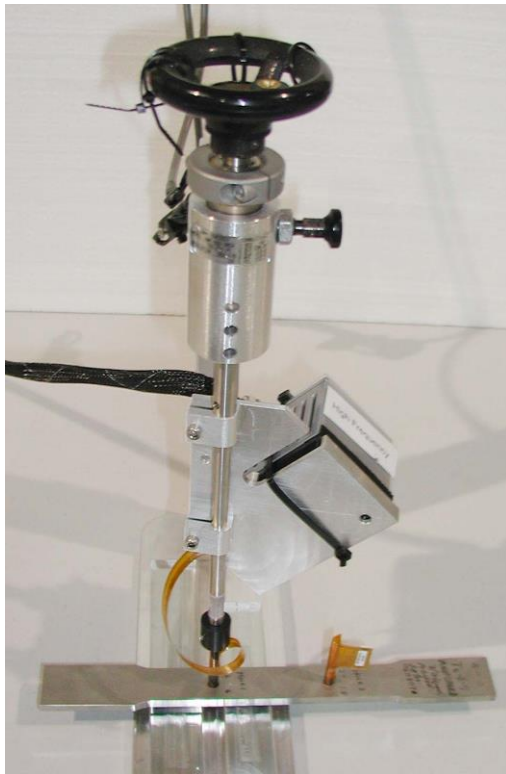
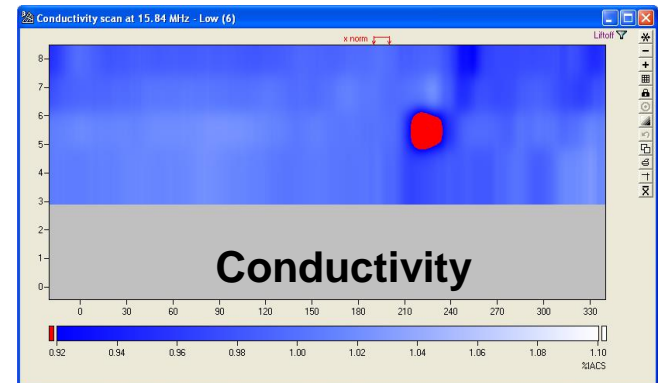
MWM-Array Scans for Bolt Hole Inspection

MWM-Array FA43

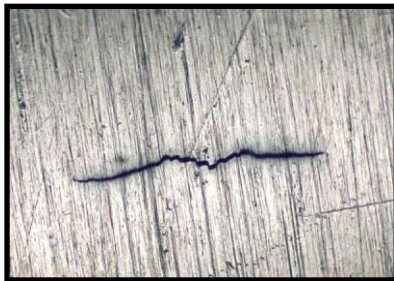
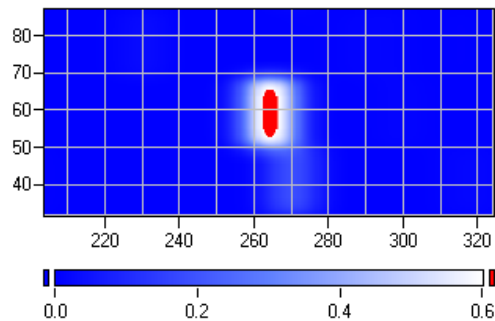
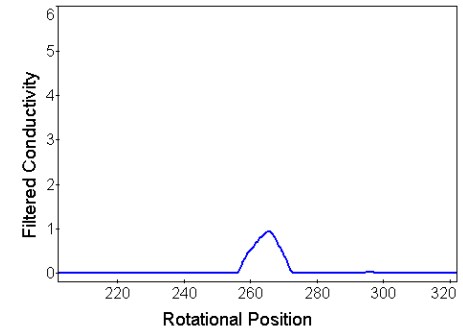
Time Sequenced Images of Crack Growth

24,840 cycles
0.017 in.

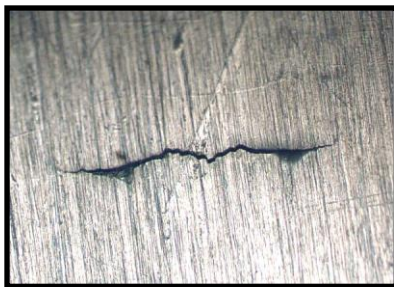
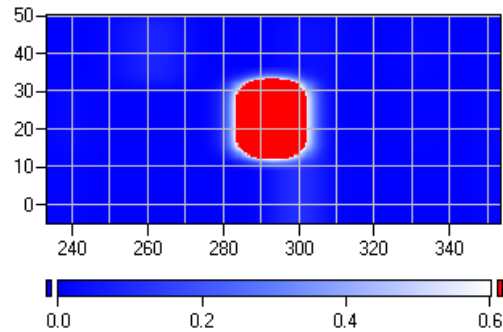
25,348 cycles
0.0205 in.

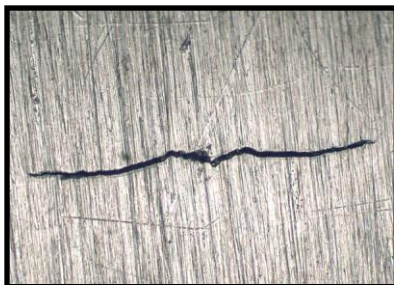
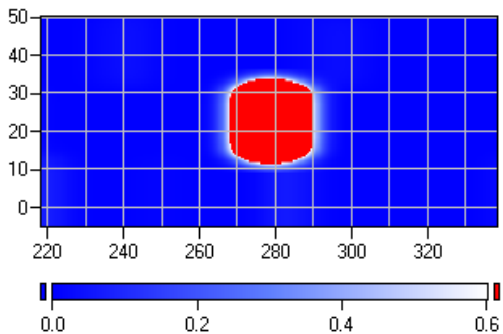
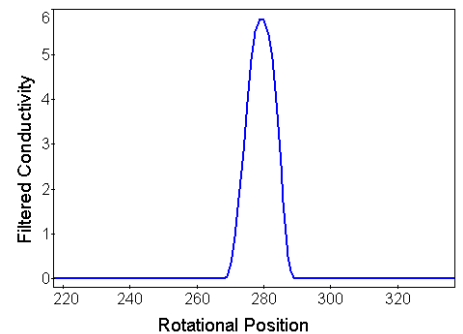
25,907 cycles
0.0259 in.

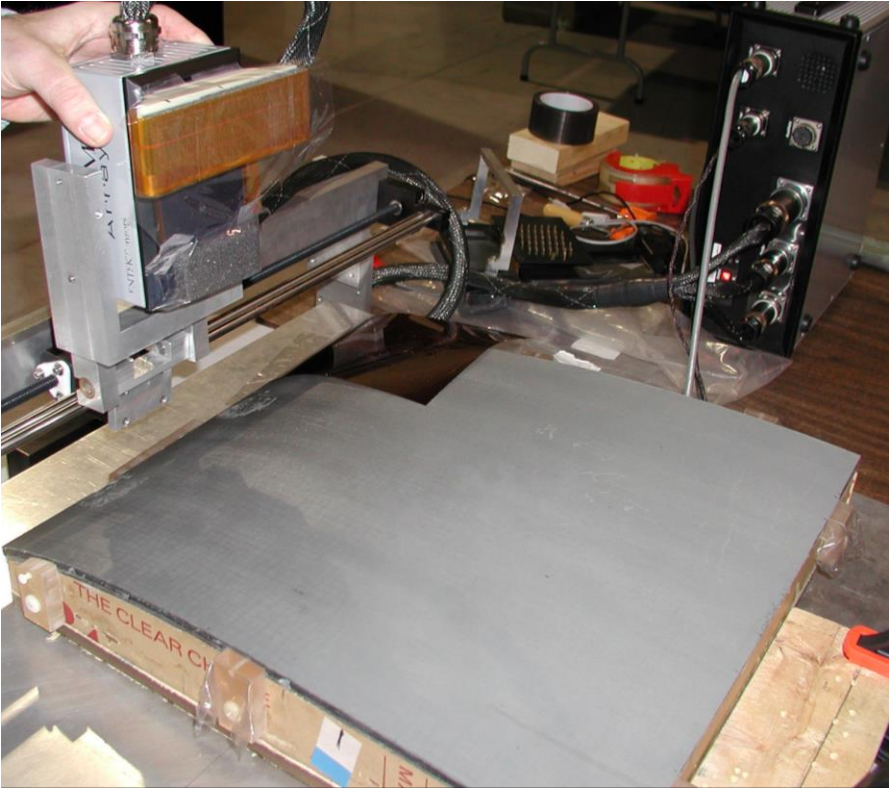
Test Setup for MWM-Array RCC Inspection Validation

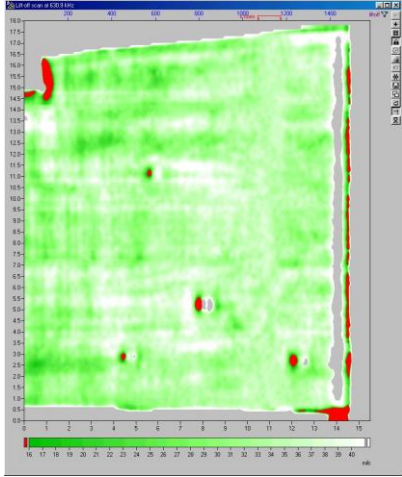
Lift-Off Image

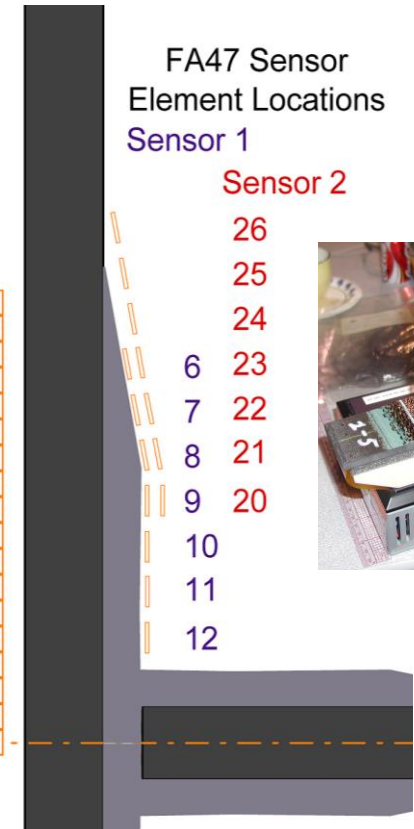
Composite (Buried) Disbond Growth Mapping and Tracking

- Surface mounted sensors
- Scanning sensors (not shown here)

FA24 Sensor Element Locations

FA47 Sensor Element Locations
Sensor 1

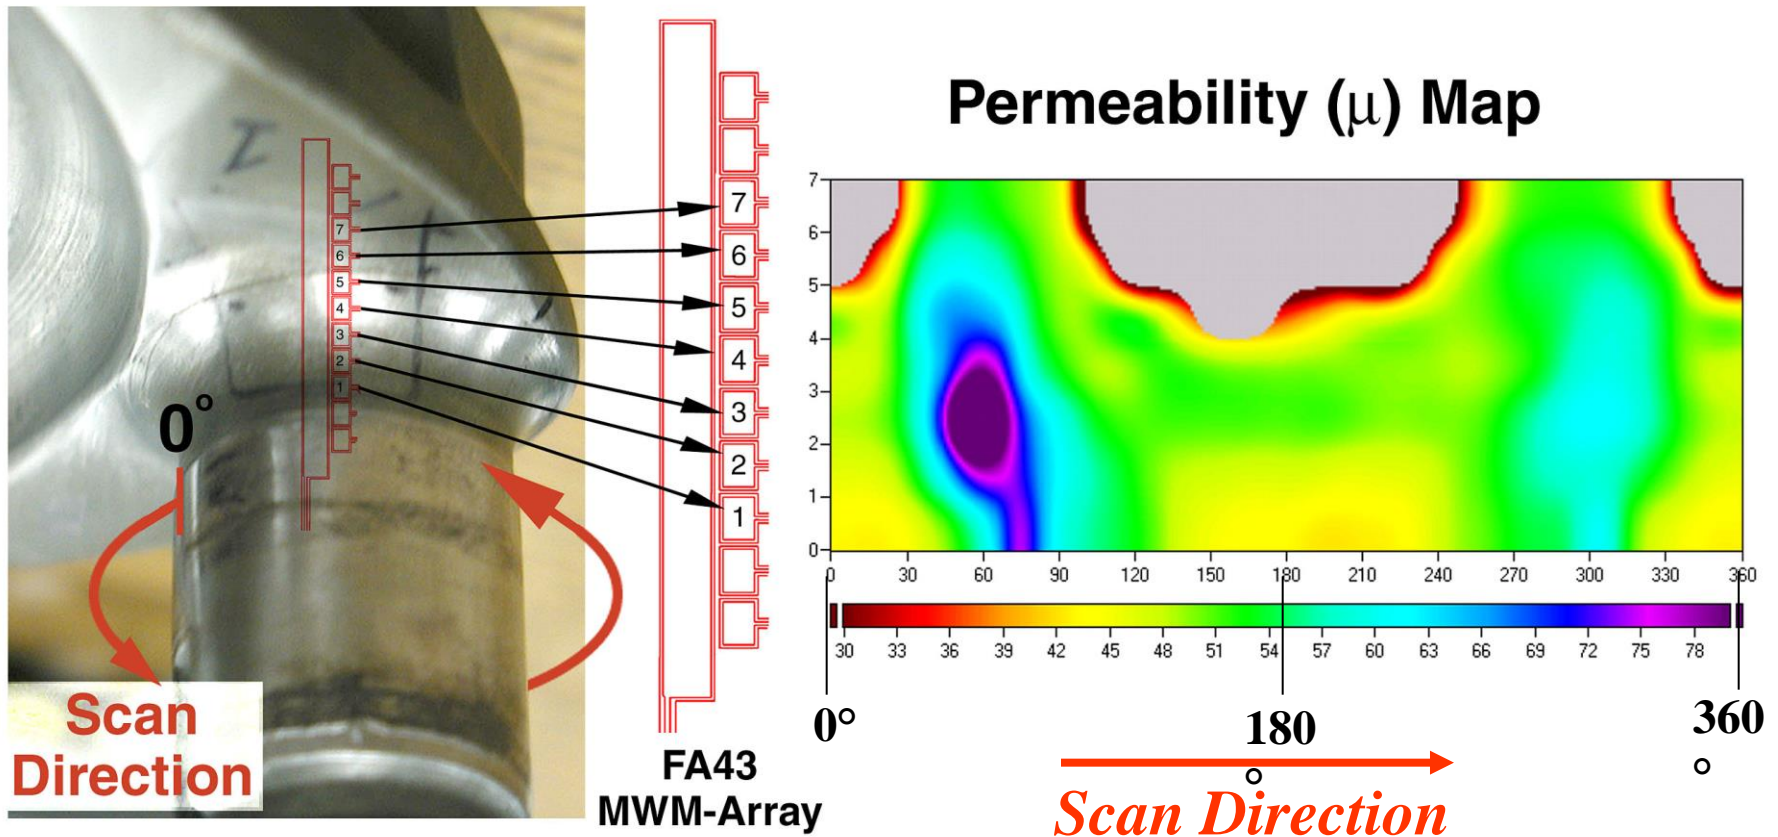
Fighter Aircraft Steering Crank Inspection

Sensor placement and permeability map produced

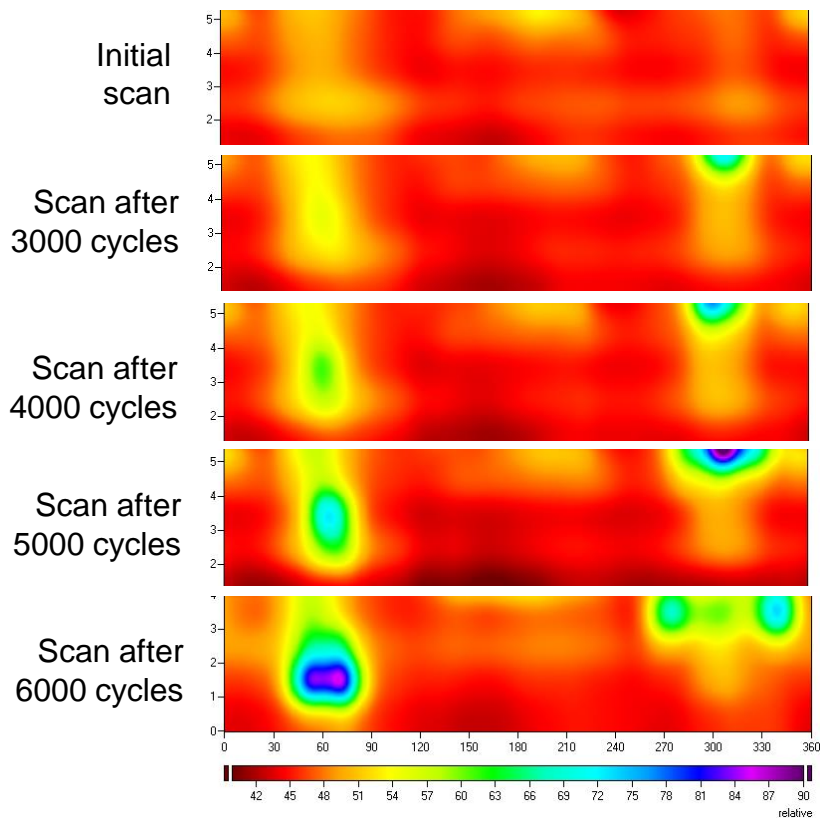
C-Scan Images of MWM-Array Measured Magnetic Permeability

Acquired during periodic interruptions of two fatigue tests

Test 1 Permeability (μ) Evolution
High Load

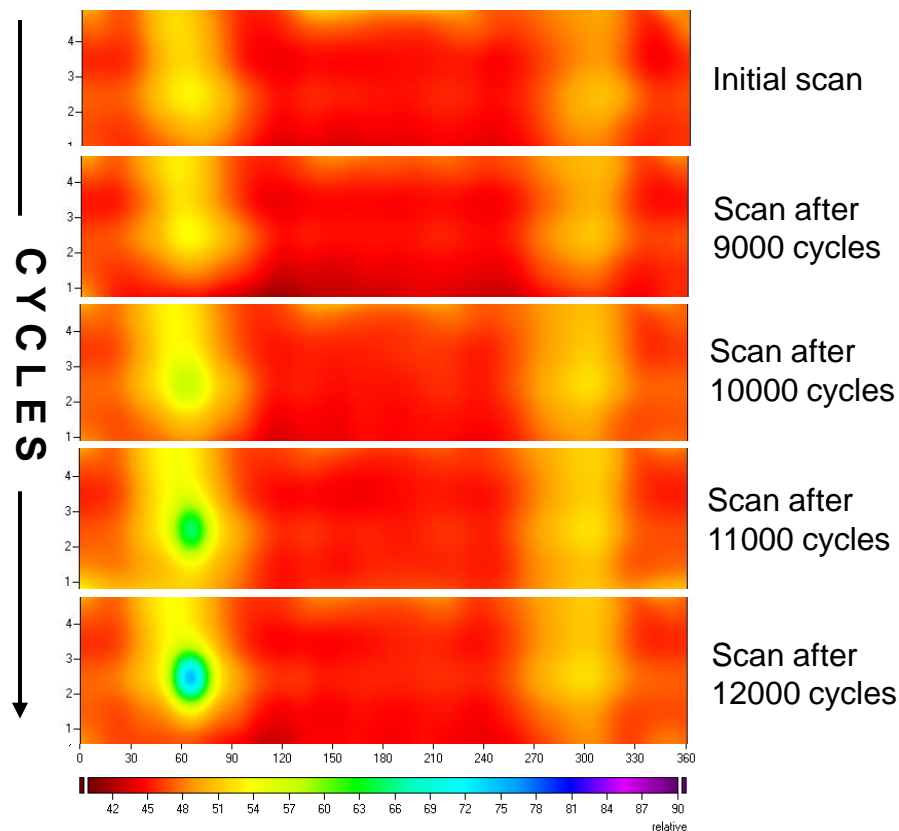
Test 2 Permeability (μ) Evolution
Low Initial Load

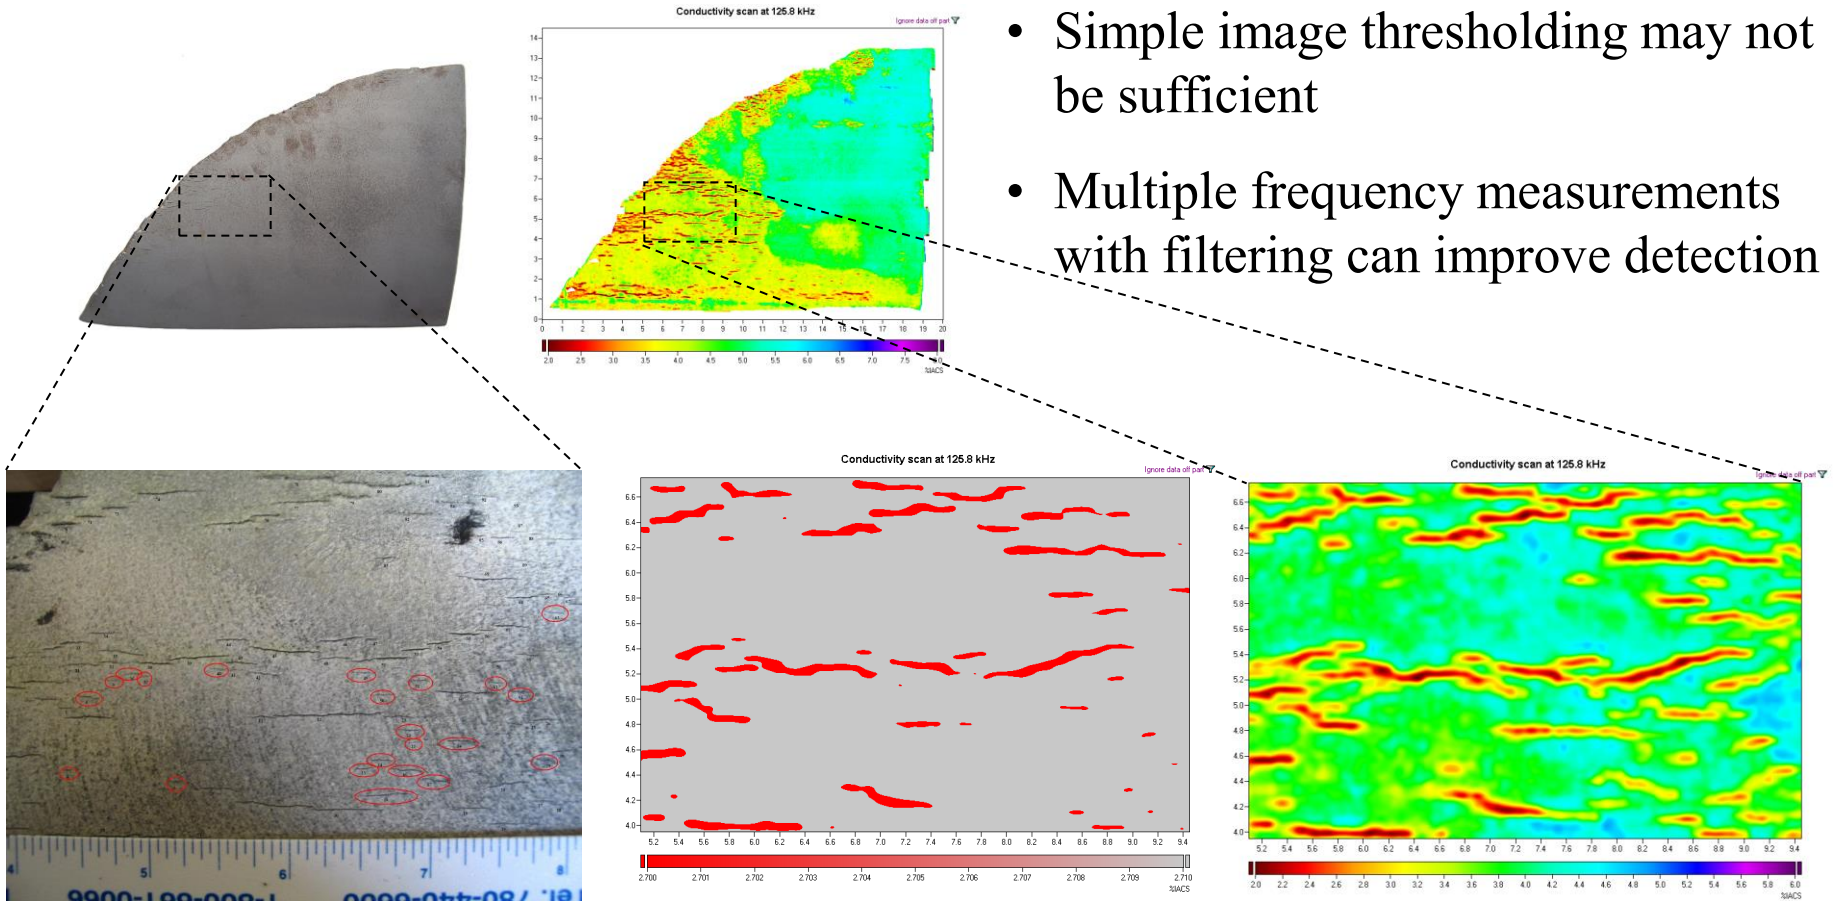
Imaging of SCC in Pipeline Sample

Establishing Detection Criteria

- Simple image thresholding may not be sufficient
- Multiple frequency measurements with filtering can improve detection

MPI Analysis by RTD.

Circled cracks do not appear in MWM thresholded image.

MWM threshold image.

MWM spectrum image.

All cracks identified by MPI were detected.

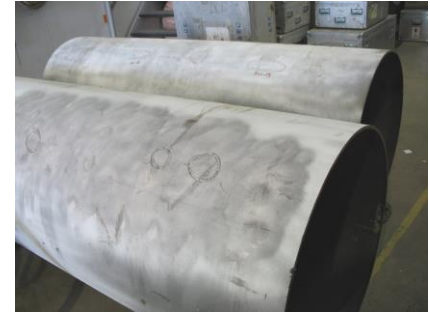
Scans of Pup Section With Identified SCC

Threshold Image

Spectrum Color Image

(RTD p/n NPS34 #1)
