ENHANCEMENTS IN MWM-ARRAY HIDDEN CORROSION IMAGING

Neil Goldfine, Vladimir Zilberstein, Darrell Schlicker, David Grundy, Ian Shay, Robert Lyons, Tim Lovett

JENTEK Sensors, Inc., 110-1 Clematis Avenue, Waltham, MA 02453-7013

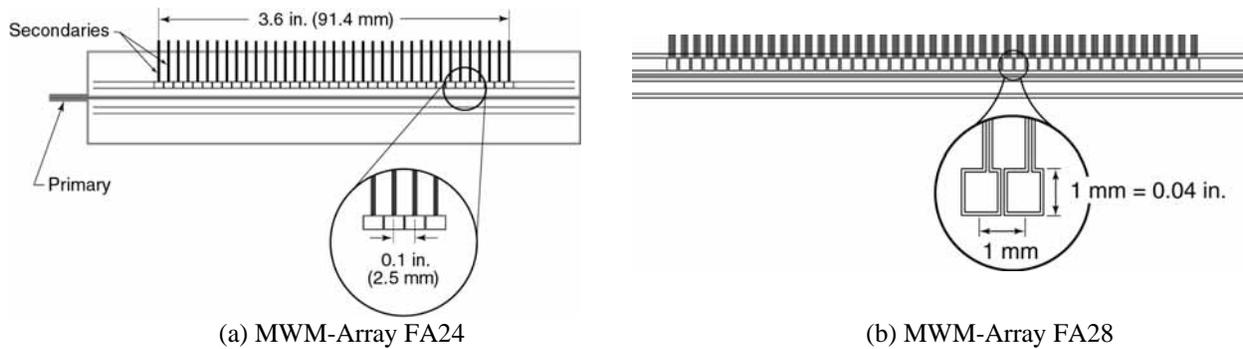
FIGURE 1. (a) FA24 MWM-Array with a wide sensing element/drive winding spacing for imaging of hidden corrosion up to 0.1 in. (2.5 mm) depth (b) FA28 MWM-Array with a narrow sensing element/ drive winding spacing and smaller sensing elements for higher resolution imaging of surface corrosion and small cracks through paint.

Figure 1 shows two MWM-Array sensor configurations:

- Deep penetration array for imaging of hidden corrosion and subsurface cracks (Figure 1a: FA24)
- Near surface imaging array for surface corrosion and near-surface cracks (Figure 1b: FA28)

Each of these MWM-Arrays has multiple inductive sensing elements. These small sensing elements, e.g., from 0.1 in. by 0.04 in. (2.5 mm by 1 mm) down to 0.04 in. by 0.04 in. (1 mm by 1 mm) are monitored by individual channels using JENTEK's fully parallel architecture impedance instrument (Figure 2a). The depth of sensitivity is defined by the drive winding spacing and frequency. For the deep penetration MWM-Array, the drive spacing is relatively wide, e.g., 0.3 in. (7.6 mm), while the MWM-Array for the surface inspection has a relatively small drive winding spacing of 0.07 in. (1.8 mm). The MWM-Array drive winding is driven with an electric current at a

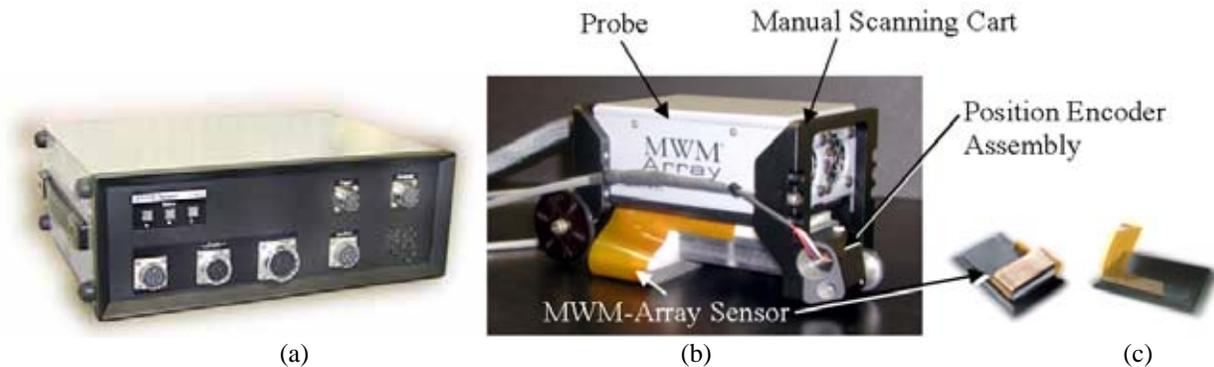
FIGURE 2. (a) Multiple channel impedance instrument, with up to 39 channels, (b) 37-channel MWM-Array probe with rolling position encoder, (c) interchangeable MWM-Array sensor tips.

The fully parallel architecture instrument with parallel architecture probe electronics, shown in Figure 2a, is used to measure the magnitude and phase of the transfer impedance at each sensing element. This high-speed, low noise parallel architecture instrumentation (e.g., with 37 channels providing absolute impedance magnitude and phase measurements in less than 10 milliseconds) combined with C-scan (2-D) imaging software and position measurement encoders provide rapid manual or automated scanning, e.g., 2 in./sec with a 1 to 3 in. wide or wider MWM-Array. High-resolution capabilities also permit imaging of internal geometric features and wall thickness for components with complex surface shape or internal features.

Note that these images are produced by scanning on the accessible side with the corrosion on the opposite side using a manual scanning cart shown in Figure 2 (b). The images are automatically corrected for lift-off (e.g., paint) variations using a measurement grid for thickness and lift-off that assumes a known conductivity value, and with calibration at the air point with no thickness standards. A single frequency method was used. Demonstrations have also included placing sheets of paper on top of the layer to illustrate variable paint thickness imaging and correction. Paint layer thickness can be accurately measured to a small fraction of a thousandth of an inch. Similar methods have been successfully demonstrated for measurement of anodized layer thickness and other thin insulating layers on aluminum for manufacturing quality control.

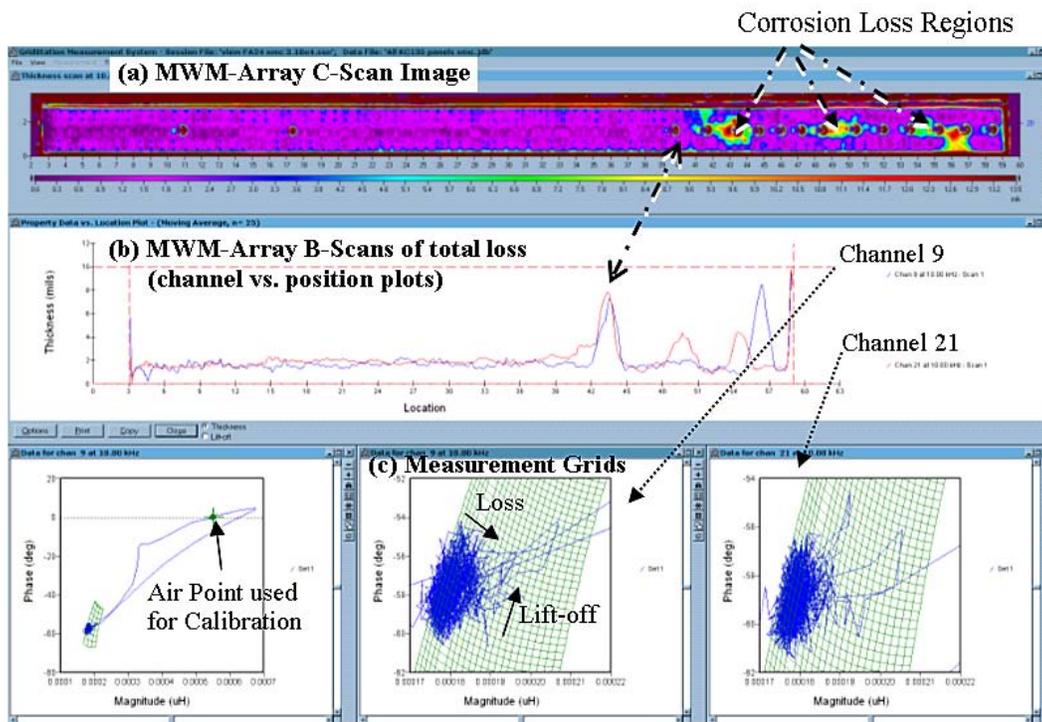
FIGURE 3. GridStation software displaying (a) C-scan image of total material loss for a cut-out section of a KC-135 lap joint (1 mil = 0.001 in. = 25.4 μm), (b) B-scan (channel vs. position plot) of total material loss, and (c) measurement grid for 2-unknown method with data from different channels and scales.

GridStation® Software Environment. Figure 3 provides a typical window from the GridStation software, showing a measurement grid, B-scan (channel vs. position plot), and C-scan image of total loss for a KC-135 lap joint. The GridStation Software Environment has two interface modes: Analyst and Operator. The Analyst mode is designed to support measurement & calibration procedure development and analysis of results using advanced tools. Operator interfaces are dedicated interfaces developed to support a specific inspection. For example, an operator interface that was developed for the C-130/P-3 propeller cold work quality inspection has been in use by the Air Force for over three years and the Navy for over two years at several depots. This interface provides operator security, historical data archiving, decision support for quality assessment and visualization tools to support operator error reduction and ease-of-use.

The method used to create this C-scan image used a calibration at the Air Point, called Air/Shunt Calibration, that uses two different MWM-Array sensor tips in Air, one standard array and one that has all sensing elements individually shunted. This permits correction for cable, instrumentation and sensor variations. The Measurement Grids for lift-off and total material thickness (or loss) are then used to correct for lift-off. Assumed gap and Alclad thickness are used in a forward model to calculate the sensor response over the entire lift-off and total material loss ranges of interest. Then for each of the thousands of MWM-Array sensing element responses in the raw impedance (sensing element voltage/drive winding current) data images, the lift-off and total material thickness are calculated using a rapid interpolation algorithm embedded in the GridStation software.

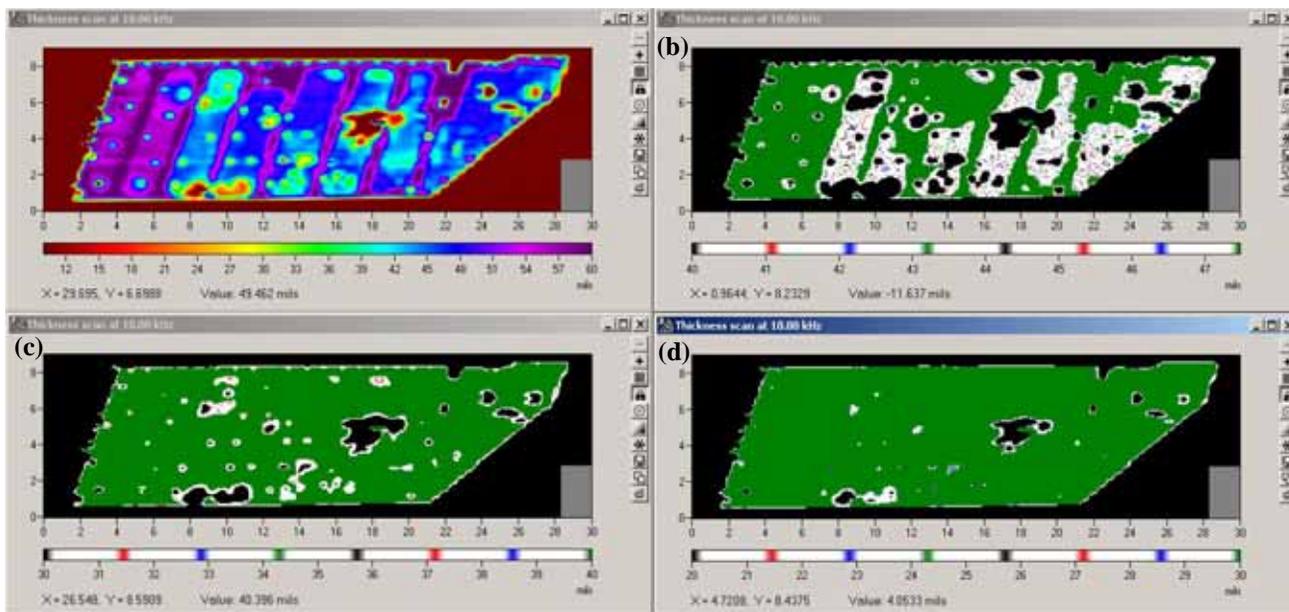
FIGURE 4. MWM-Array thresholded thickness images of C-130 flight deck chine plate: (a) color image not thresholded to demonstrate capability to map internal geometric features, (b, c, d) green=good, white=repairable, black=replace, decision support images with different remaining thickness thresholds shown in the color bar for (b) repair if between 0.04 and 0.475-in. thick, (c) repair if between 0.03 and 0.04-in. thick, and (d) repair if between 0.02 and 0.03-in. thick.

Figure 4 provides improved versions of the C-130 flight deck chine plate images taken with an enhanced version of the original MWM-Array sensor. In Figures 4 (b), (c) and (d), a possible operator view is provided that permits thresholding of the images based on remaining material thickness. In this case, the green region is good, the white regions require further investigation and might be reparable, while the black regions would indicate the need to replace the component. The thresholds in this particular image are arbitrarily set for illustration purposes only.

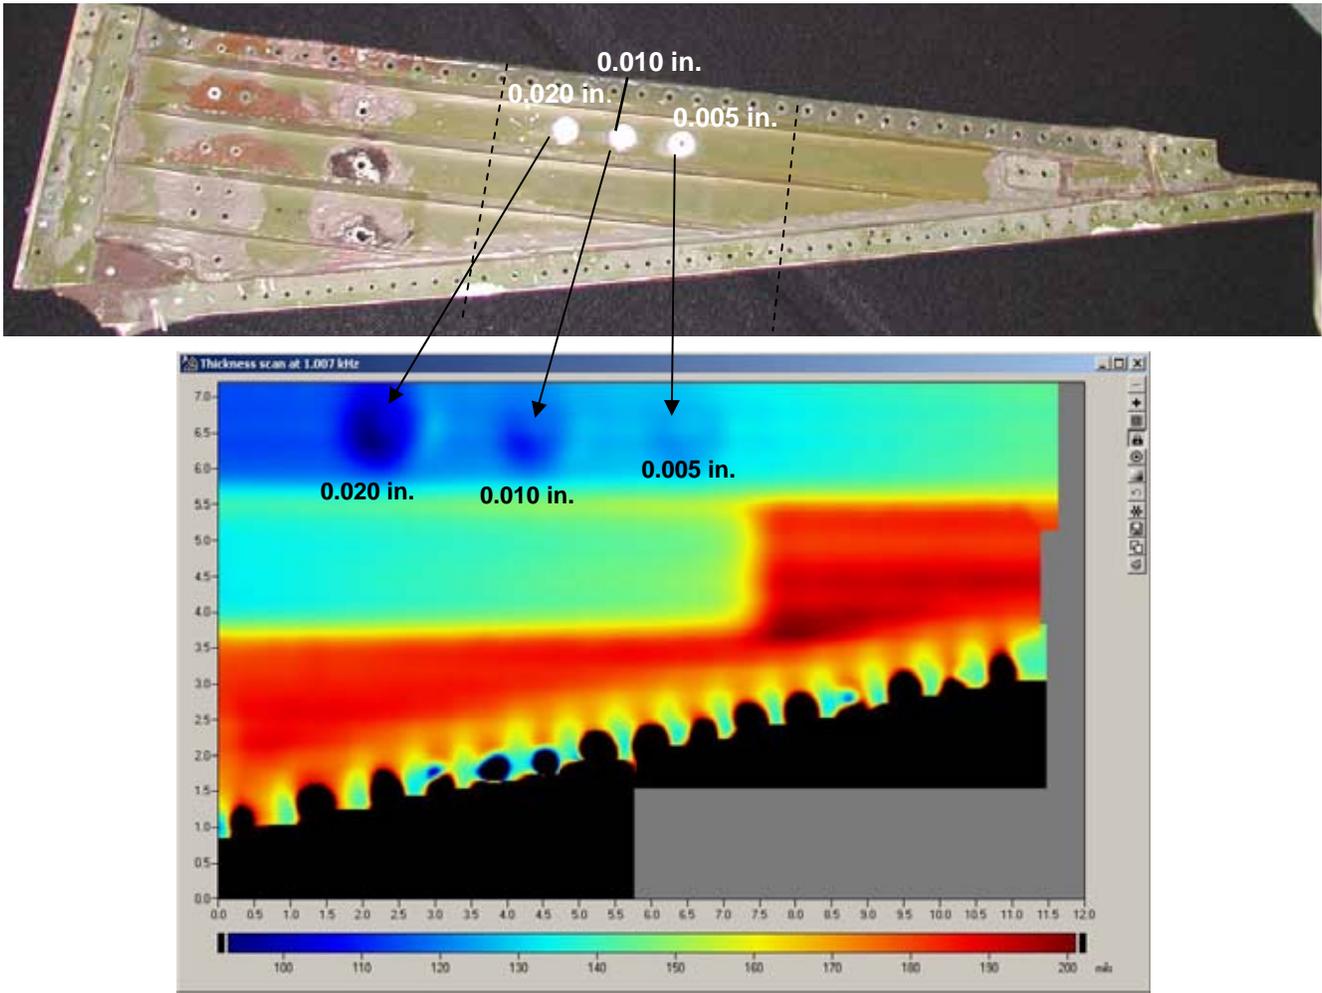
FIGURE 5. Top: Photograph of a P-3 wing plank with milled out regions to simulate corrosion loss. Bottom: MWM-Array image of section of wing plank.

Hidden Corrosion Imaging for P-3 Orion Wing Planks. As a demonstration of MWM-Array capability to provide accurate metal loss estimates, MWM-Array scans were performed on a P-3 wing plank with simulated regions of material loss on the back side. Figure 5 (top) shows the wing plank with material loss on the back side, milled out in this wing plank to simulate corrosion loss of approximately 0.005, 0.010 and 0.020 in. deep. Figure 5 (bottom) provides the results of scans with a deep penetration version of the MWM-Array that uses a much wider drive than the FA24 to permit inspection of aluminum layers up to 0.3 in. Figure 6 illustrates the agreement between the maximum material loss depth estimated by the MWM-Array compared to the actual maximum depth within each of the milled out regions. The actual depth was measured using a depth gauge. This data was obtained in a quasi-blind test run internally at JENTEK without knowledge of the loss. Loss measurements were made after completion of the MWM-Array estimations. The sensor was calibrated without the use of loss standards. This was a single frequency, 1 kHz, measurement.

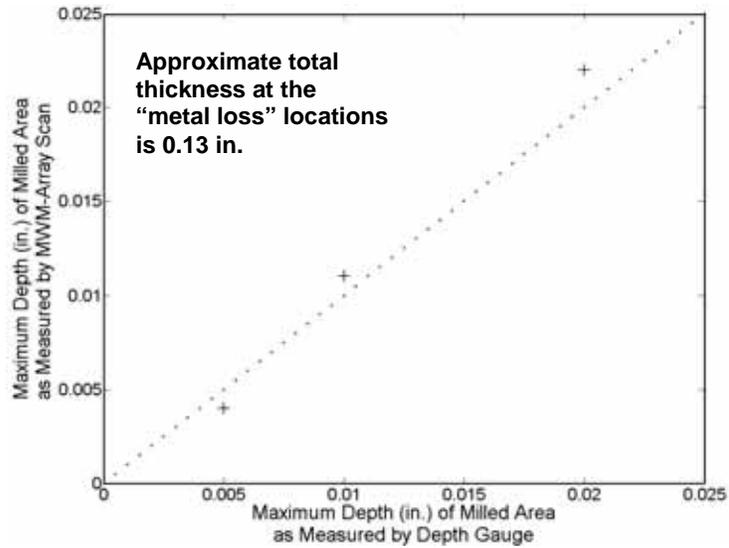
FIGURE 6. MWM-Array hidden metal loss estimates for the three milled out regions versus the actual depth measured with a depth gauge.

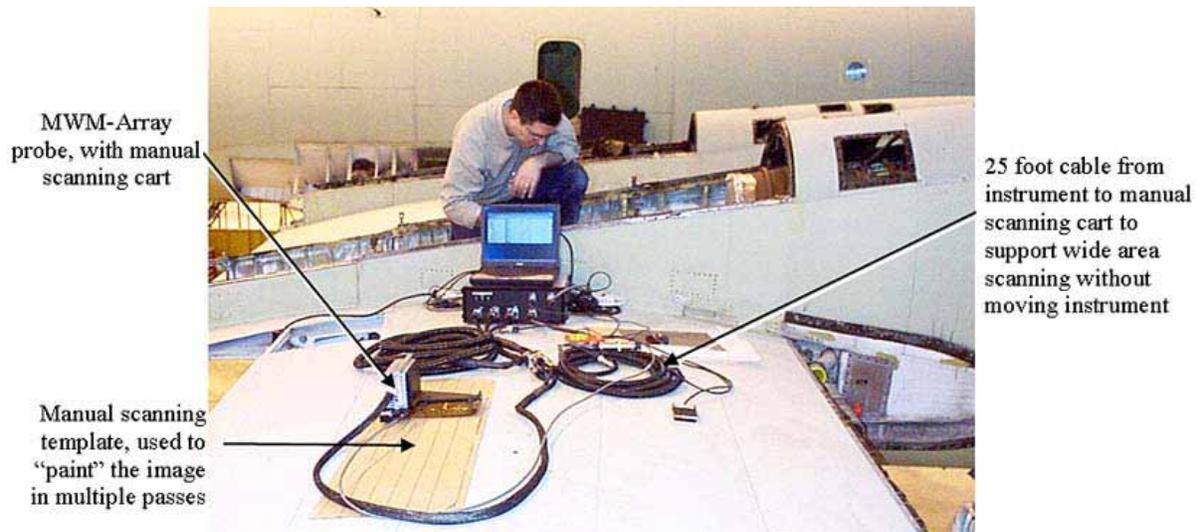
FIGURE 7. Setup and examination of P-3 Plank #2 on an actual aircraft.

Figure 7 shows the setup used for MWM-Array imaging of hidden corrosion in wing planks on an actual aircraft. These tests illustrated the capability to perform this inspection with a single operator.

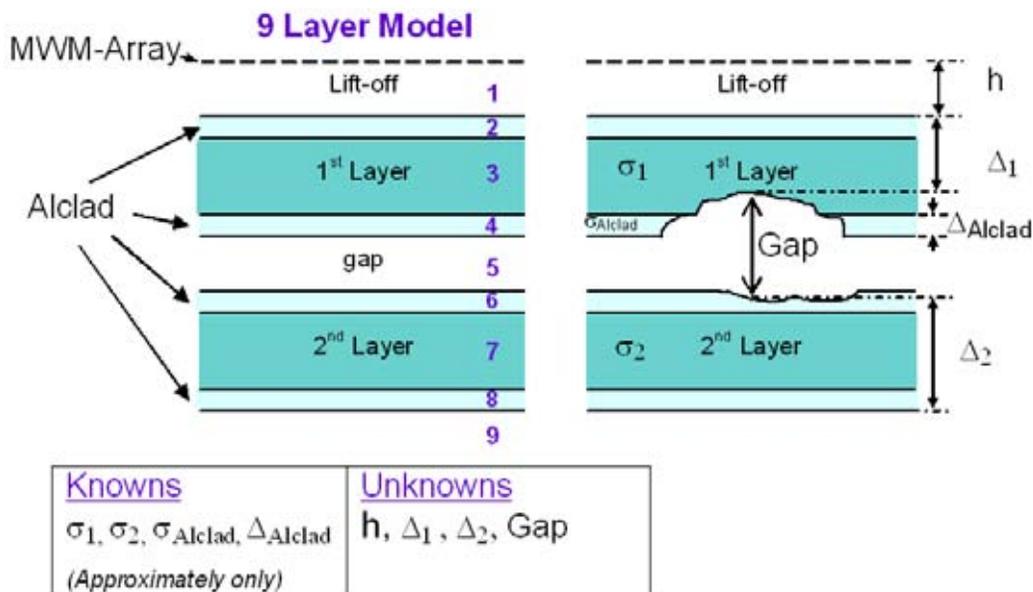
FIGURE 8. Schematic of Multiple Layer Model.

Hidden Corrosion Imaging for KC-135 Fuselage Lap Joints with Three- and Four-Unknown Methods. Figure 8 shows a diagram of the 9-layer model used to generate the pre-computed sensor responses. These pre-computed responses are stored in 2-, 3-, and 4-dimensional databases called Measurement Grids, Lattices, and Hypercubes, respectively. When a doubler is included, the model uses 13 layers instead of nine. Note that each of the Alclad layers must be accounted for and, as described in the following, estimation without accounting for the Alclad layers can produce substantial errors in the material loss estimates. This is because the Alclad is nearly twice as conducting as the aluminum substrate material. Thus, a 0.002-in. thick Alclad layer on a 0.04-in. thick skin represents 5% of the thickness but not including it can result in errors as high as 5% of the thickness. Since the goal is often to estimate the thickness to within a few percent, not including the Alclad, alone, can make it impossible to achieve the required accuracy for material loss.

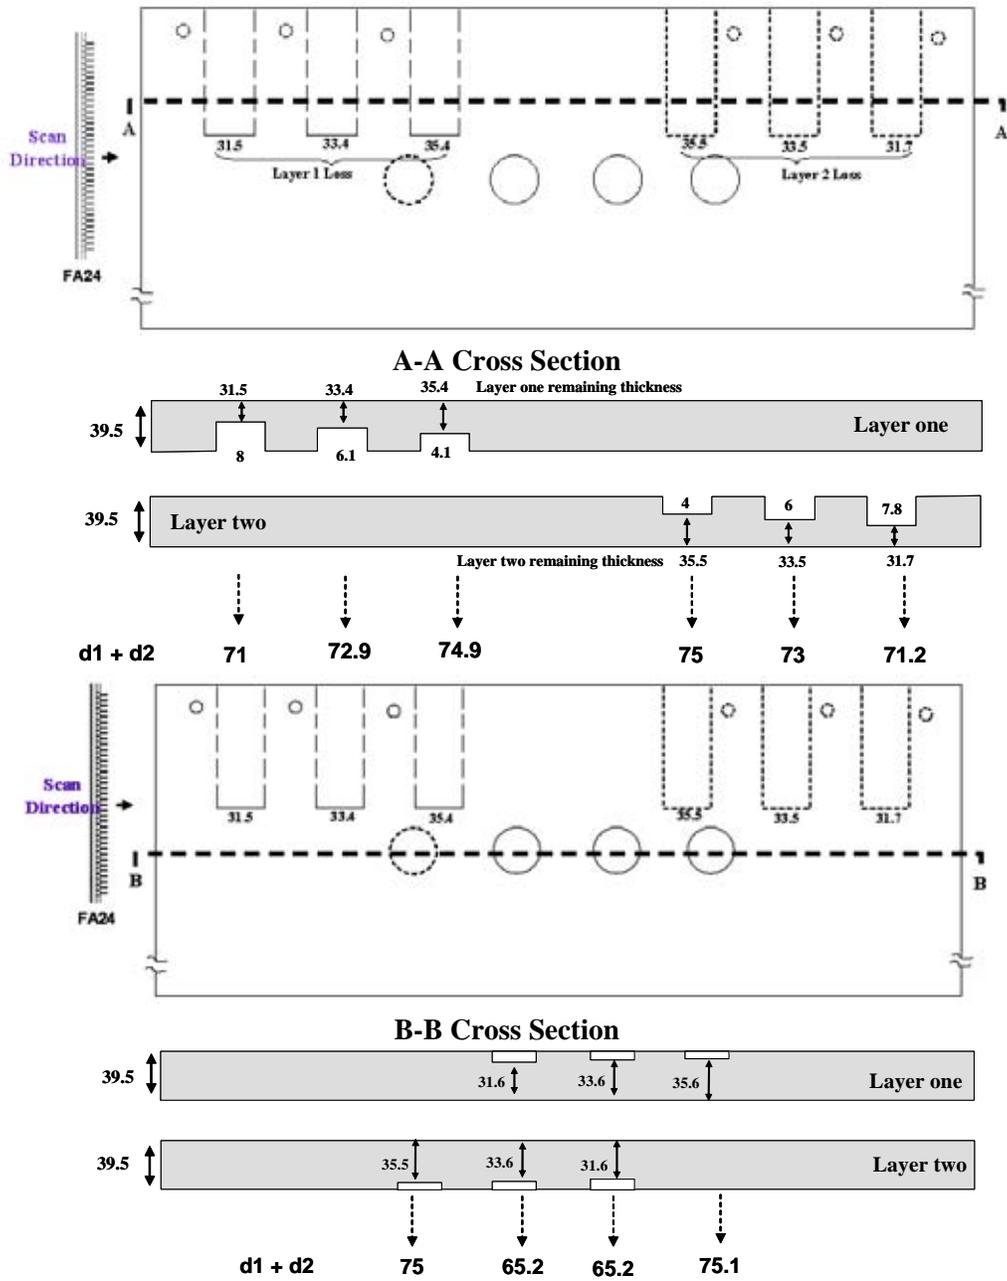
FIGURE 9. AF material loss calibration standards as configured for MWM-Array demonstrations; dimensions in mils (1 mil = 0.001 in.).

1. Air Force samples with two 0.04-in. thick layers, no Alclad and a “dome” shaped material loss region (either 1st or 2nd layer) of 5%, 10%, 20% or 30%, for which some results were reported previously.
2. Air Force material loss calibration standards configured as shown in Figure 9 (d1 and d2 are the remaining thickness values for layers 1 and 2, respectively).
3. KC-135 S25 lap joint cut-out with hidden corrosion, cut in four sections, as shown in Figure 10. Note: corroded area has a doubler.
4. On-aircraft lap joints at S25 and S7.

If an eddy current sensor is calibrated on a loss standard, such as shown in Figure 9 above, that has a different Alclad value than the KC-135 skin, this could result in substantial loss estimation errors. We measured the Alclad on these standards and on actual skins and found substantial variation. Thus, this is a serious concern.

The accuracy of the method can be seen by comparing the specific areas to the dimensions provided in Figure 9. For example, for the circular regions with loss both on the top exposed surface and the bottom exposed surfaces, the MWM-Array measured total thickness is approximately 0.065 in., which is within 0.5 thousandths of an inch of the actual value. This level of accuracy appears to be achievable over a wide range of conditions with the MWM-Array and 3-unknown method. Ongoing efforts are underway to further validate this capability and ease of use.

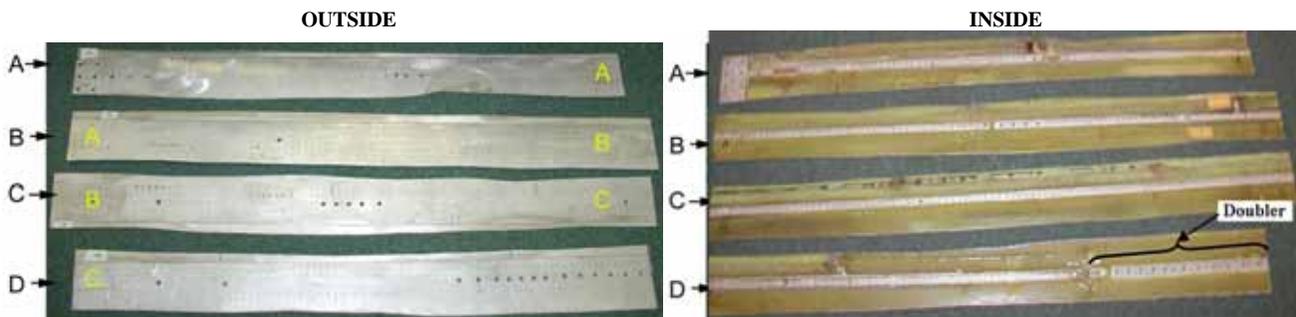
FIGURE 10. Cut out KC-135 lap joint specimens from Station 25 (S25) with actual corrosion damage.

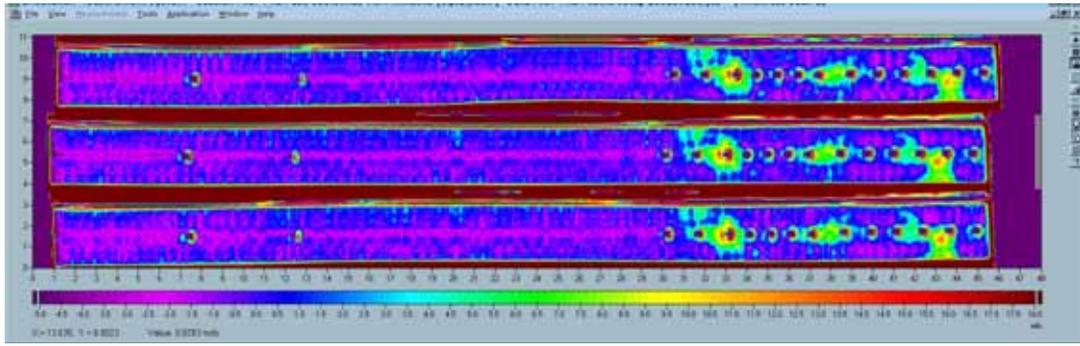
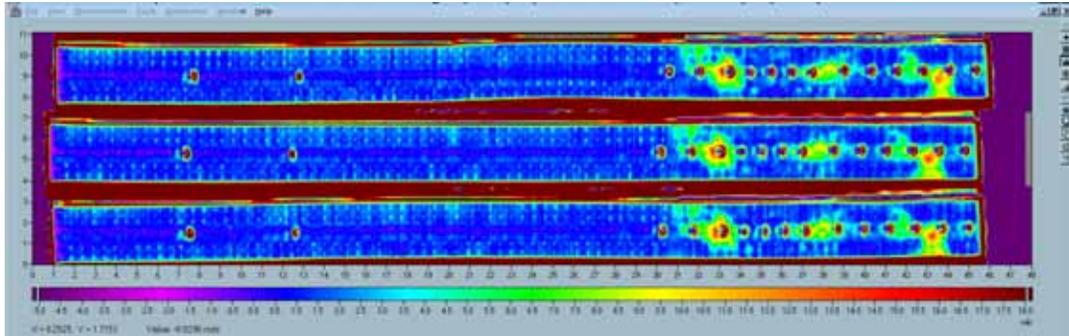
(a) Without Alclad in the model; “negative loss” shown in pink

(b) With Alclad in the model

FIGURE 11. MWM-Array 2-unknown results for three repeat rapid manual scans with air calibration (a) without Alclad correction, and (b) with Alclad correction. These images do not include the doubler correction; the doubler is located in a thin strip down the center and in the last several inches of the scan (see Figure 10).

Figure 11 provides the material loss image generated using the 2-unknown method with and without the MWM measured Alclad properties. Accounting for Alclad provides substantial improvement in the results. The top three images, produced without accounting for Alclad properties, show a negative loss that is not physically possible. The loss in the lower three images (away from the heavily corroded region) is no longer negative. The negative loss can result from using incorrect Alclad properties or not accounting for Alclad.

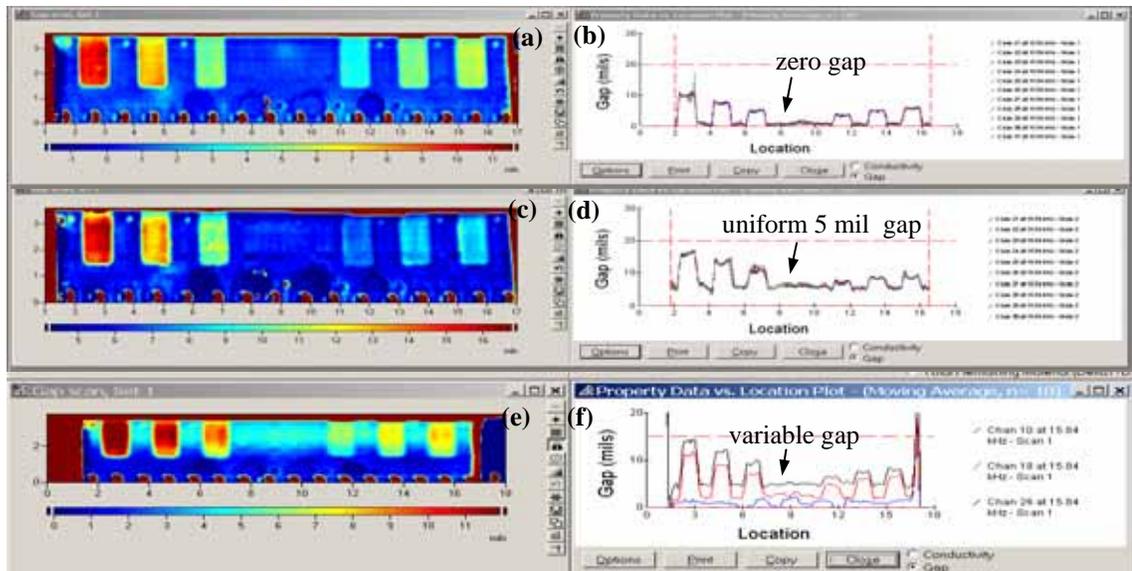
FIGURE 12. 3-Unknown method results for Gap estimation only using an MWM-Array (FA24) scans on the reference calibration standard panels in the configuration shown in Figure 9.

(a) Total Gap C-Scan image and (b) individual channel gap plots (B-Scans) with no additional gap other than that created by the material loss regions; (c) total Gap C-Scan images and (d) individual channel gap plots (B-Scans) with a 0.005-in. shim between the skins to simulate a uniform gap, but only within the top 1 in. of sample; (e) total Gap C-Scan images and (f) individual channel gap plots (B-Scans) with a variable gap.

KC-135 Test/Calibration Panel Results for 3-Unknown Method. For the 3-unknown method, three frequencies are used to estimate the total material loss, the gap and the lift-off (e.g., paint thickness), all independently at each data point within the scanned image. Figures 12 and 13 show the results of 3-unknown scans on the calibration test panels provided by OC-ALC. The test panels were configured as shown earlier in Figure 9, but with a few different gap conditions. In Figures 12a, b, and c, only the images (C-Scans) of the gap variation are provided, along with representative channels versus position plots (B-Scans). As seen here, the three-unknown algorithm provides an accurate estimation of the zero and 0.005-in. gap regions, as well as the gap produced by the loss areas, as compared with Figure 9. Figure 12c also shows the ability to estimate the varying gap produced by placing a shim between the layers in the top inch of the specimen only.

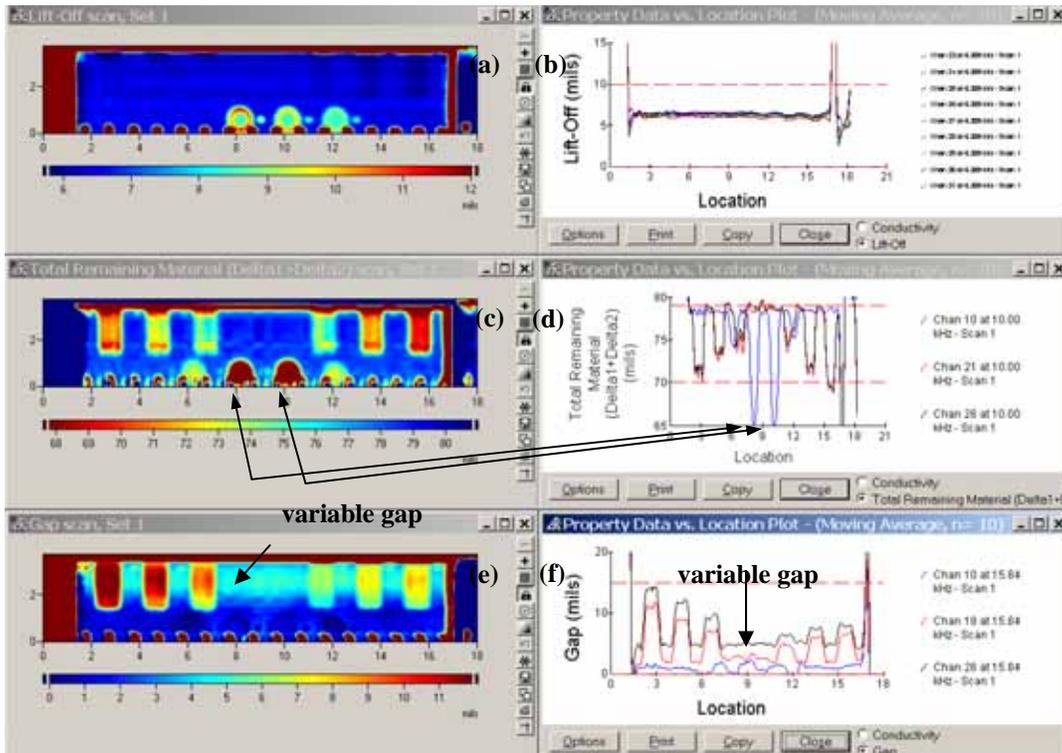
FIGURE 13. 3-Unknown method results for MWM-Array (FA24) scan of reference calibration standard with 0.005 in. nominal gap across top 1 in. of entire sample length: (a) lift-off image, (b) individual channel lift-off vs. location plots, (c) total remaining material (thickness) image, (d) individual channel total thickness plots, (e) total gap image, (f) individual channel gap plots.

Figure 13 shows the results for the 3-unknown method using an MWM-Array (FA24) to scan the reference calibration standard shown in Figure 9 with a 0.005-in. nominal gap across top 1 in. of entire sample length. The figure provides the (a) lift-off image, (b) individual channel lift-off vs. location plots, (c) total remaining material (thickness) image, (d) individual channel total thickness plots, (e) total gap image, (f) individual channel gap plots. This clearly illustrates the capability to independently measure both the total material loss and the actual gap, as well as the lift-off (or paint thickness). This was accomplished using an air calibration without the use of material loss or gap standards. This assumed that the nominal Alclad thickness and layer conductivities were known.

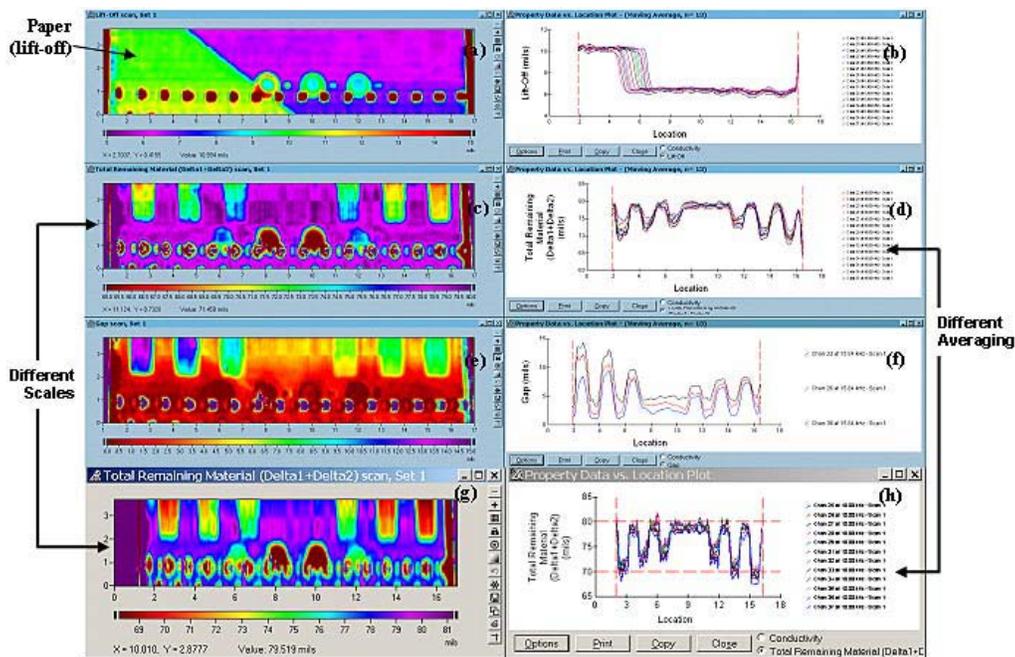
FIGURE 14. 3-unknown method results for MWM-Array (FA24) scan of KC-135 reference calibration standard with 0.005-in. nominal gap across top line of entire sample length and with a piece of paper across the lower left section of the top surface to simulate a variable paint layer thickness. (a) Lift-off image, (b) individual channel lift-off vs. location plots, (c) total remaining material (thickness) image, (d) individual channel total thickness plots, (e) gap image, and (f) individual channel gap plots. Except for some minor changes, figures (g) and (h) are similar to figures (c) and (d): figure (g) has more averaging, and a wider color scale, than figure (c), Figure (h) has less averaging than figure (d), and two channels (22 and 23) have been removed; these channels cover the lower end of the material loss regions (from 2 to 2.2 in. on the vertical axes of Figures (c) and (g)). Note that channel 30 at ~2.9-in. vertical position was removed from (c) and (g) because of an apparently poor calibration.

Figure 14 provides similar 3-unknown results, but now including both a variable lift-off and variable gap condition. This is essential if measurements are to be performed on aircraft without paint removal. During a recent visit to OC-ALC, JENTEK performed measurements on an actual lap joint on a painted aircraft that demonstrated the apparent robustness of the method, although the results for material loss could not be confirmed.

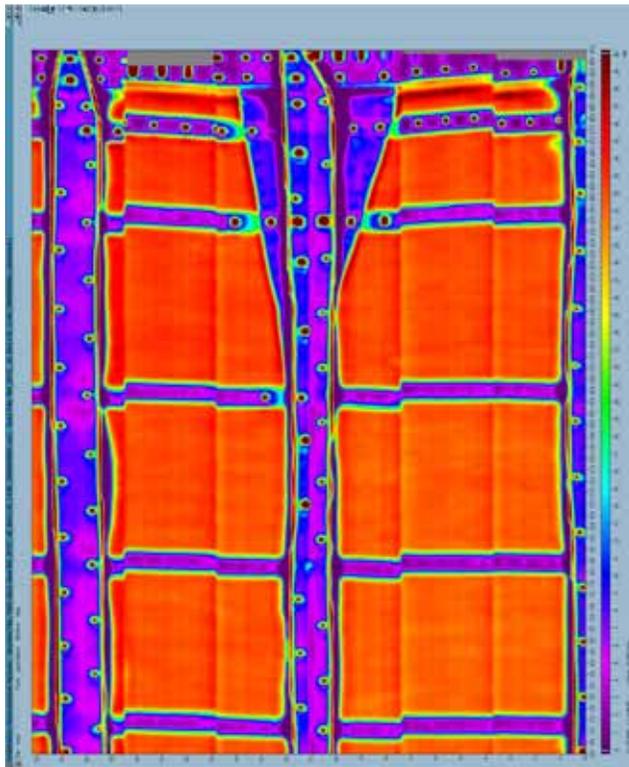
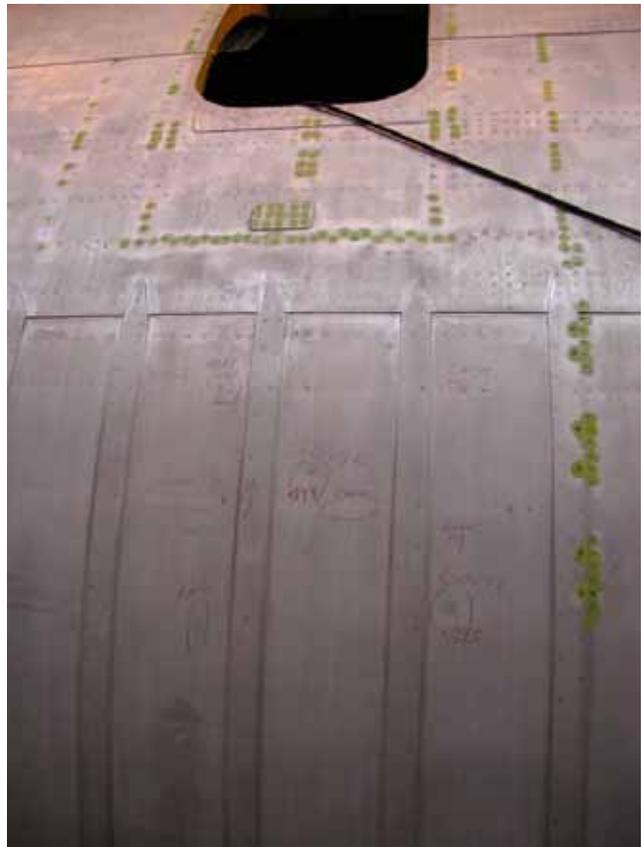
(a) MWM-Array metal loss image

(b) Photograph of scanned area

FIGURE 15. (a) MWM-Array image of wide area of interest obtained on a KC-135 aircraft scanned during a visit by JENTEK to OC-ALC, (b) photograph of scanned area on aircraft.

KC-135 On-Aircraft (KC-135) and Cut-Out Lap Joint Results for 3-Unknown Method. Figure 15 illustrates that both the 2- and 3-unknown method can be applied to more complex configurations. This scan on an actual KC-135 at OC-ALC, by JENTEK, illustrates the capability to inspect a wide area using an MWM-Array in multiple passes with a simple low cost manual scanner. This image, created from six vertical swipes of the sensor, was automatically constructed in the GridStation software.

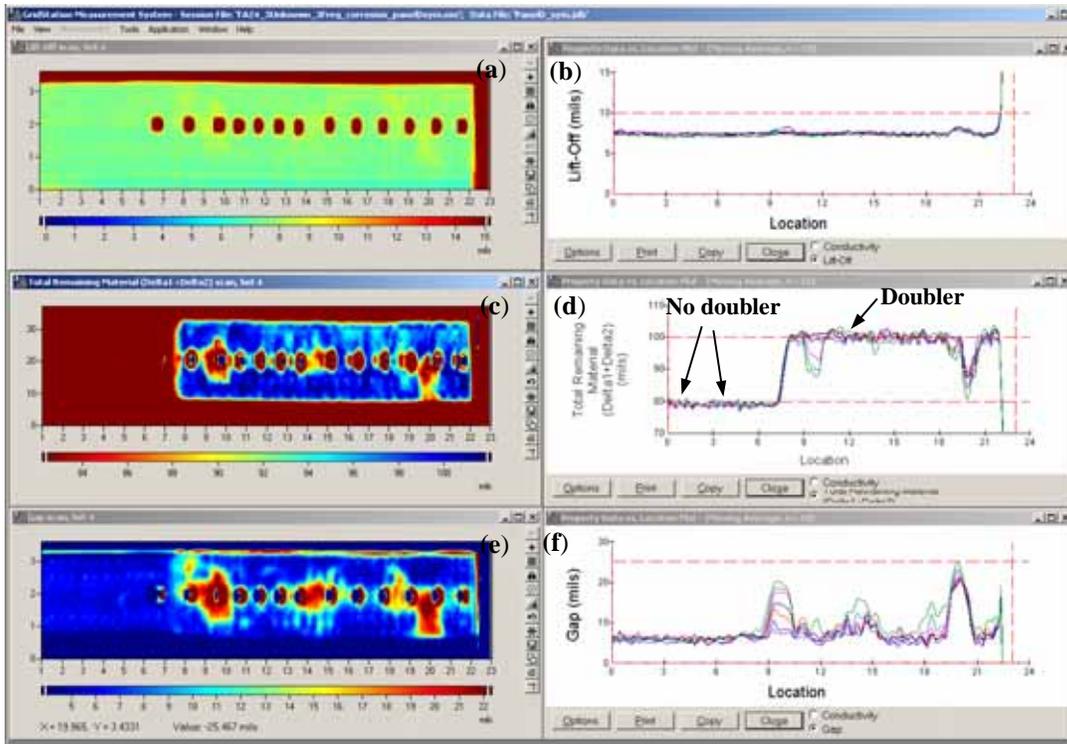
FIGURE 16. 3-Unknown results for cut out lap joint, without doubler correction included in model. (a) and (b): lift-off, (c) and (d): total remaining material thickness, (e) and (f): gap.

Figure 16 provides results of the 3-unknown method on the end of the lap joint section shown in Figure 10(d). As shown here, the gap correction dramatically reduces the amount of the response that is assigned to the material loss. This illustrates the critical importance of accurately correcting for the gap. However, these results do not account for the presence of the doubler. Figure 17 illustrates the effect of accounting for the doubler, which is easily detected so that its location is easily determined from the thickness image in Figure 16 even when it is not initially accounted for. As shown in Figure 17, when the doubler is included, even more of the corrosion signal is deemed to be due to the gap, further reducing the material loss estimate. Thus, in this case not correcting for both the gap and the doubler would result in replacement of this lap joint, when it appears that the actual loss is below 0.01-in., i.e., far less severe than originally estimated.

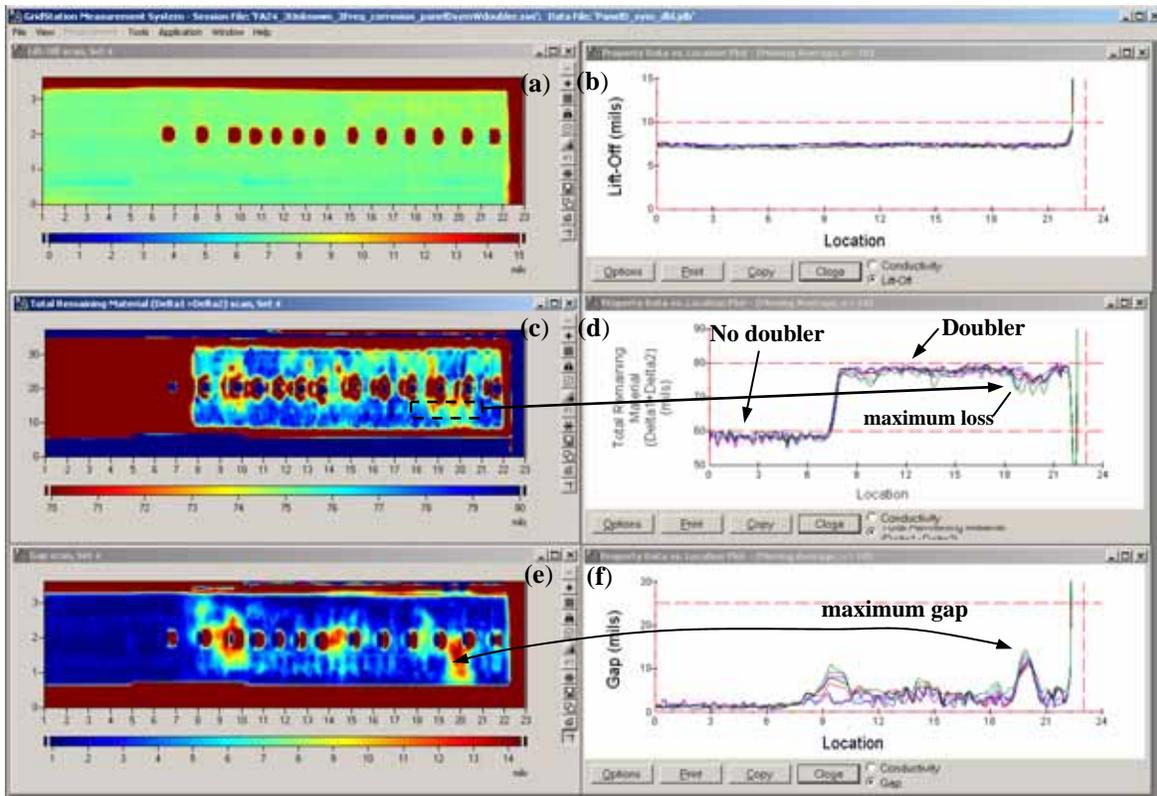
FIGURE 17. 3-Unknown results for cut-out lap joint with doubler correction. (a) and (b): lift-off, (c) and (d): total remaining material thickness, (e) and (f): gap.

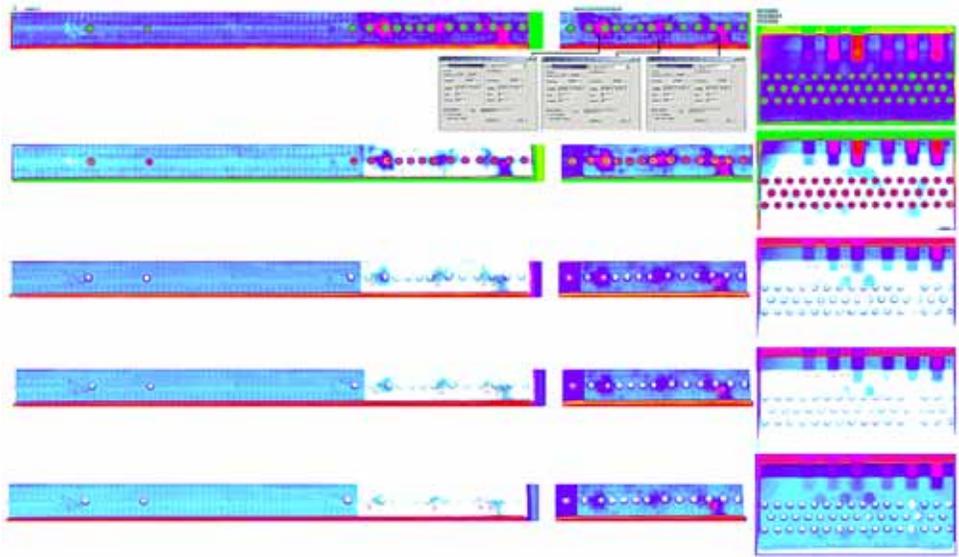
FIGURE 18. MAUS data.

Figure 18 shows the gap corrected MAUS (Mobile Automated Scanner) data for the same lap joint, as scanned by specialists at OC-ALC. These results are consistent with the MWM-Array results in general, but seem to provide a more gradual corrosion loss representation. The MWM-Array corrosion loss areas, on the other hand, in Figure 17 appear more typical of expected corrosion, in that they are not uniform over a large area. This specimen is expected to be destructively tested by the Air Force to determine the actual loss levels.

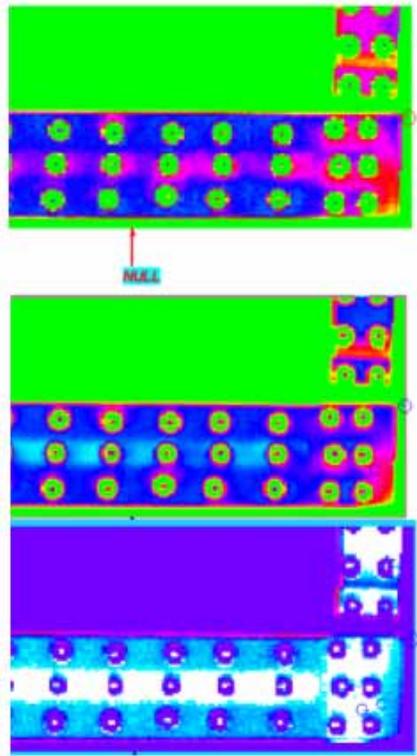
FIGURE 19. MAUS data for the S-7 Lap joint.

Figure 19 provides MAUS image results for a shorter lap joint near station 7, above the cargo door of a KC-135. As shown here the MAUS is detecting a corroded area. MWM-Array 3-unknown data for this same joint is provided in Figures 20 and 21, with and without the doubler correction.

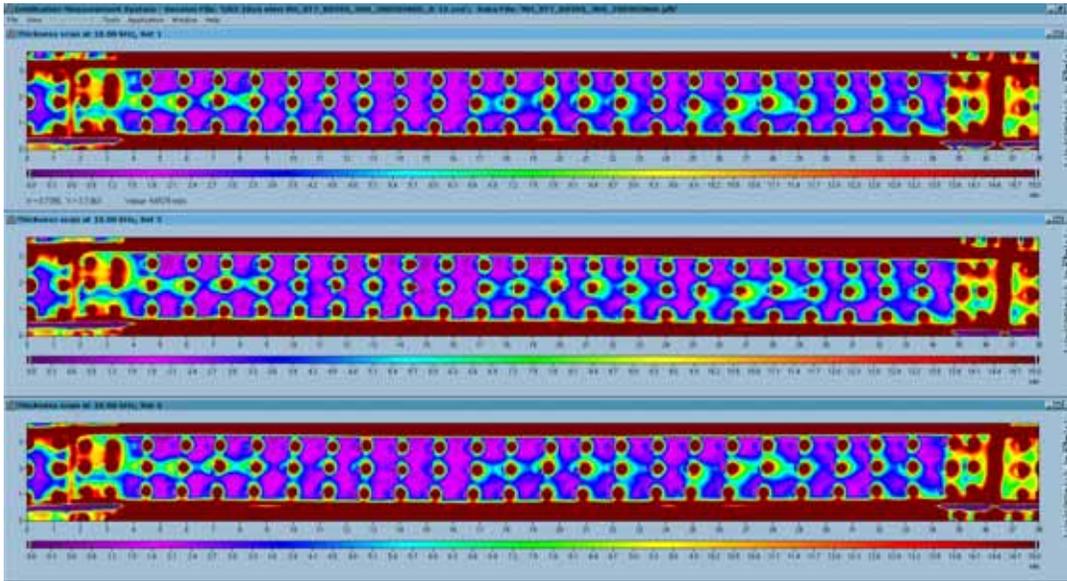
FIGURE 20. Three repeat scans of S-7 lap joint: 2-unknown thickness images without doubler correction.

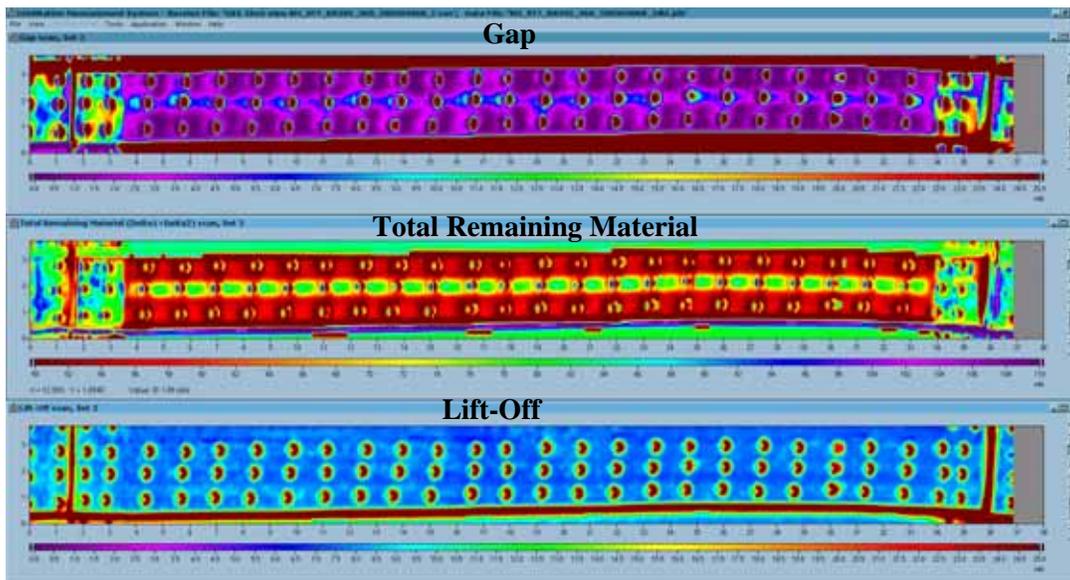
FIGURE 21. S-7 lap joint: 3-unknown results with doubler correction.

As shown in Figure 21, with the doubler correction it appears that the majority of this response may also be a gap response and not due to significant corrosion loss. More importantly, when corrosion loss images would be used in a damage tolerance assessment with an account for corrosion, accurate spatial images of the corrosion loss would be required to determine stress concentration coefficients from the geometry of the loss region. Although fastener and edge effects are evident, the current data appears to demonstrate improved resolution in areas of material loss. In any case, in view of the significant difference between the MWM-Array and MAUS results for local corrosion variations, as seen by a comparison of Figure 21 (MWM-Array) versus Figure 19 (MAUS) and Figure 17 (MWM-Array) versus Figure 18 (MAUS), there is a need to perform a detailed destructive evaluation of these and additional lap joints to support a comparison of MWM-Array and MAUS data to determine if either is appropriate for a damage tolerance based determination of effective stress concentration for corrosion fatigue applications in lap joints.

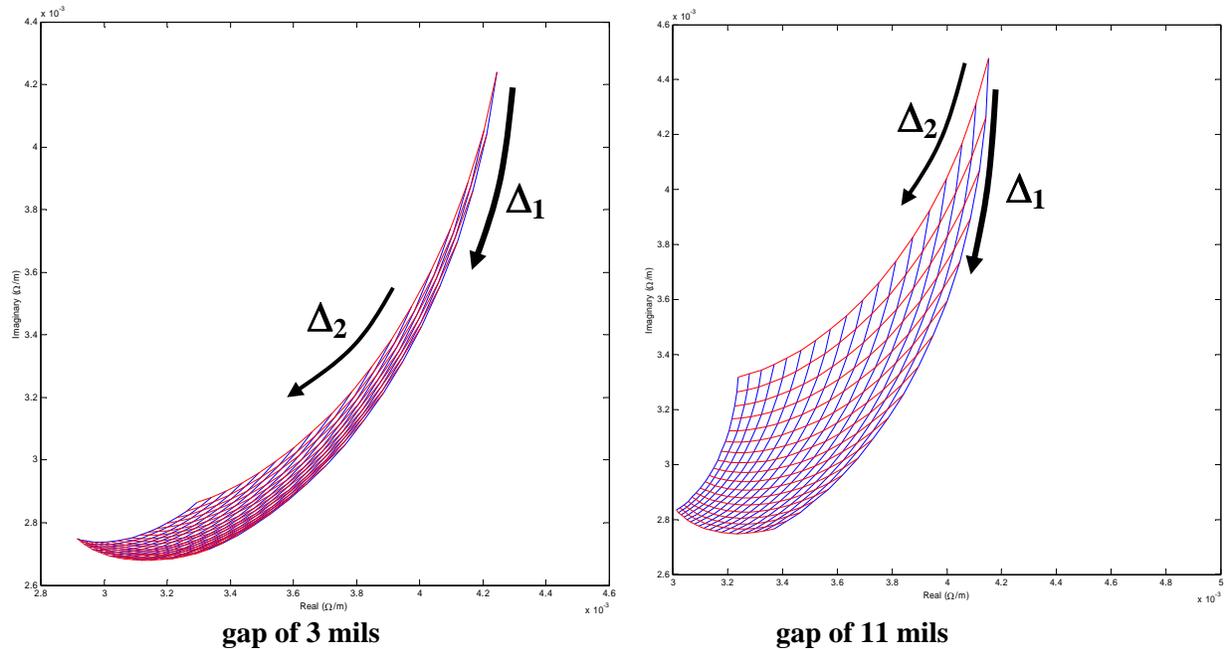
FIGURE 22. 1st layer thickness vs. 2nd layer thickness measurement grids at 10 kHz for a gap of 0.003 in. and 0.011 in.

KC-135 Test/Calibration Panel Results for 3-Unknown Method. Figure 22 provides a two-unknown measurement grid visualization of independent measurement of layer one thickness, Δ_1 , and layer two thickness, Δ_2 . For grid visualizations, the larger and more square the “rectangles” in the grid are, the higher the sensitivity and the more independently the two properties of interest can be measured. Figure 22 illustrates that for gaps of 0.003 in. independent measurement of layer thicknesses is far more difficult than for larger gaps. This makes sense, since, as the gap gets smaller, the regions of loss on the first layer and second layer are close to each other and are exposed to similar field levels by an eddy current sensor. Fortunately, the need to distinguish between the layers may be more critical when the gaps are larger, e.g., greater than 0.005 in., because an 0.005 in. gap might be caused by a loss as small as 0.0025 in. since corrosion products will expand to the gap produced by the loss. Thus, most loss levels of interest should be accompanied by a significant gap.

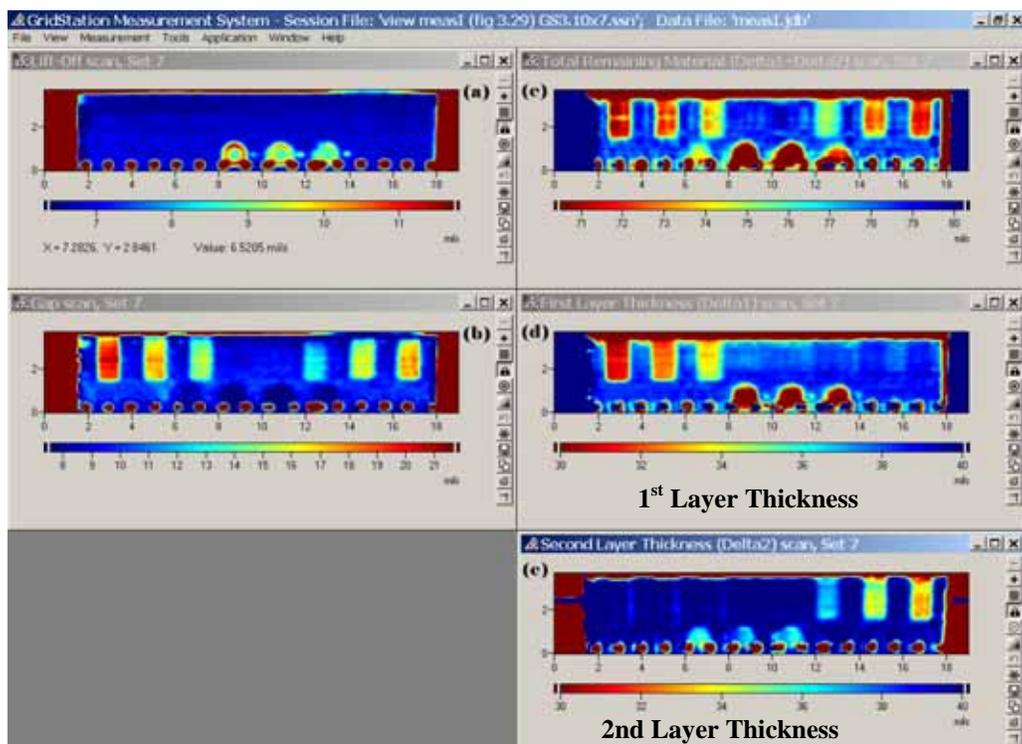
FIGURE 23: 4-unknown image results for calibration panels with 0.01 in. nominal gap: (a) lift-off, (b) total gap, (c) total remaining thickness, (d) 1st layer thickness, and (e) 2nd layer thickness.

Figure 23 illustrates the successful demonstration of the 4-unknown method on the reference panels. Here, Figures 23d and 23e clearly show the capability to separate the first layer loss from the second layer loss. This was accomplished by calibrating on a standard with no metal loss but with a known gap. The resulting algorithm can correct for and estimate local gap and lift-off variations, while independently measuring the first and second layer thickness.
