EDDY CURRENT SENSOR ARRAYS FOR PIPELINE INSPECTION WITH AND WITHOUT COATINGS

Andrew Washabaugh, Shayan Haque, David Jablonski, Neil J. Goldfine
JENTEK Sensors, Inc.
Waltham, MA, 02453-7013

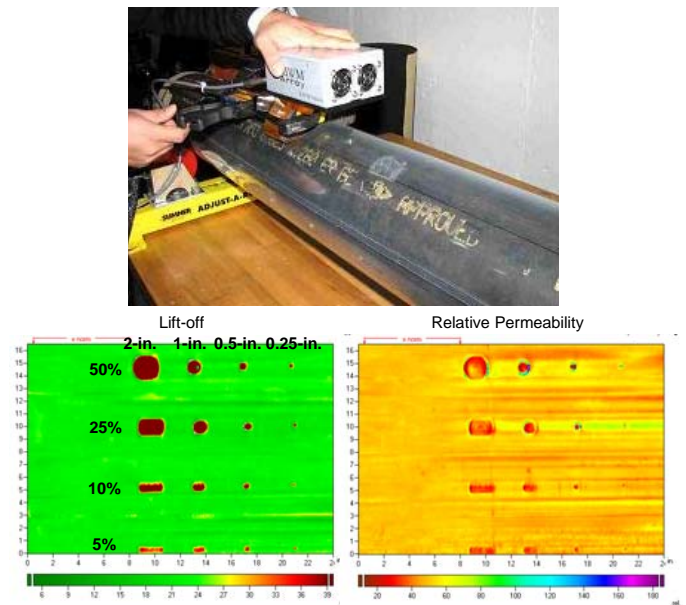
Figure 5. (Upper) Photograph of an FA24 MWM-Array being scanned over a pipe section with a thin coating. (Lower) Effective property images showing flaws machined in the outside surface.

This imaging capability has been demonstrated on a 6.625-in. diameter, 4 ft long pipe section that had a wall thickness of 0.28-in. and machined flaws on the external surface. Figure 5 shows property images obtained for the FA24 MWM-Array at a frequency of 100 kHz. The left and bottom axes are expressed in inches. The regions of material loss are clearly visible as areas of increased lift-off as the effective distance between the sensor array and the steel surface increases. The shapes of the regions are also appropriate; for the shallower and larger flaws the regions are rectangular in shape. The flaw

regions are also apparent in the relative permeability image. Since the magnetic permeability can vary with material condition, such as residual stress, this may reflect property changes associated with the flaw machining process. Here, plastic sheets are wrapped around the pipe section to simulate the presence of a very thin (0.020-in. thick) insulating coating. An air-shunt calibration was performed. This type of calibration uses a measurement in air and a measurement with a shunt sensor in which the sense elements are shorted. This is a robust method of calibration since it does not rely on knowledge of a reference material, but it requires having a shunt that is essentially identical to the sensor array. Figure 6 shows B-scan (individual sense element response) plots of the lift-off response for a sense element that passed over the center of each region. These plots show that each of the material loss regions is detected.

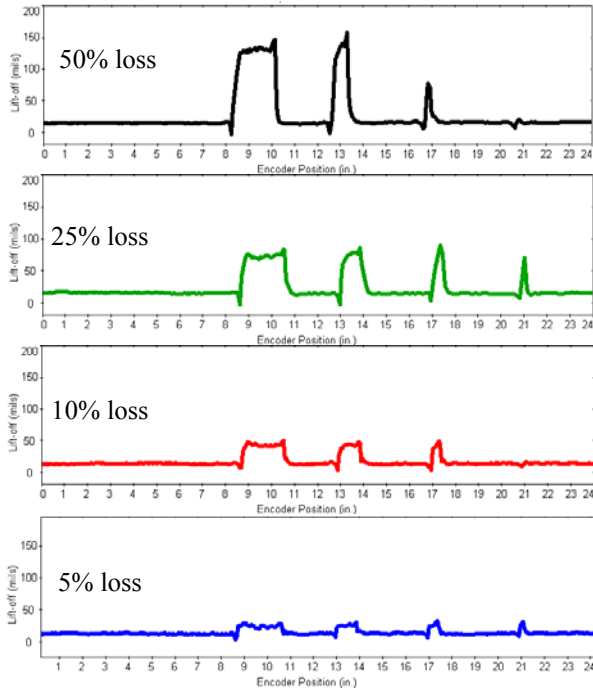
Figure 6. B-scan lift-off plots over material loss regions for an FA24 with a 0.020-in. thick coating.

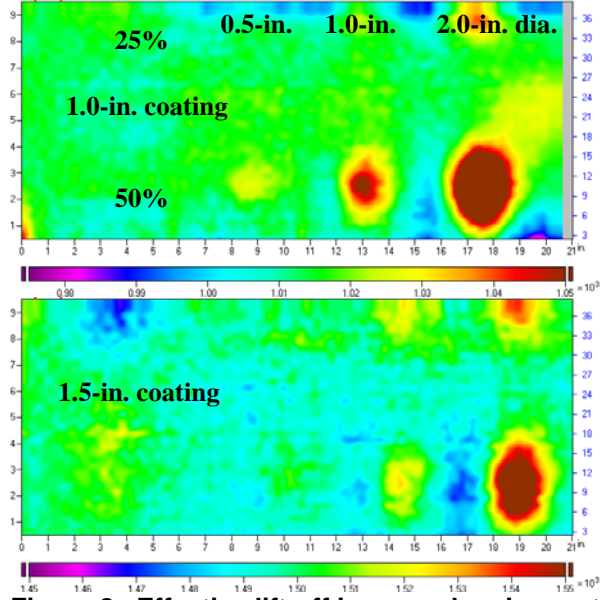
Figure 8. Effective lift-off images showing material loss regions through 1.0 and 1.5-in. coatings.

Figure 8 shows lift-off images obtained with the VWA001 for some thicker coatings. The images show the 25% and 50% material loss regions, with the high spatial resolution images obtained for coating thicknesses less than around 1.0-in. For thicker coatings the larger flaws are still visible but there is a noticeable degradation of the flaw images.

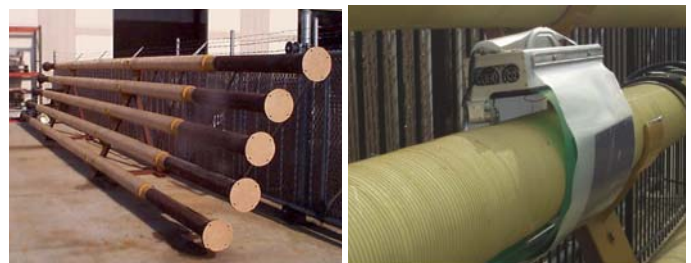
Figure 9. (Left) Simulated PRCI riser samples with embedded corrosion defects. (Right) Photograph of a prototype external scanner on these pipe sections.

Measurements have also been performed on 40 ft long, 6.-in. diameter riser sections made available by Chevron and PRCI (Pipeline Research Council International). Figure 9 shows five sections containing embedded defects with each section having a 0.5-in. thick “Splashtron” coating, along with the prototype external scanner fixture and VWA001. Since each scan spanned approximately $\frac{1}{4}$ of the pipe, scans were made at four positions around the circumference to construct a complete scan image. Figure 10 through Figure 12 show initial results over several detected flaws in the pipe underneath the coating. These are absolute images, where the impedance measurement data has been processed to obtain the lift-off (proximity of each sense element to the steel pipe surface) and the relative permeability for the steel pipe wall (which is related to material property and residual stress). Flaw responses are evident in each of these images and appear as a local increase in lift-off and variation in magnetic permeability; variations in lift-off that are not associated with a change in the magnetic permeability are caused by coating thickness variations. Note that no attempt was made to filter these images to reduce channel-to-channel variability of the images at this time.

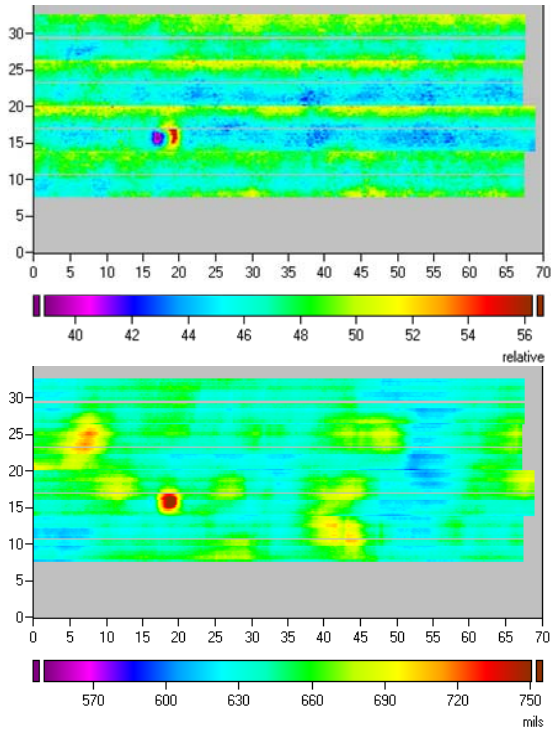
Figure 10. Property images for an elongated flaw: (Upper) Relative permeability; (Lower) Lift-off.

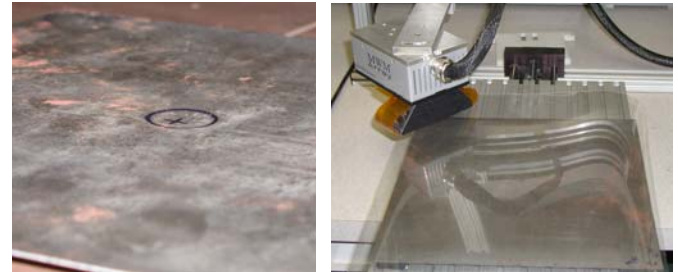
Figure 15. Left: A dented steel plate. Right: Plate with an FA24 MWM-Array and a 0.020-in. plastic sheet.

Additional measurements have been performed on steel plates to help develop a better understanding of the relation between the effective property measurements and the mechanical damage conditions. For example, consider the steel plate of Figure 15. The depressed area is clearly indicated in the lift-off scans. A hydraulic press was used to introduce a dent into the center of the steel plate. The 1-in. diameter punch created a shallow (0.100 in.), flat-bottomed depression, surrounded by a depressed region. The plate was scanned using the FA24 MWM-Array. The resulting lift-off and permeability images and plots are shown in Figure 16. The depressed area is clearly indicated in the lift-off scans. In addition, the permeability scans indicate an area of residual stress surrounding the depressed area.

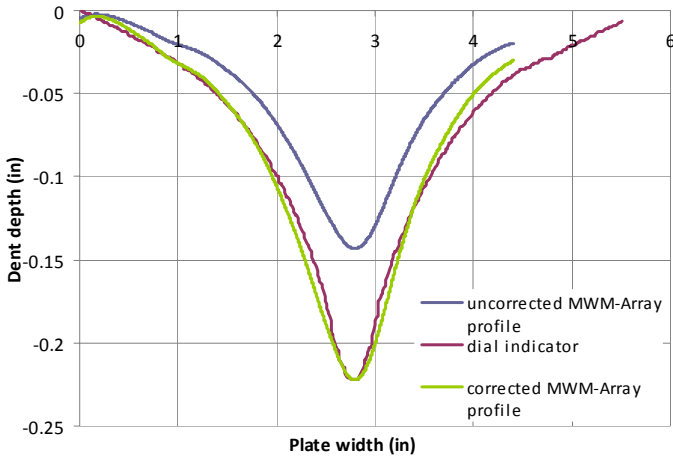
Figure 17. Comparison between lift-off and dial indicator measurements.

Additional measurements have been performed on 0.25-in. thick steel plates that were indented with steel balls. The steel balls had a diameter of 0.782-in. or 1.575-in. Figure 17 shows comparisons between lift-off measurements along the center-line of the dent to measurements made with a dial indicator. The raw measured lift-off shape is similar to the dial indicator but less than the dial indicator depth because the measurement grids used here assumed uniform planar layers. Since the dented surface is curved, the planar models are not as accurate; other analysis tools were used to determine a scaling factor

correction that compensates for the geometric effect on the dent profile estimate. For a shallow dent, the correction factor is near one. However, for deep and narrow dents, the correction factor can be significant. These model-derived scale factors match those obtained empirically and confirm that accurate dent depth and geometry can be made using MWM-Arrays when corrected for the non-planar geometry that occurs in a steel wall with mechanical damage.

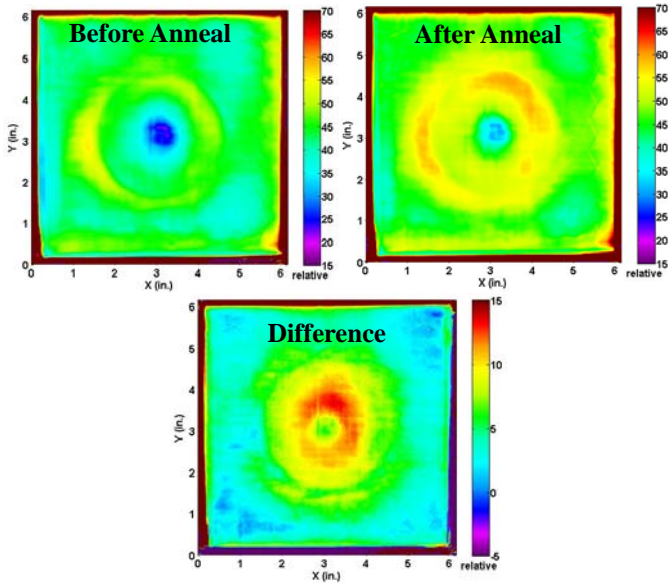
Figure 22. Effective permeability images for symmetric mechanical damage in a plate.

Figure 22 shows effective permeability images for one of the plates before and after annealing. The left and middle images were obtained by averaging the measured permeabilities in two orientations, which reflects the symmetrical circular shape of the dent. The difference was found by subtracting the permeability images before and after annealing; since annealing should remove the residual stress, these results indicate that the permeability measurements are sensitive to the stress distribution around the mechanical damage.

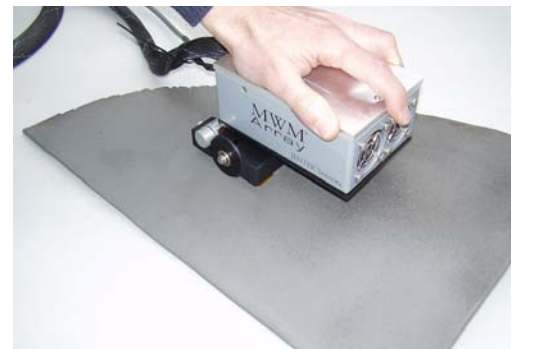
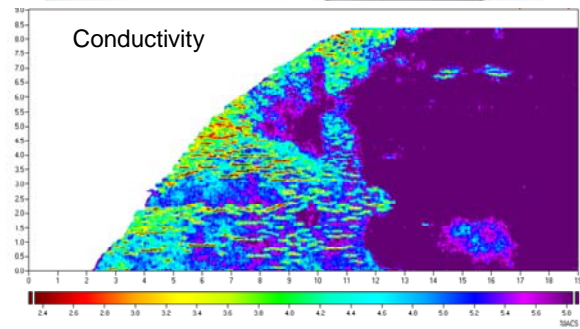
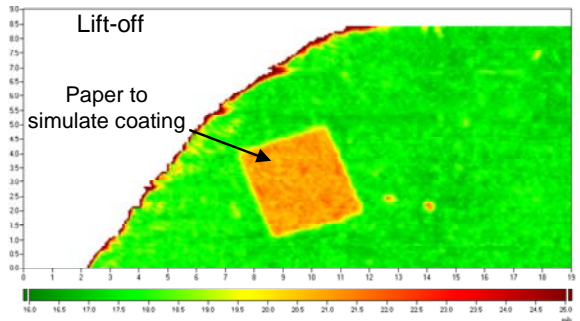
Figure 23. (Upper) Photograph of a steel pipeline section having clusters of SCC damage with a hand-scanner. Effective property images for conductivity (middle) and lift-off (lower) from an FA28.

A variety of measurements have been performed on steel pipeline sections that contain region of SCC to demonstrate the capability to image SCC through thin and medium-thickness coatings. One pipeline section, provided by RTD, is approximately triangular in shape as shown in Figure 23(upper) along with a hand-scanner. This section has approximate dimensions of 18-in. by 13-in. and is 0.33-in. thick. An MWM-Array is located at the bottom of the scanner and supported with a layer of foam so that the sensor array conforms to the surface of the section. Results of FA28 (very small size MWM-Array) scans are presented in Figure 23 (middle and lower). The square patch visible in the lift-off image is paper to simulate a very thin coating variation. The fact that the square shows up in the lift-off image only, and not in the conductivity image, illustrates that the multivariate inverse methods are effectively compensating the conductivity measurement for uncontrolled variations in lift-off. The fact that crack-like conductivity responses are present in the area covered by the paper (as well as the areas not covered) illustrates that SCC can be detected and accurately imaged through a very thin coating.
