Enhancements in MWM-Array Hidden Corrosion Imaging

*Dr. Neil Goldfine, Dr. Vladimir Zilberstein,
Darrell Schlicker, David Grundy, Dr. Ian Shay,
Dr. Robert Lyons, Tim Lovett*

JENTEK Sensors, Inc., Waltham, MA 02453-7013**
Phone: 781-642-9666, email: jentek@shore.net

November 20, 2003

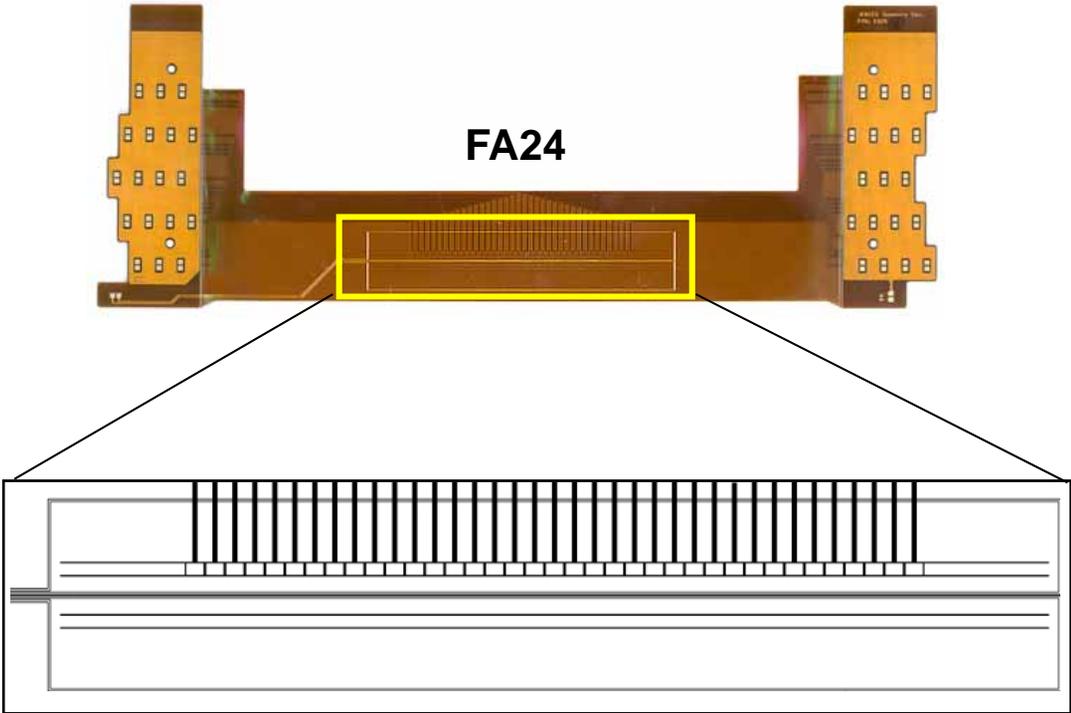
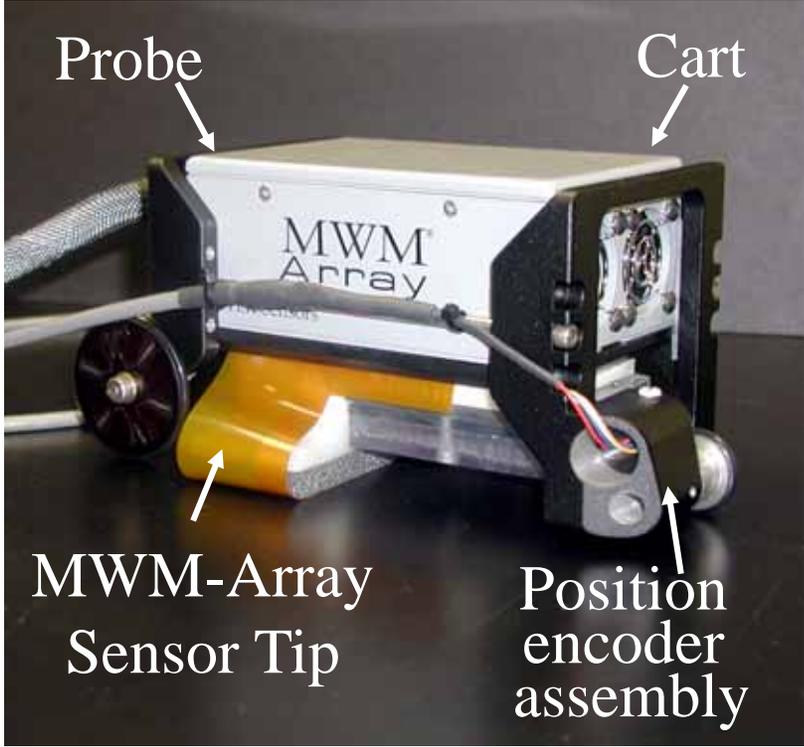
MWM-Array Sensor with Manual Scanning Cart

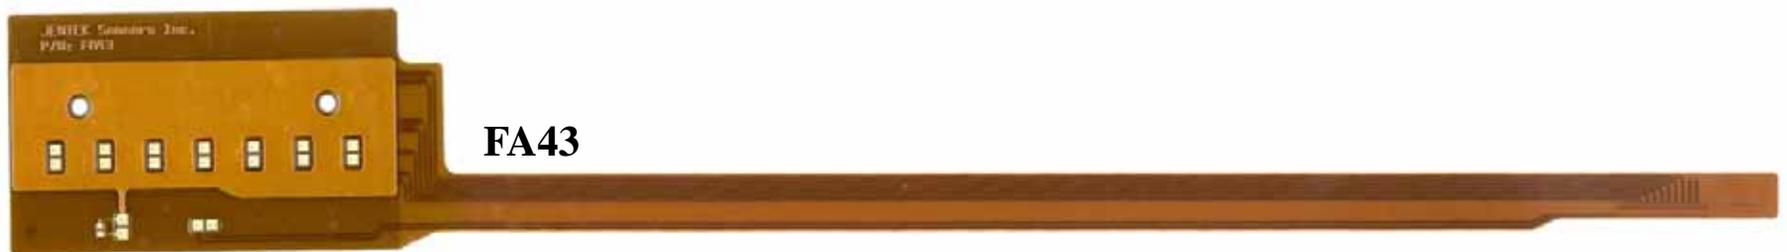
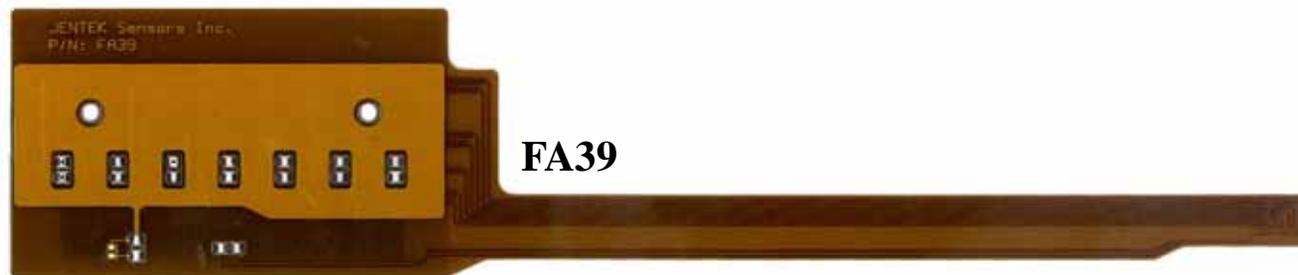
7 Channel MWM-Arrays for Near-Surface Crack Detection

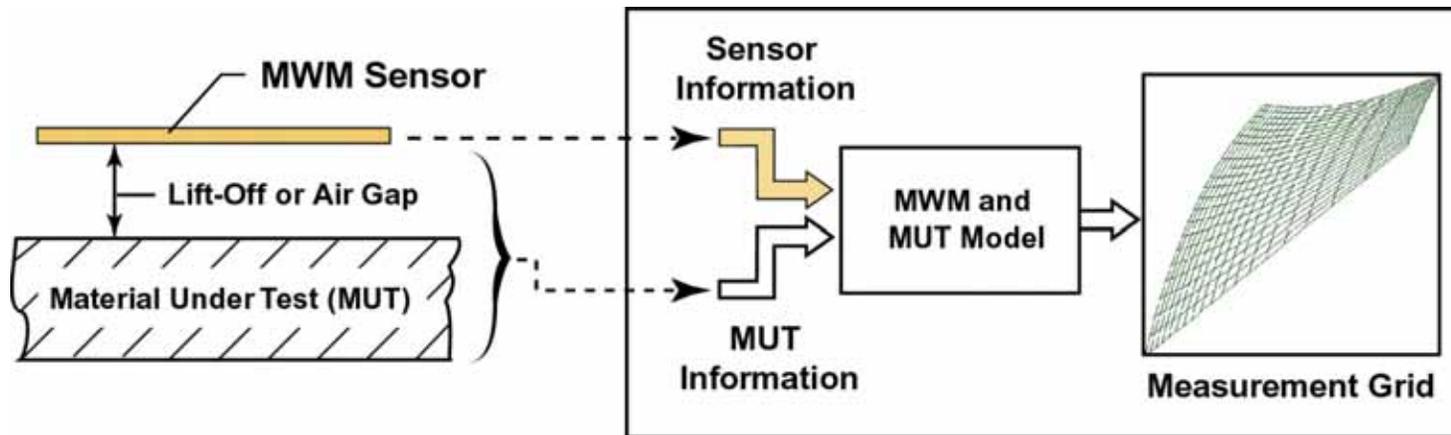
Measurement Grids for **RAPID** Data Analysis/Imaging

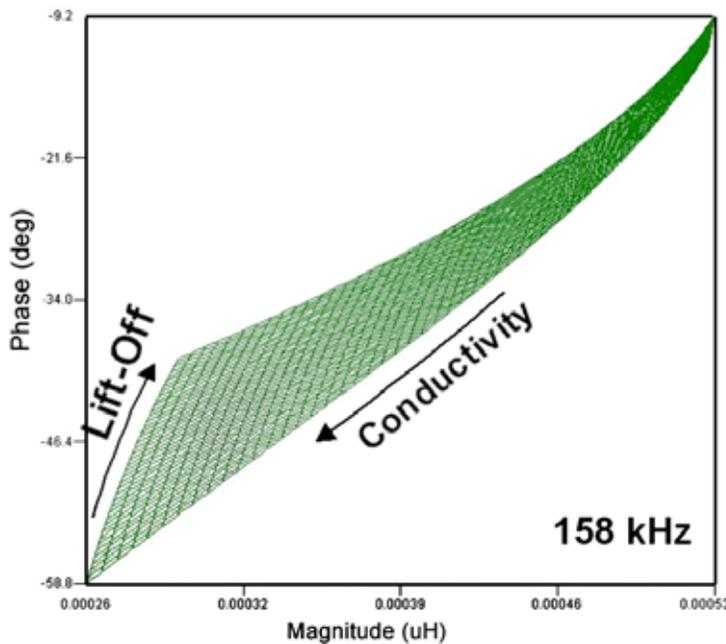
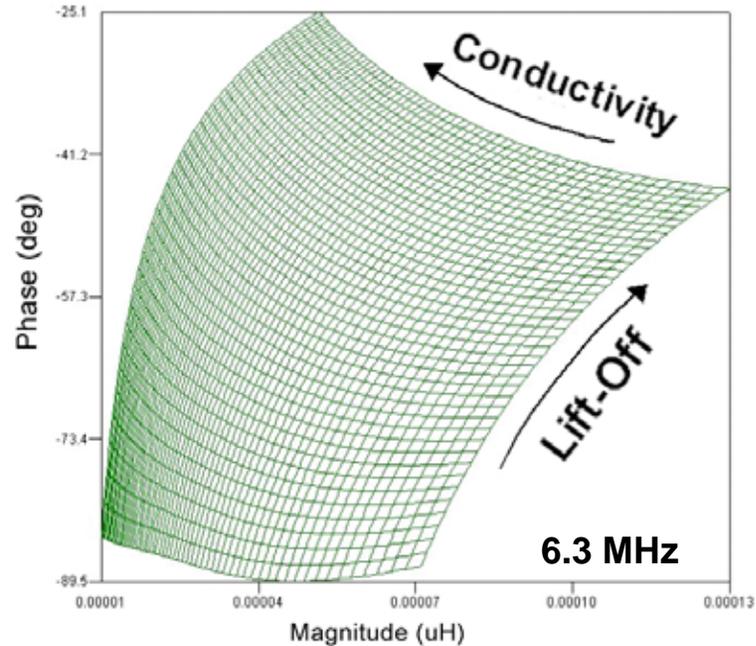
Example Grids for the MWM sensor on Titanium

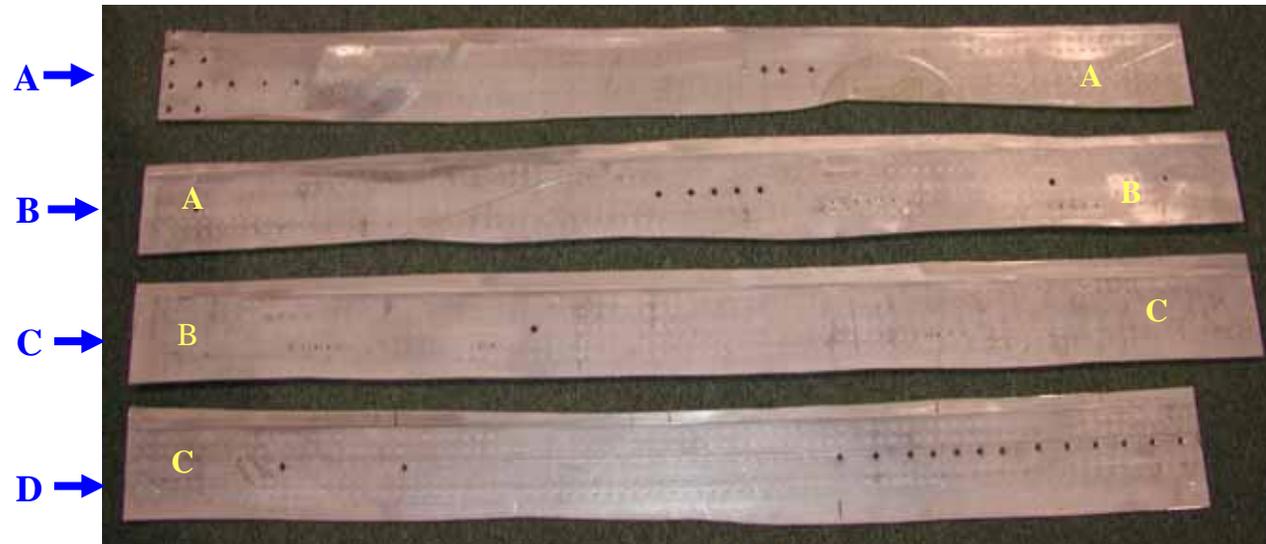
Actual KC-135 Lap Joints Cut-Out from Aircraft

KC135_4
(A,B,C,D)
top view

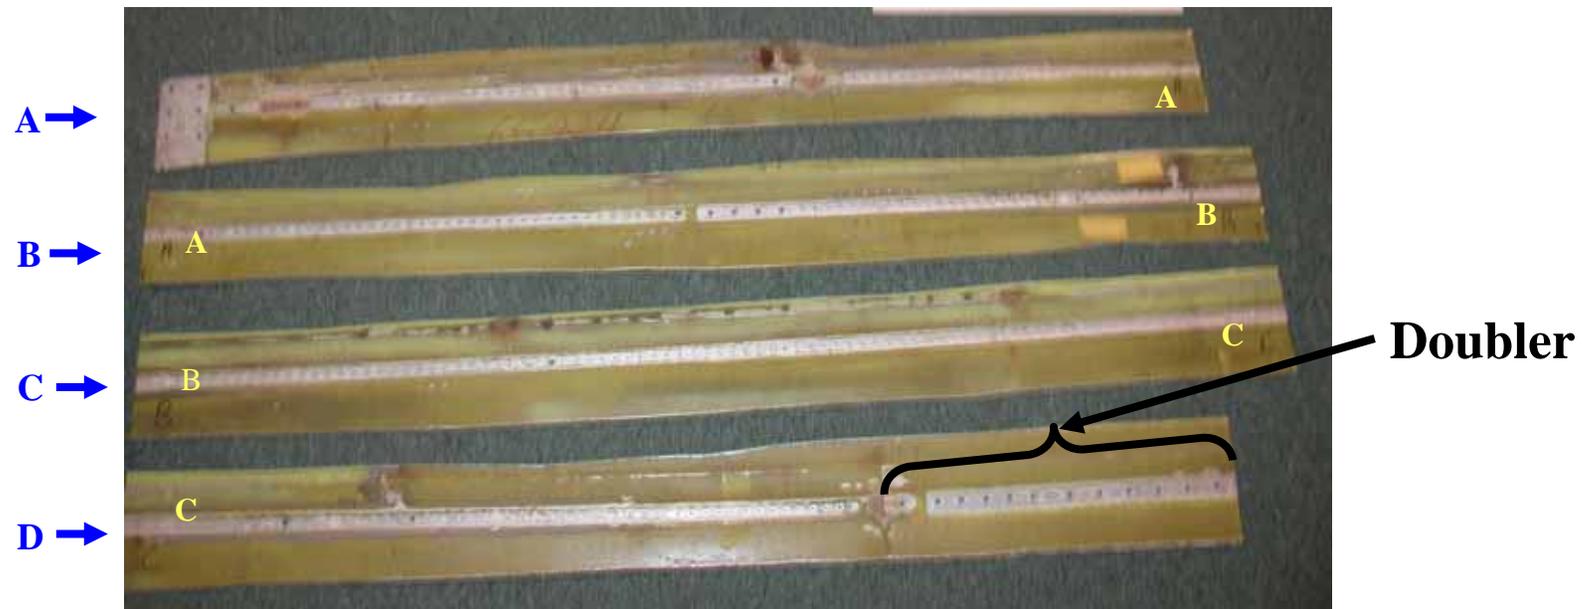
KC135_4
(A,B,C,D)
bottom view

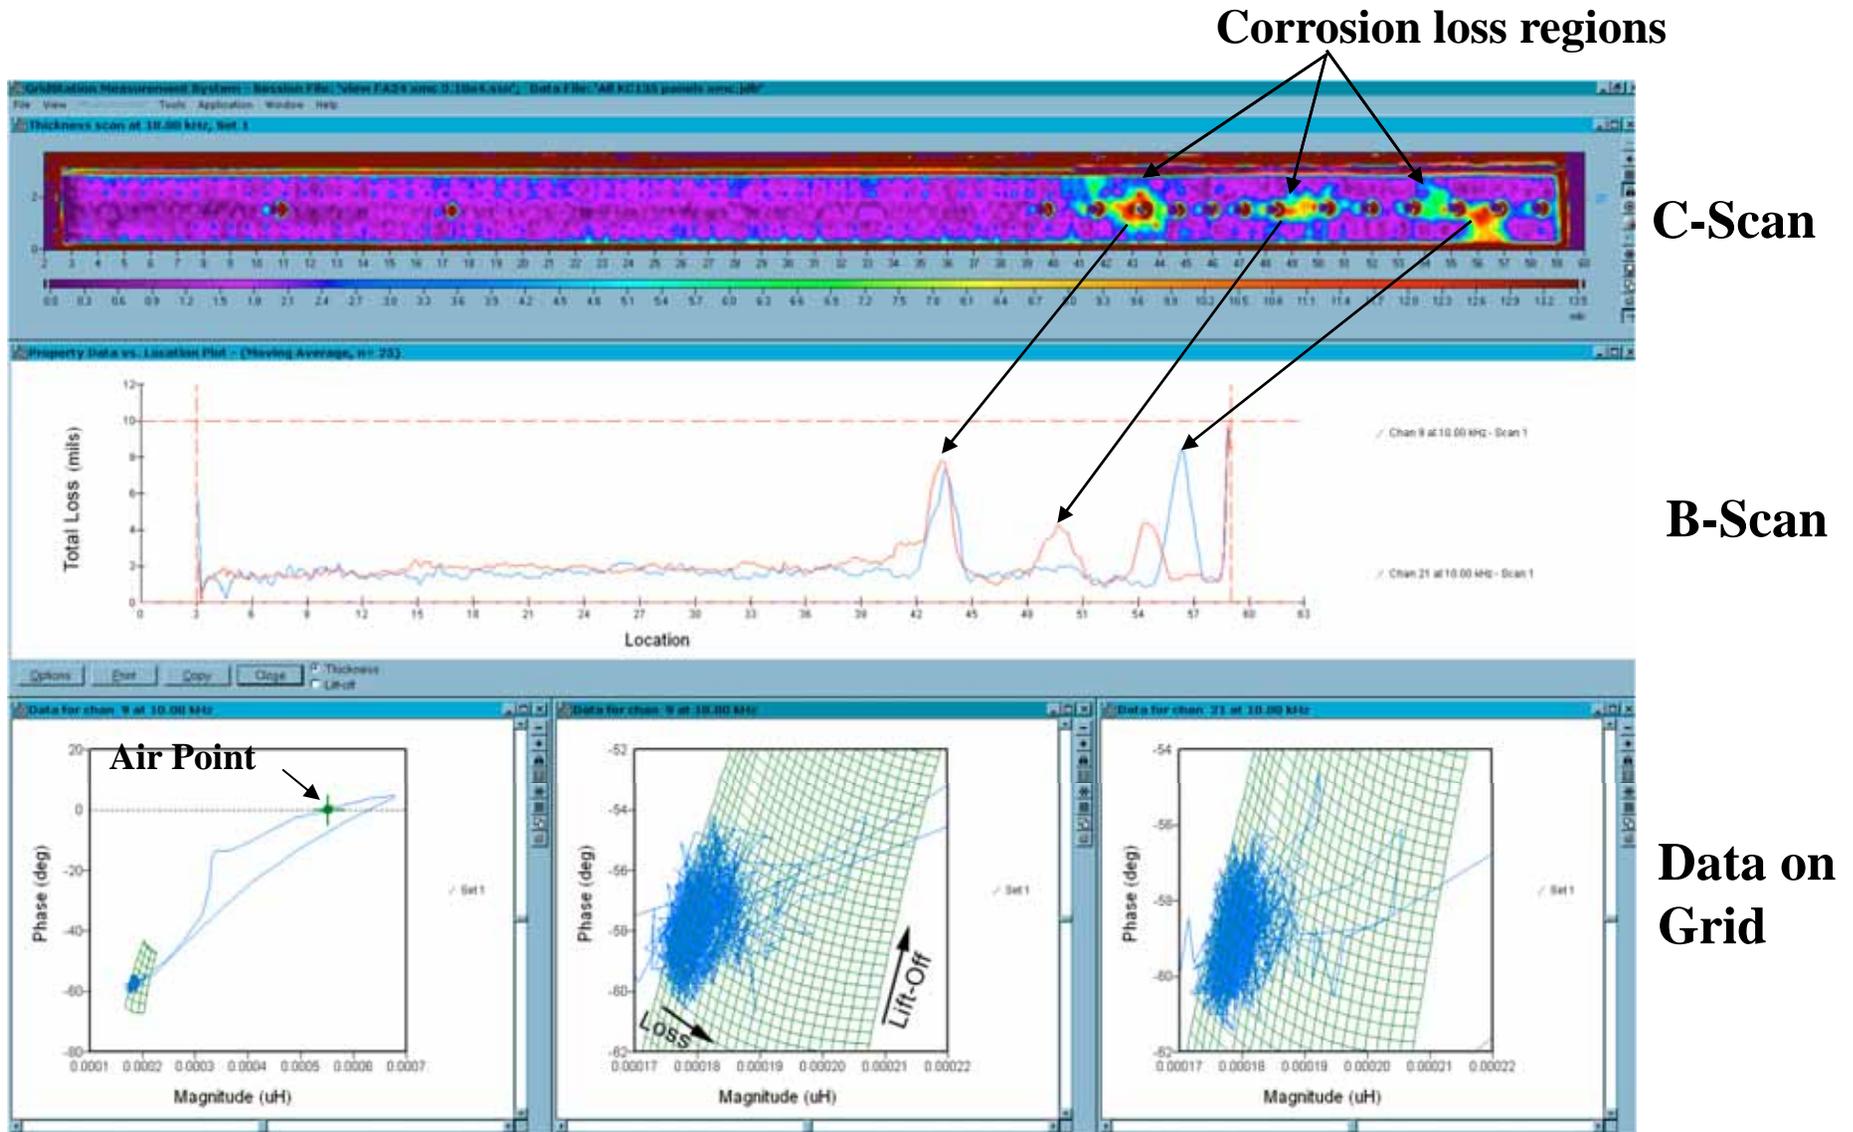
Example GridStation Software Display

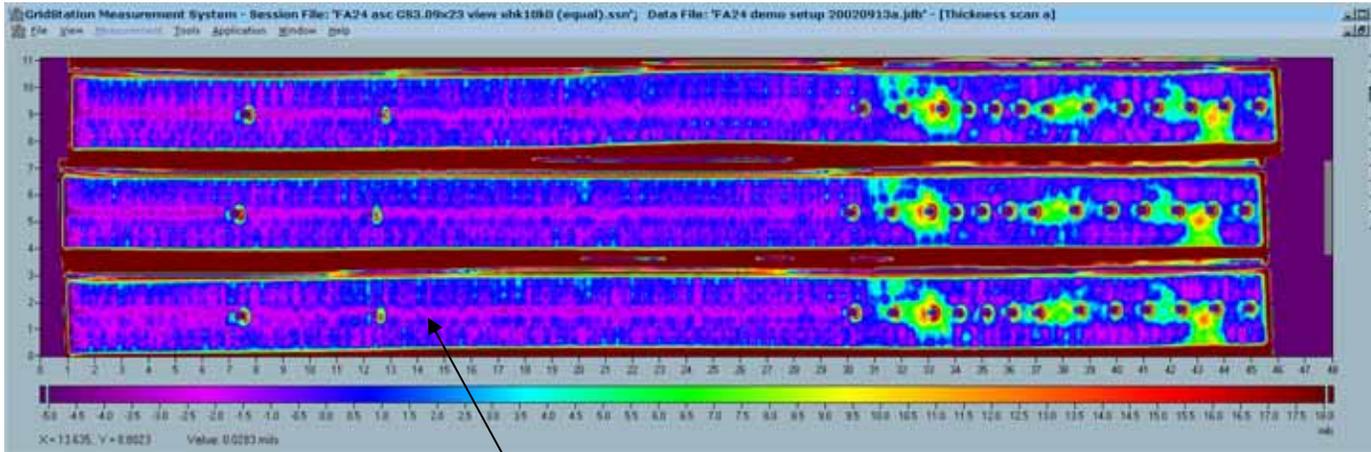
2-Unknown Image Assuming Equal Loss

Negative loss shown in pink

Without Alclad in Model

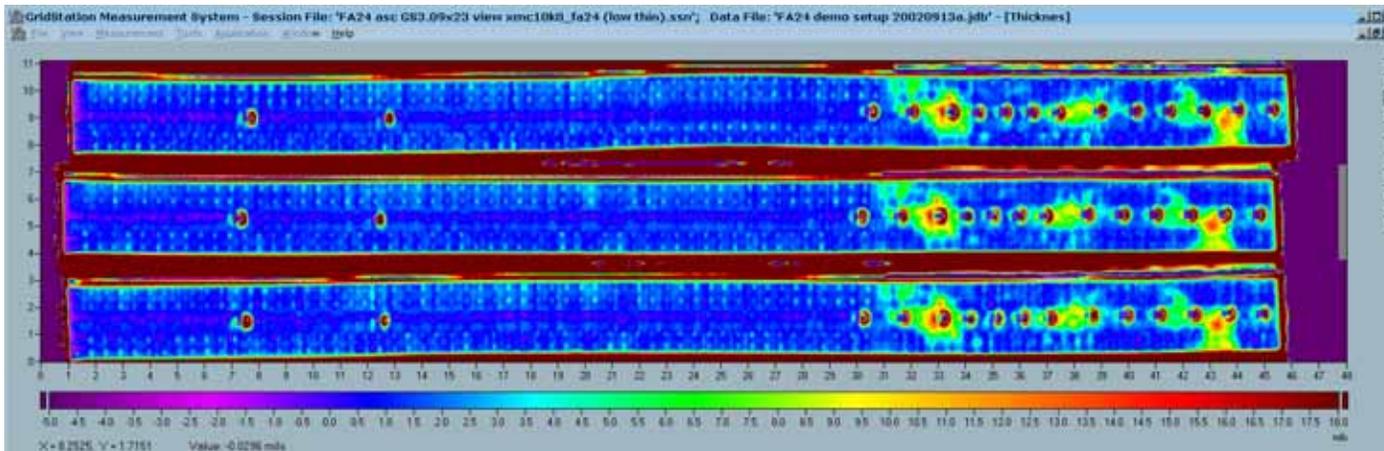
With Alclad in Model

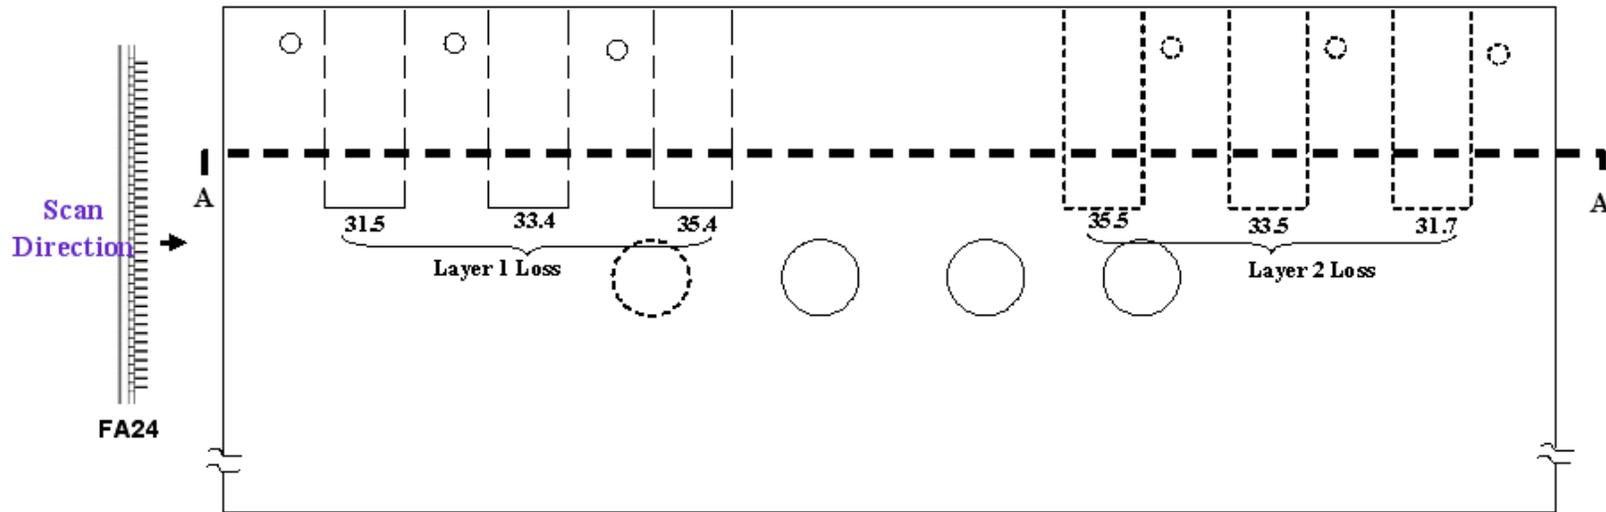
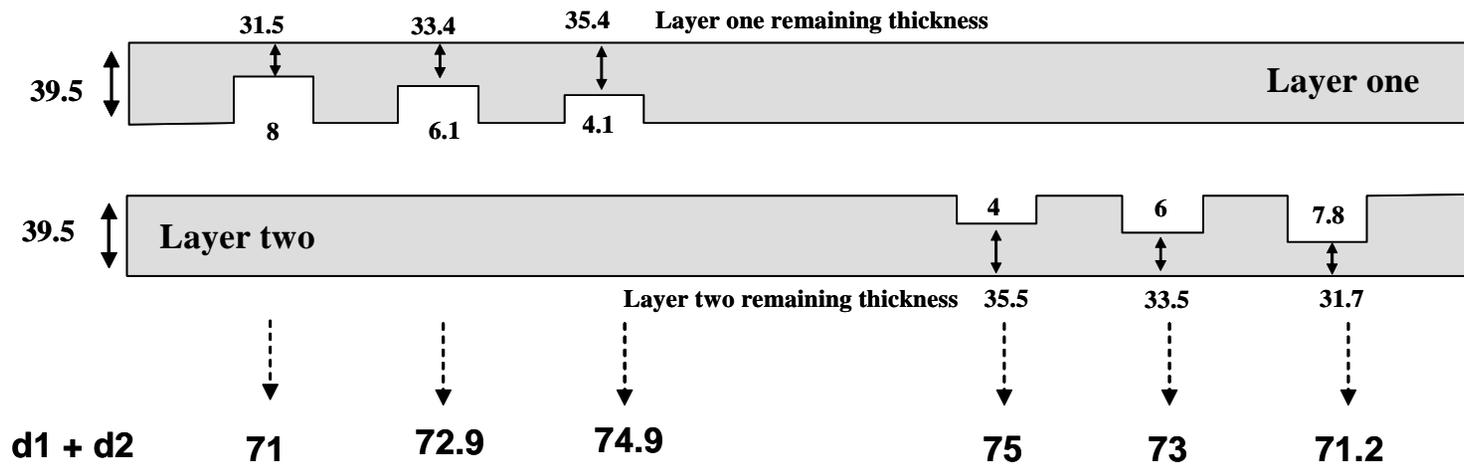
Air Force Material Loss Calibration Standard as Configured for MWM-Array Demonstrations

A-A Cross Section

Dimensions in Mils (1 mil = 0.001 in.)

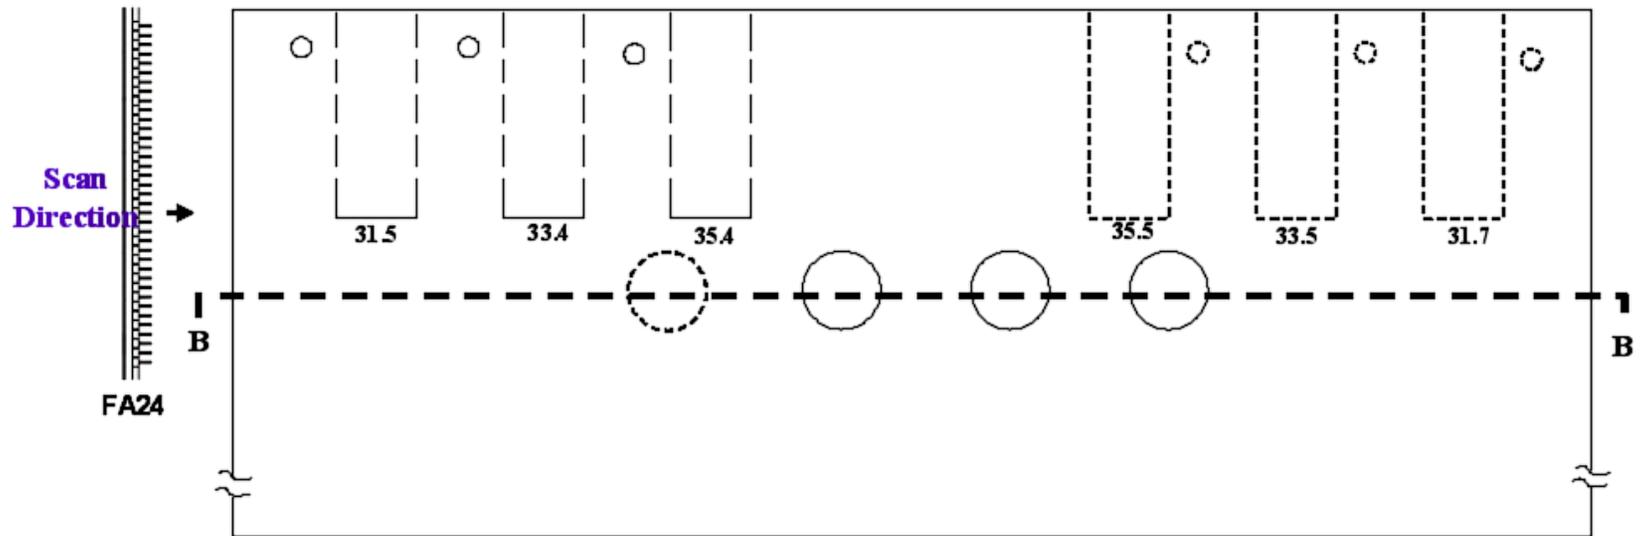
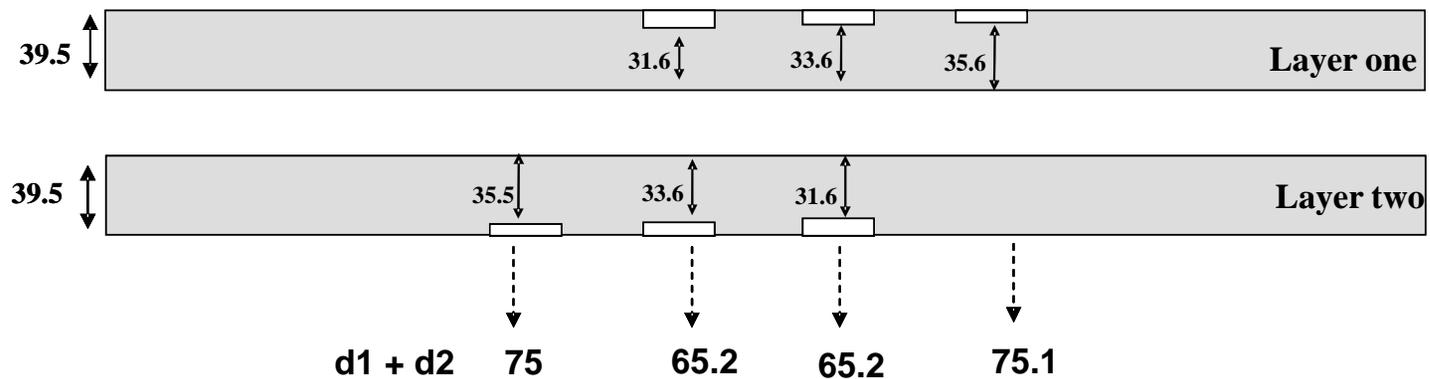
Air Force Material Loss Calibration Standard as Configured for MWM-Array Demonstrations

B-B Cross Section

Dimensions in Mils (1 mil = 0.001 in.)

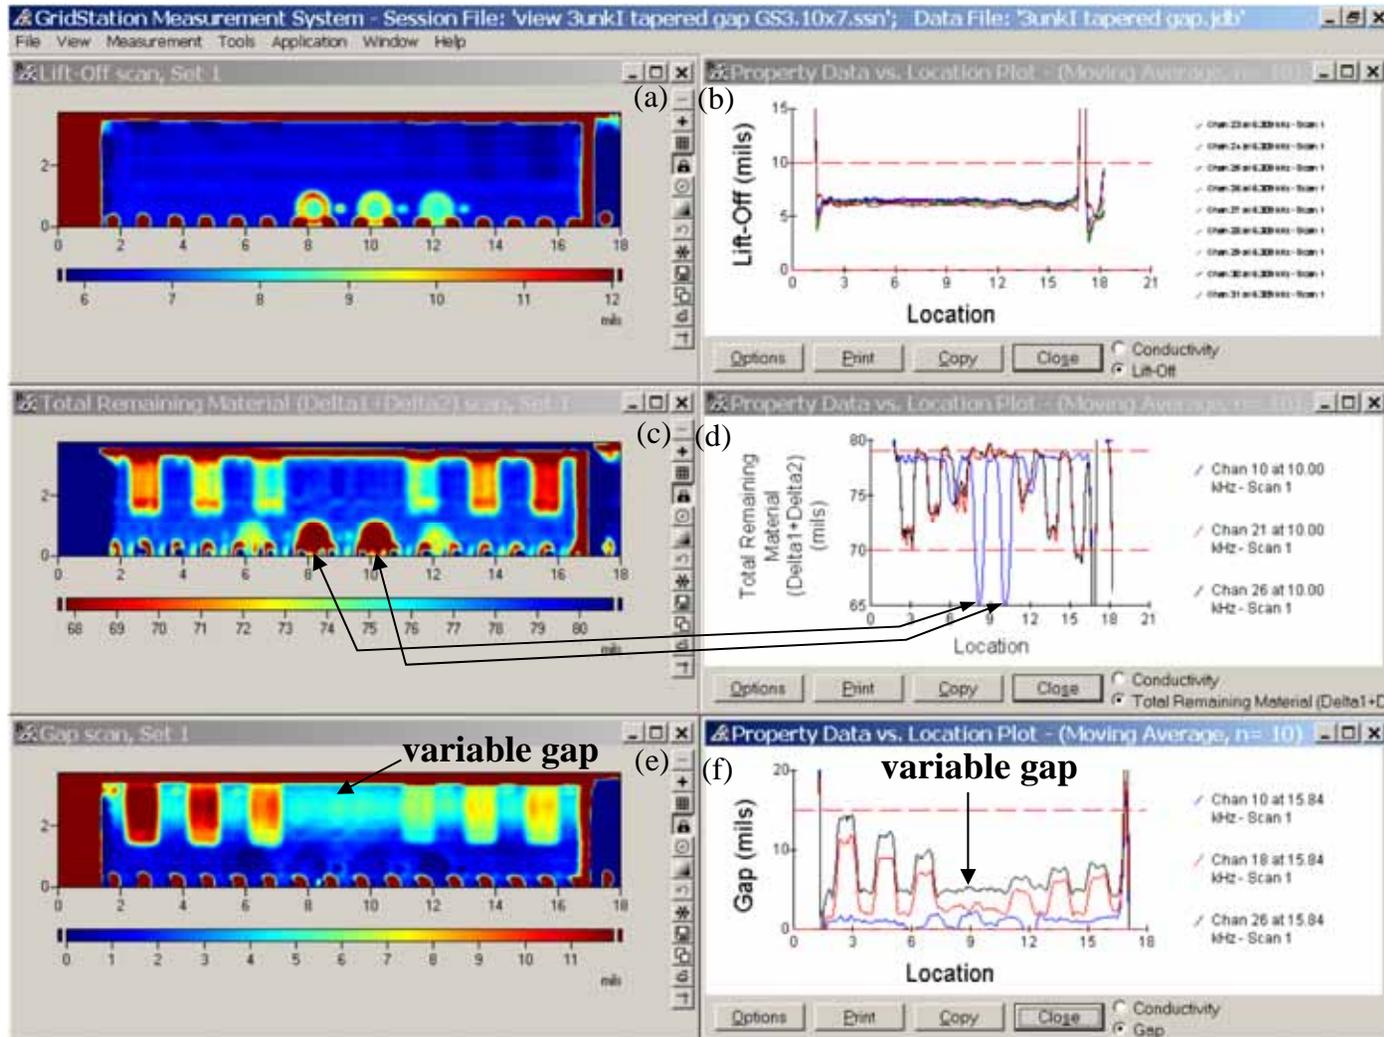
3-Unknown Method Results for MWM-Array Scan of KC-135 Reference Calibration Standard Panels

With 0.005 in. nominal gap across top 1 in. of entire sample length

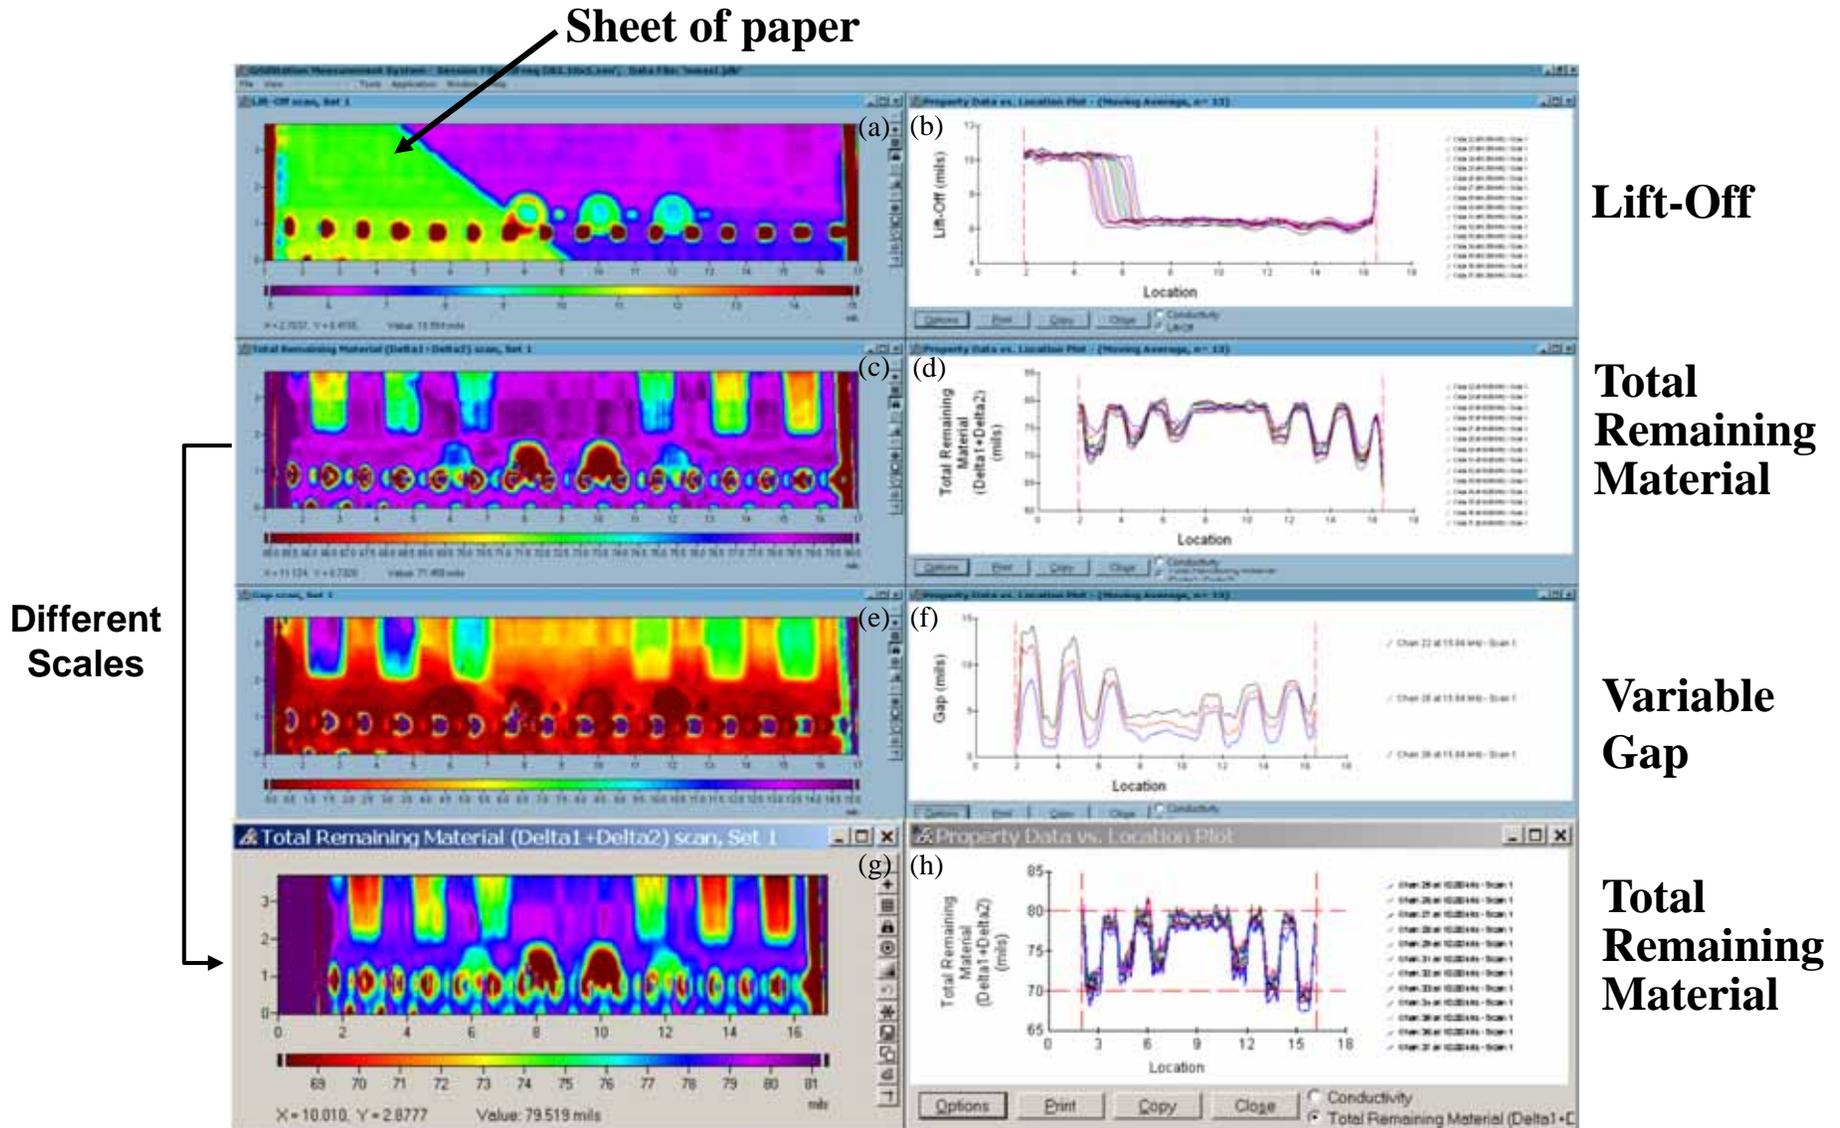
Lift-Off

Total Remaining Material

Variable Gap

Variable Lift-Off (e.g. Paint) and Variable Gap

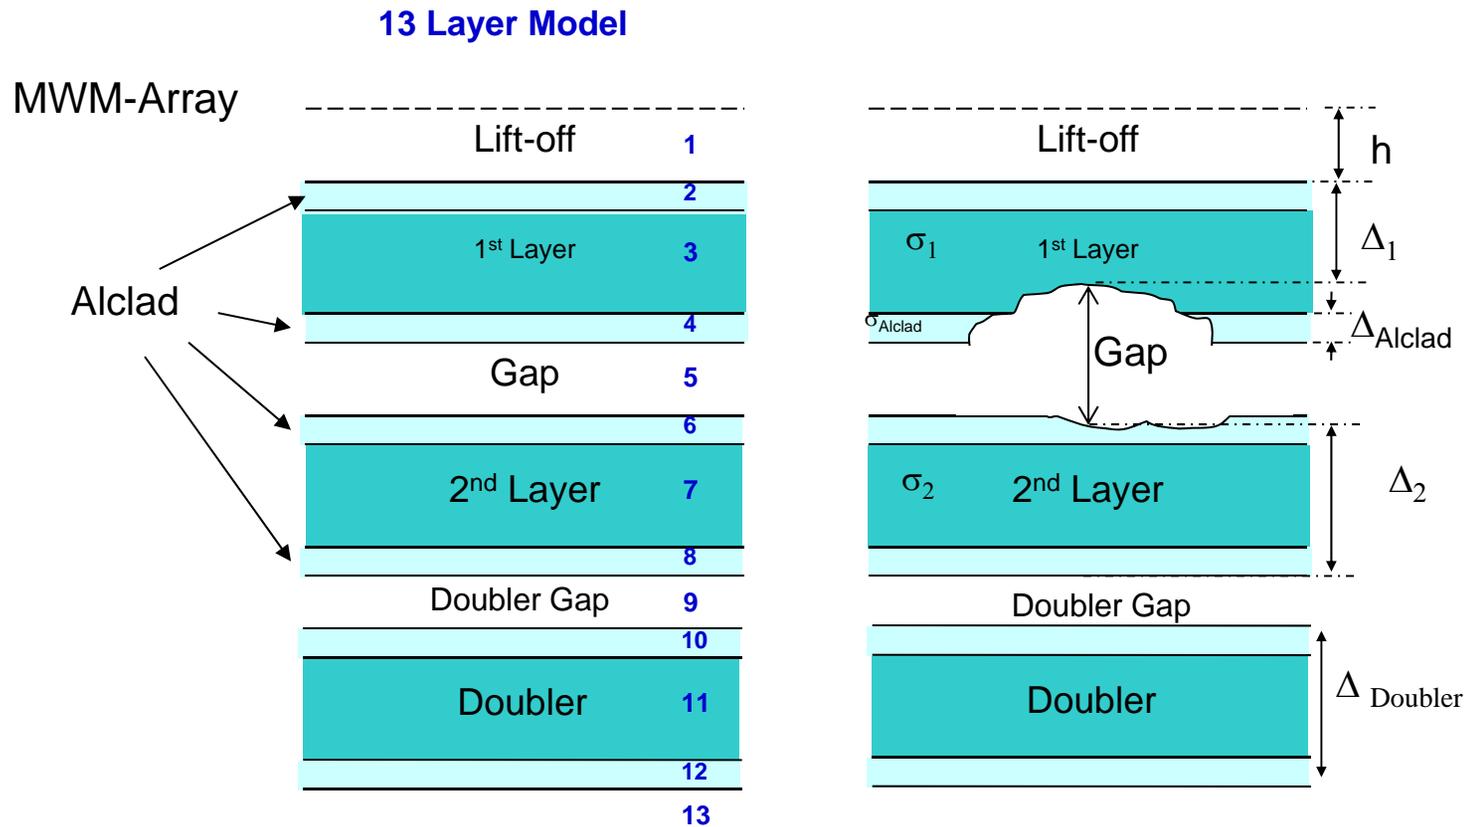
Schematic of 13 Layered Model with Doubler Included for MWM-Array Hypercube Generation

Knowns

$\sigma_1, \sigma_2, \sigma_{Alclad}, \Delta_{Alclad}, \Delta_{Doubler}, \text{Doubler Gap (Approximately only)}$

Unknowns

$h, \Delta_1, \Delta_2, \text{Gap}$

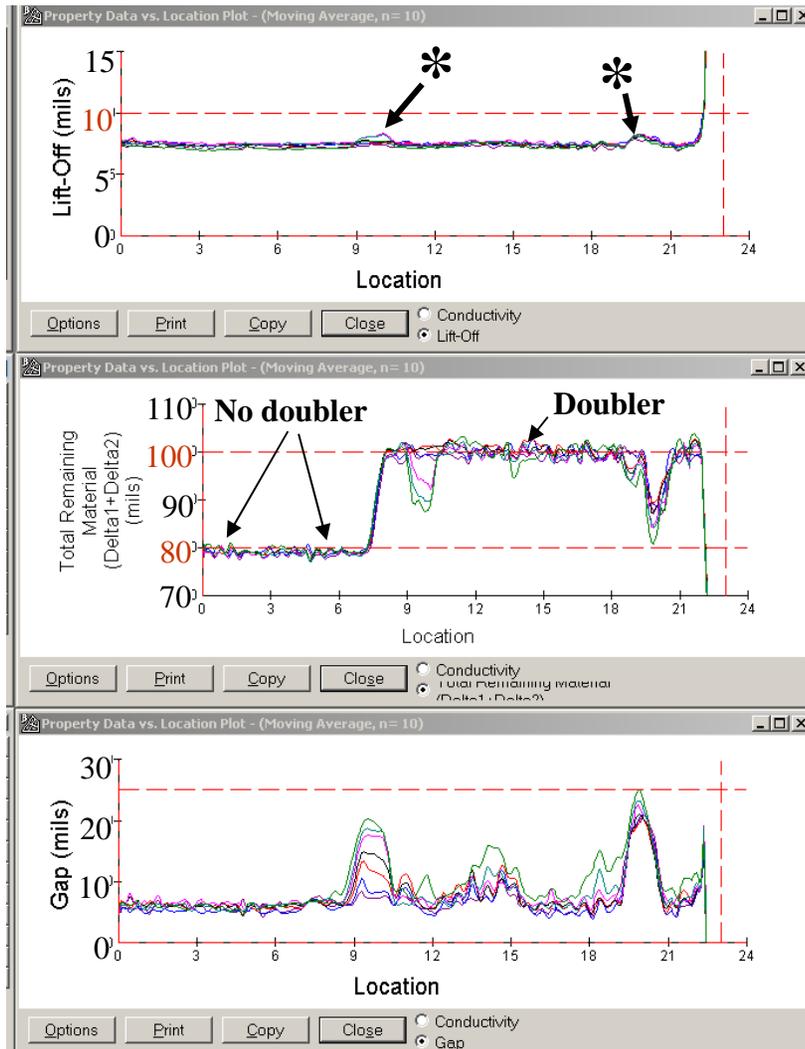
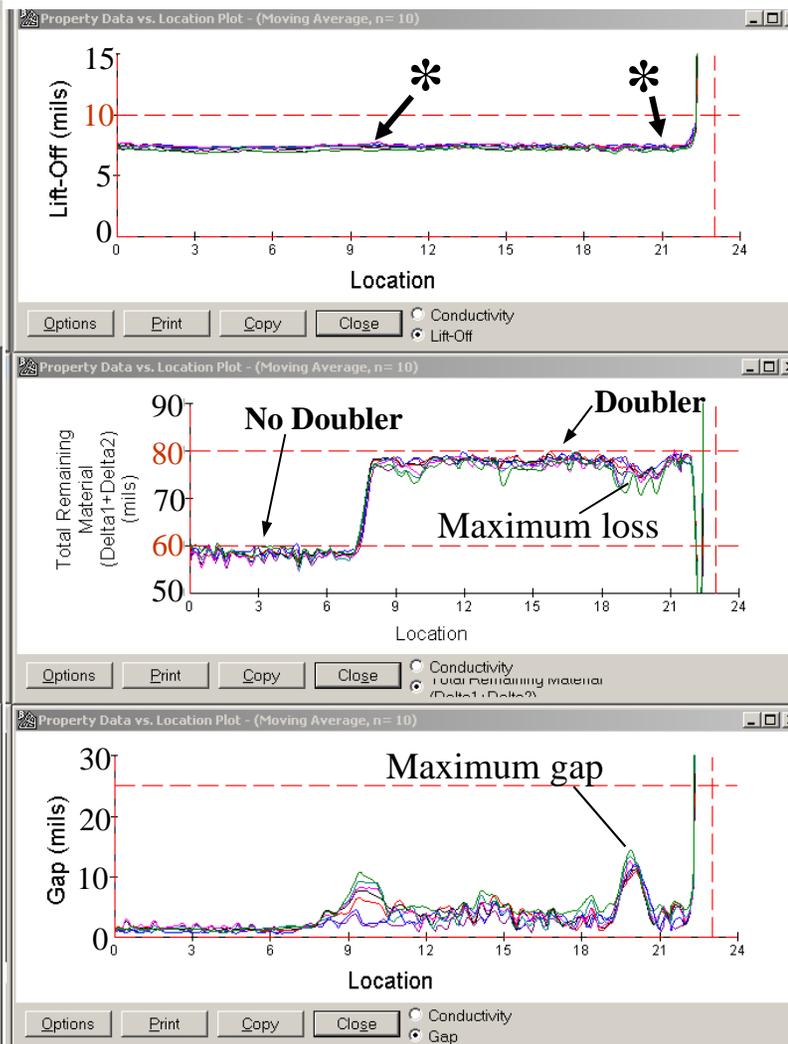
3-Unknown Results for Cut-Out Lap Joint

Without Doubler
Included in Model

With Doubler Correction

Lift-Off

Total Remaining Material

Gap

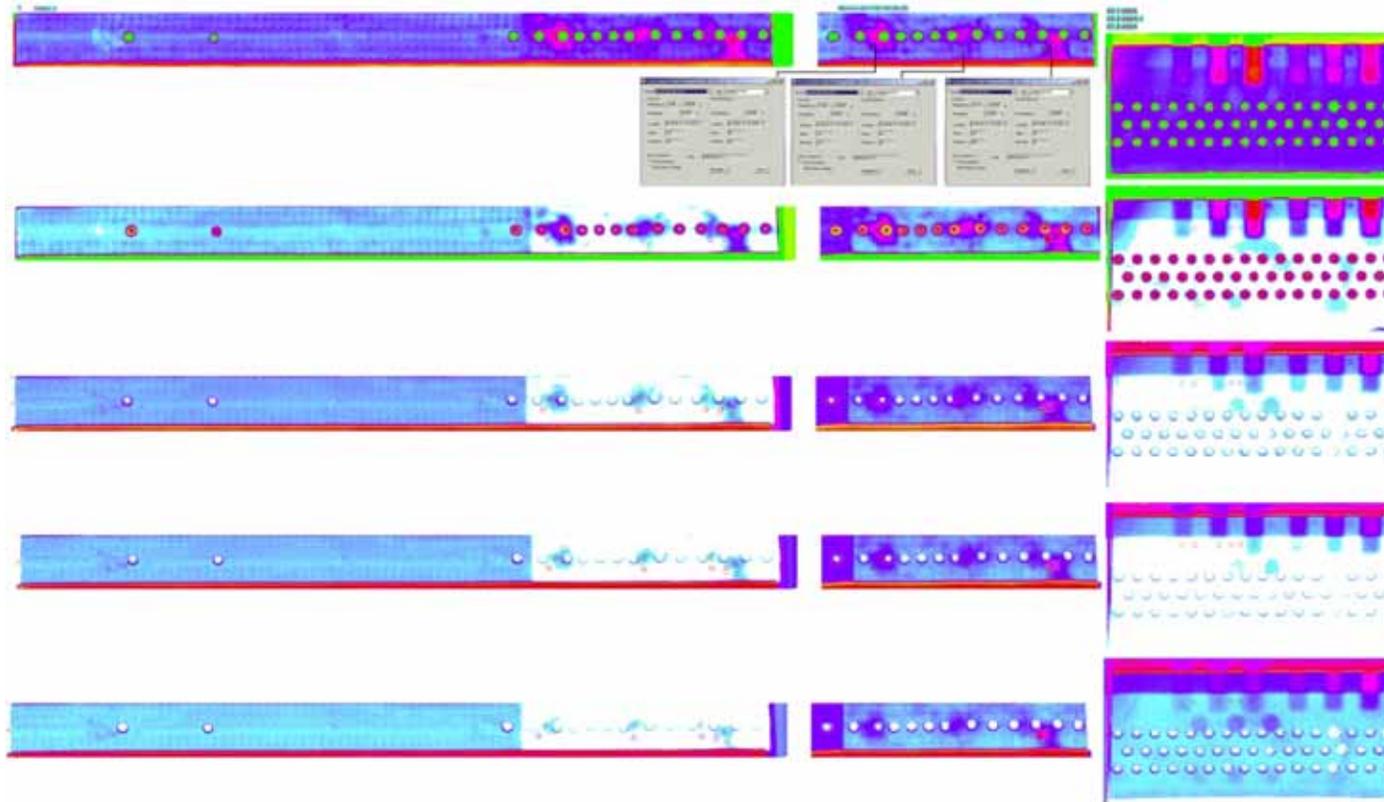
MAUS Data Displaying Gap Correction Reducing the Estimated Loss Level in the MAUS Data

MAUS data for same region as MWM-Array data in previous slide.

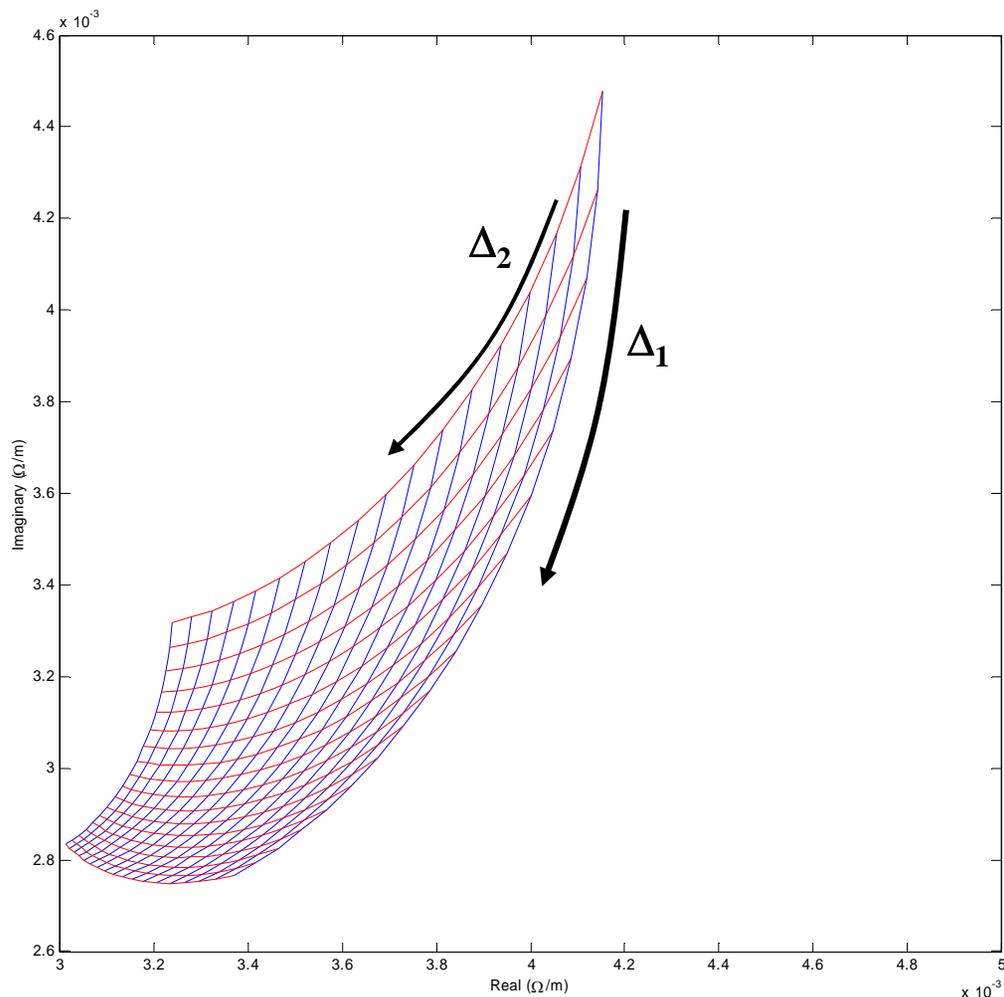
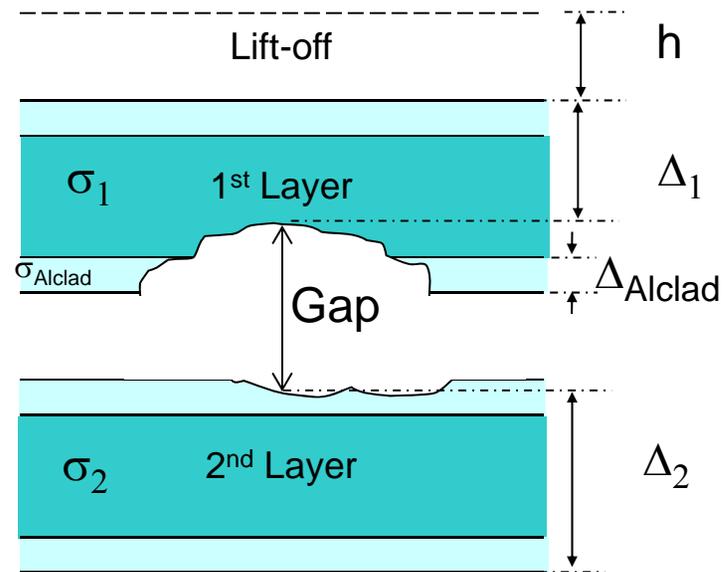
1st Layer Loss vs. 2nd Layer Loss Measurement Grids at 10 kHz for a Gap of 0.011 in.

gap of 11 mils

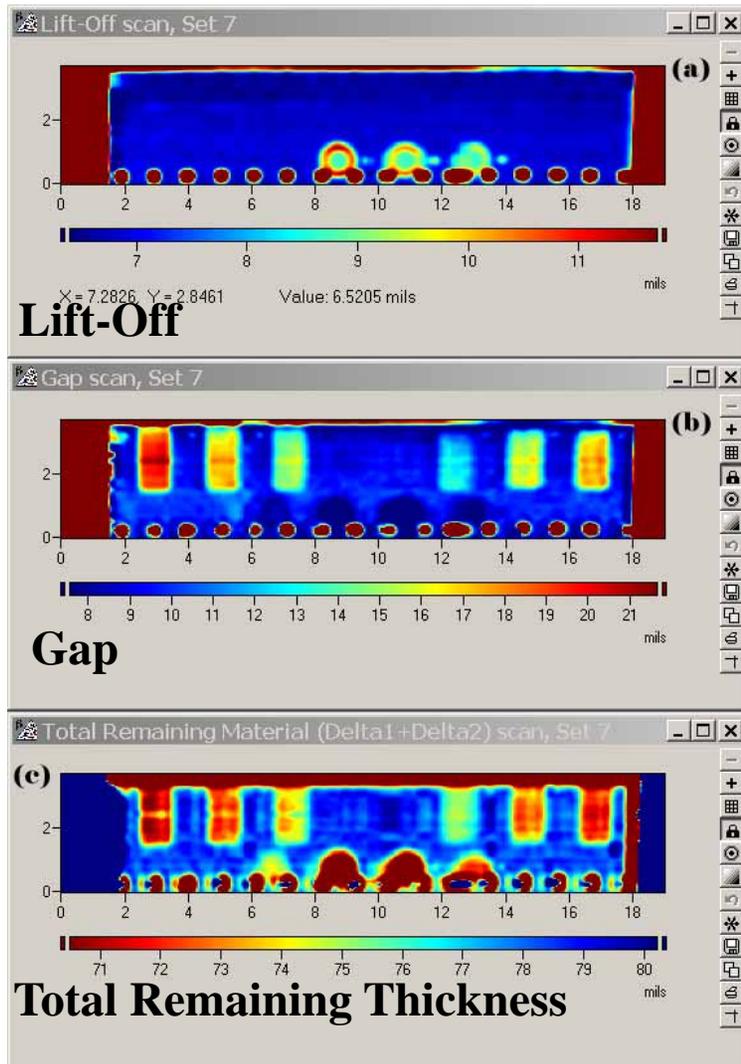
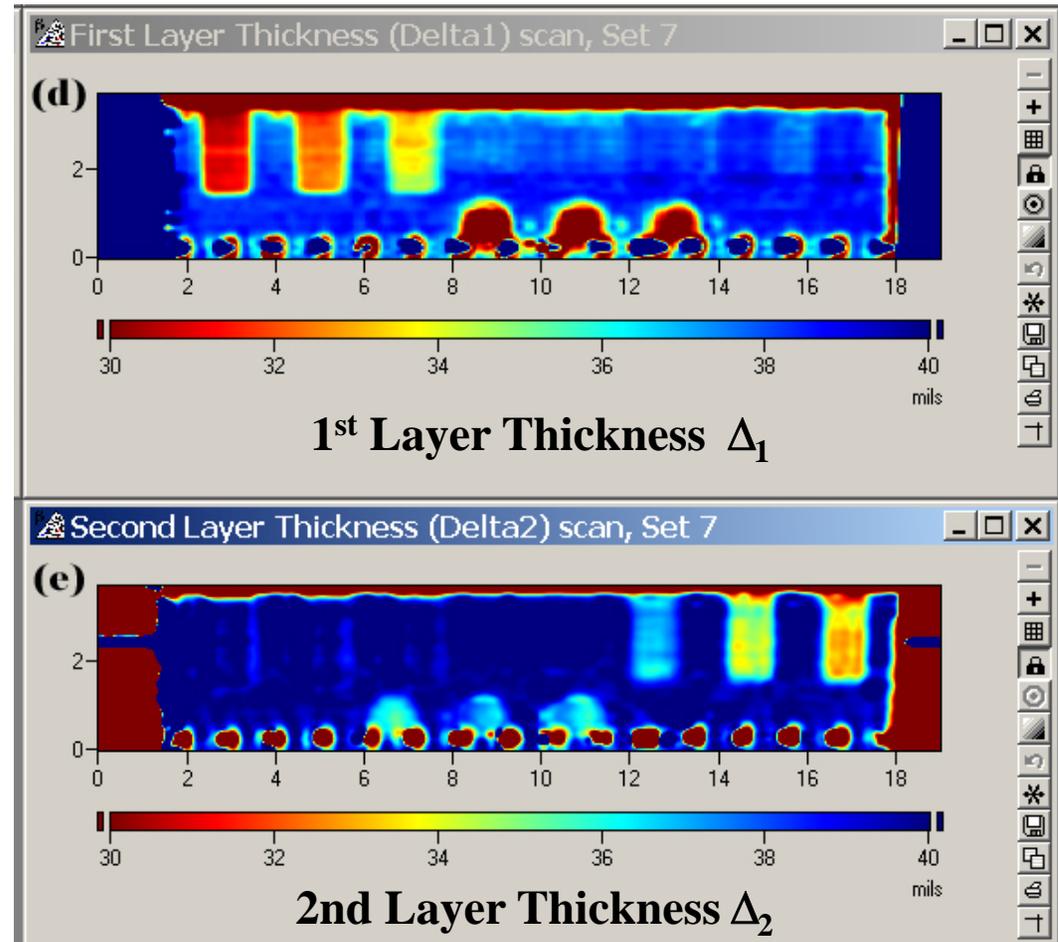
4-Unknown Results h , Δ_1 , Δ_2 , Gap
