Enhancements in MWM-Array Hidden Corrosion Imaging

*Dr. Neil Goldfine, Dr. Vladimir Zilberstein,
Darrell Schlicker, David Grundy, Dr. Ian Shay,
Dr. Robert Lyons, Tim Lovett*

JENTEK Sensors, Inc., Waltham, MA 02453-7013**
Phone: 781-642-9666, email: jentek@shore.net

November 20, 2003

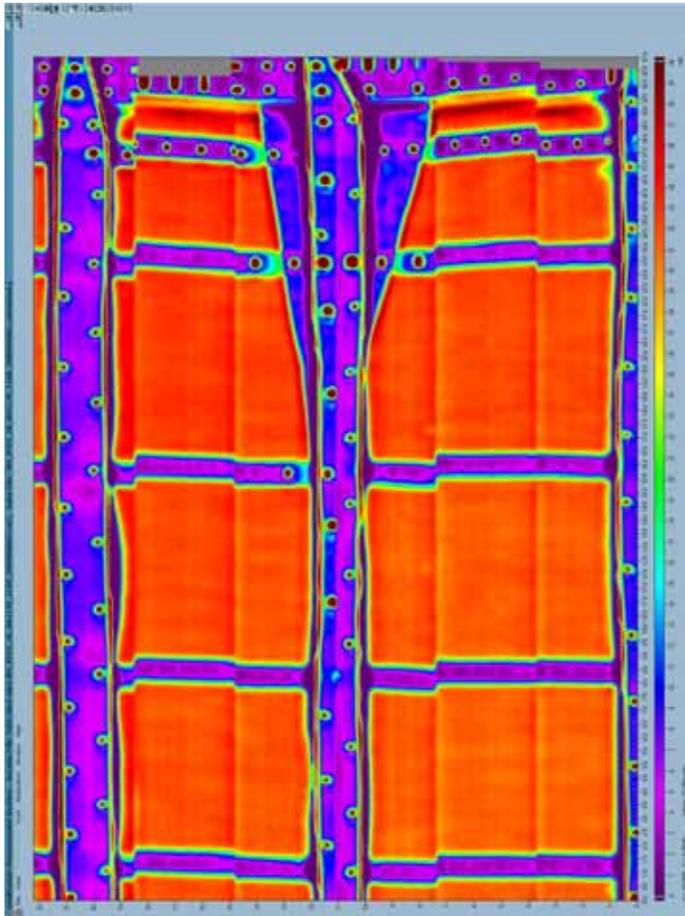
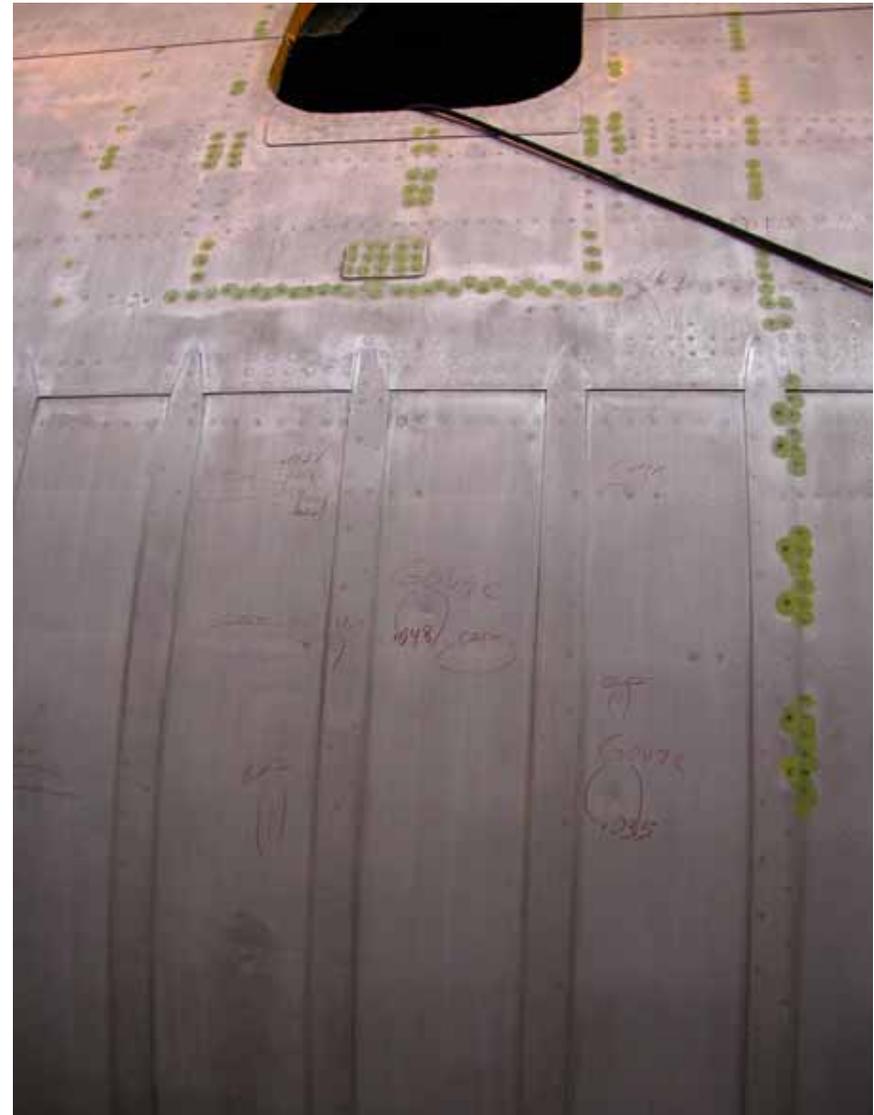
MWM-Array Image of Wide Area

Using Multiple MWM-Array
Scan Passes

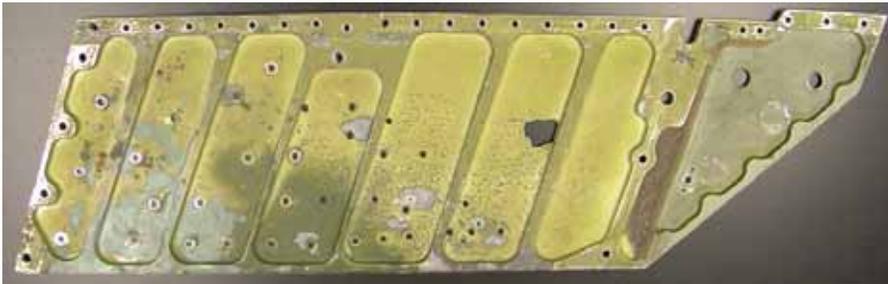
Internal Geometric Feature and Hidden Damage Imaging: C-130 Flight Deck Chine Plate

Inaccessible Side

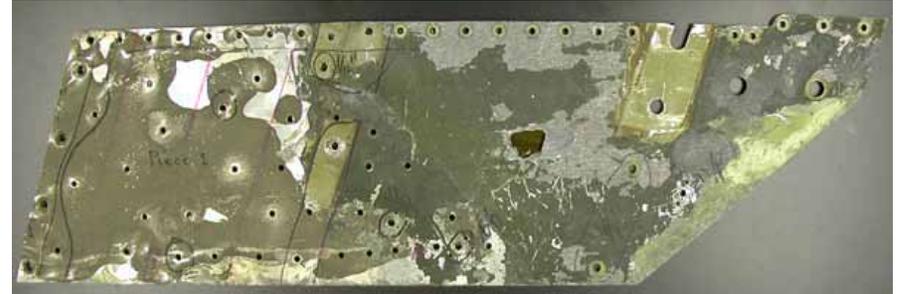
Accessible Side

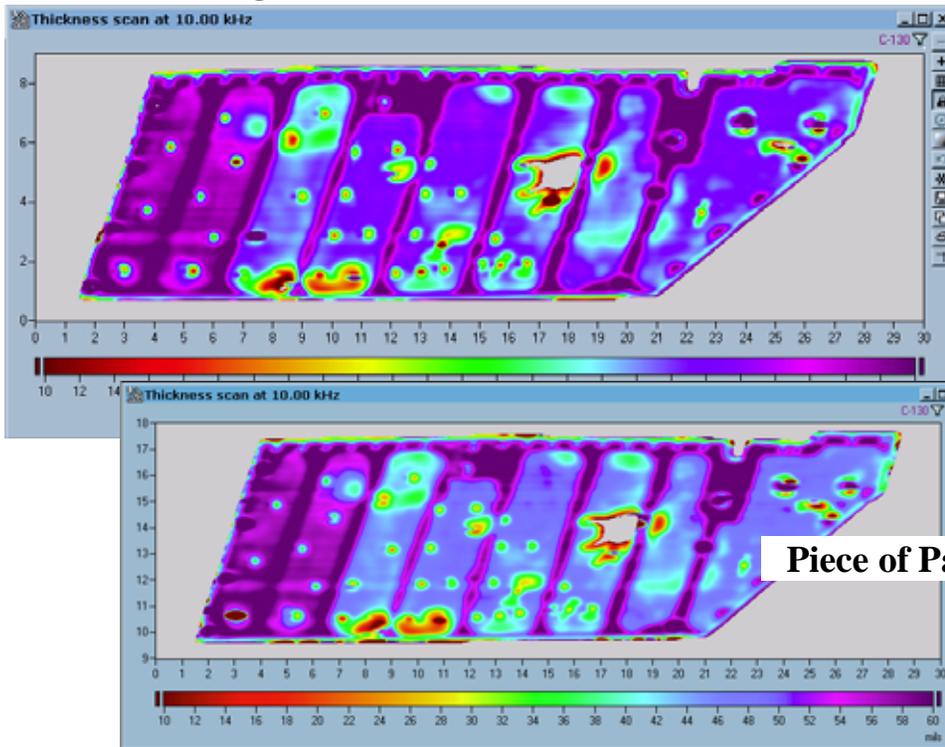
Thickness Image from Accessible Side

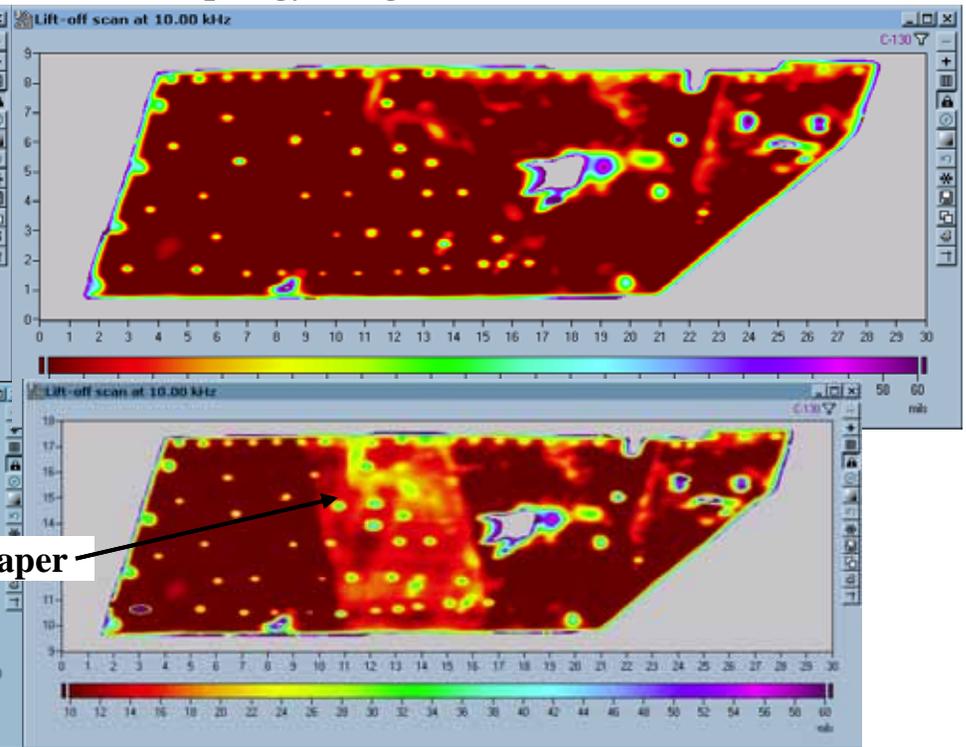
Surface Topology Image

Piece of Paper

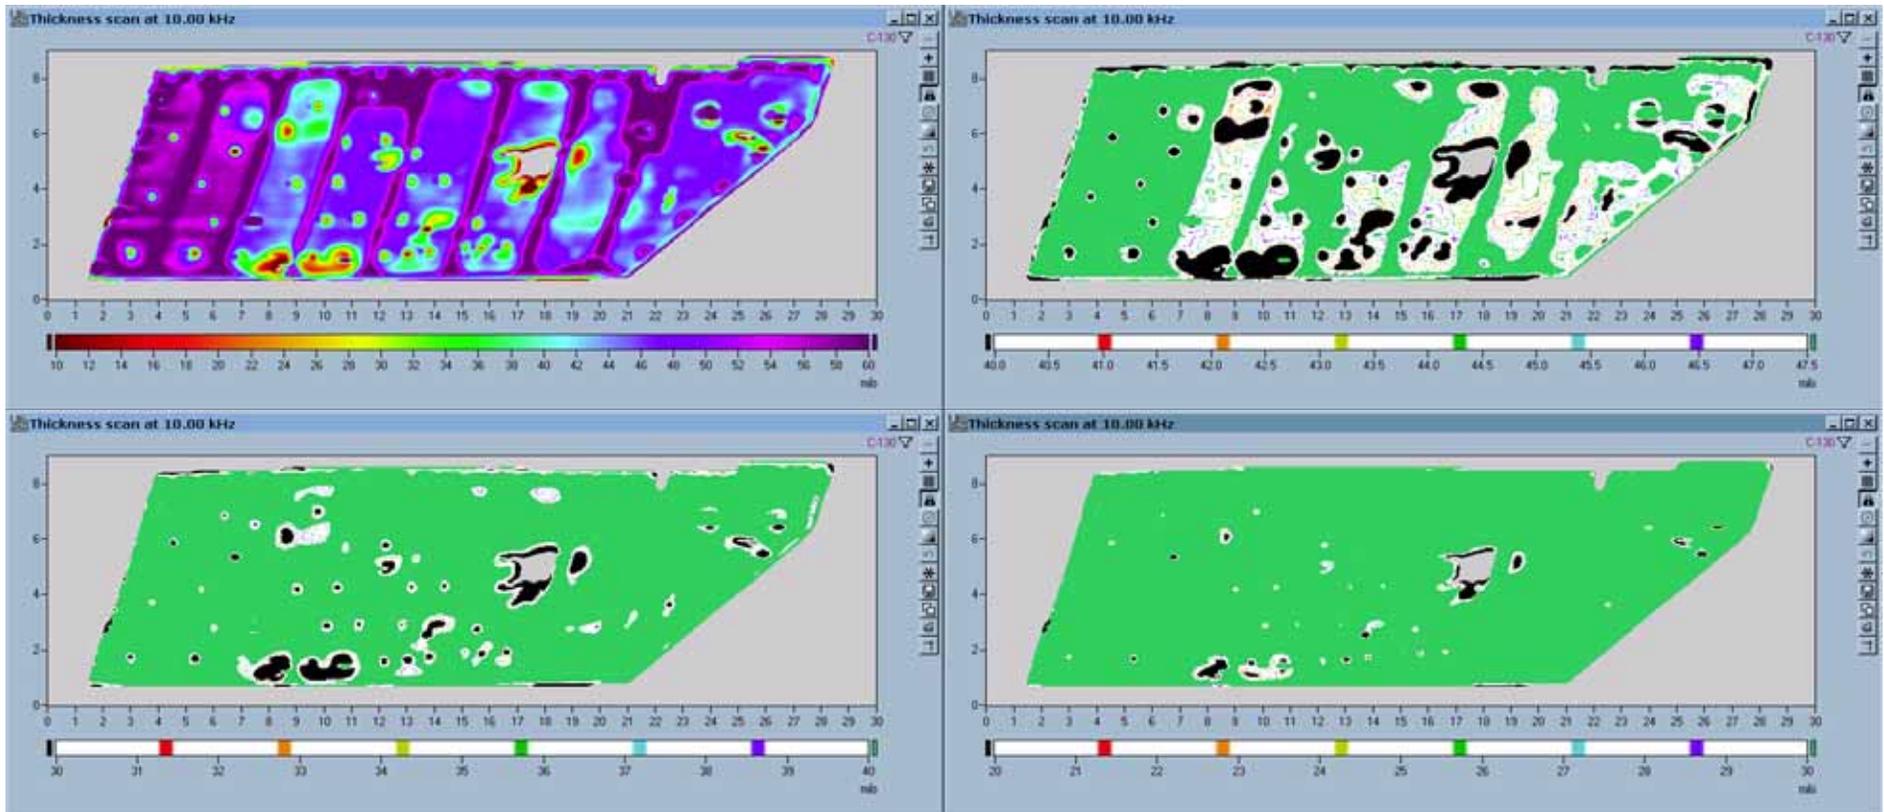
Hidden Damage Imaging of C-130 Flight Deck Chine Plate

Thickness Image

Green: < 5% Material Loss
White: 5-20% Material Loss,
Black: >20% Material loss

Green: < 20% Material Loss
White: 20-40% Material Loss
Black: >40% Material loss

Green: < 40% Material Loss
White: 40-60% Material Loss
Black: >60% Material loss

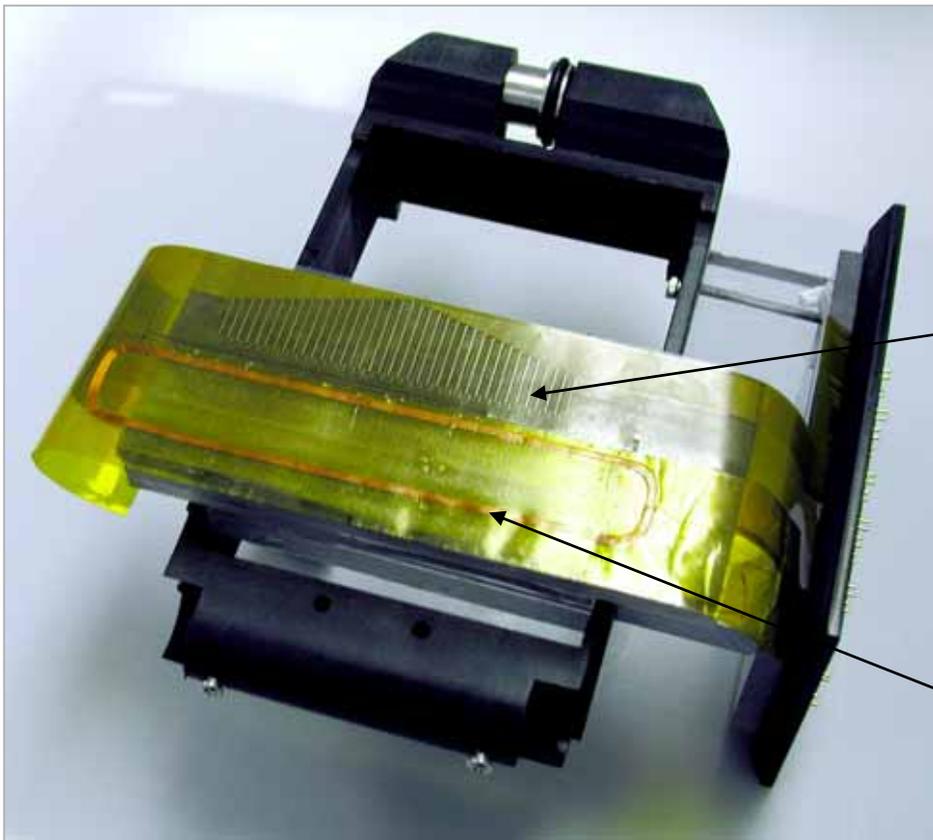
Hybrid Wound/Etched MWM-Array

- Wound drive winding - permits lower frequency operation
- Etched sense element array - controlled element geometry and registration

Etched Sensing Element Array

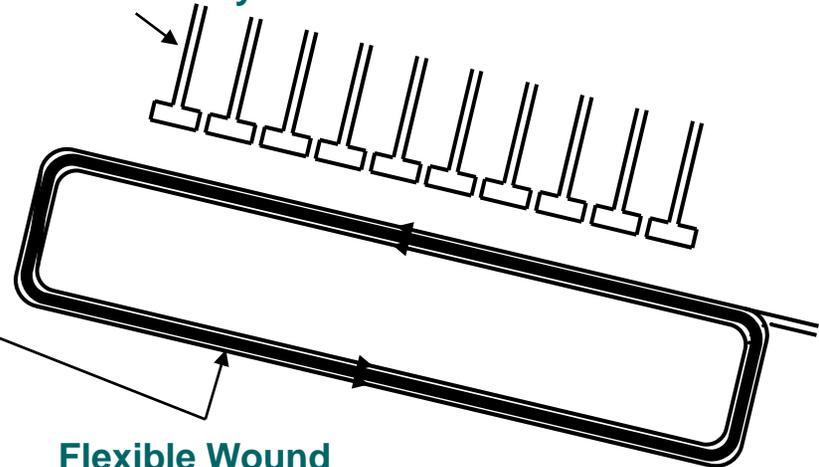
Flexible Wound Drive Winding

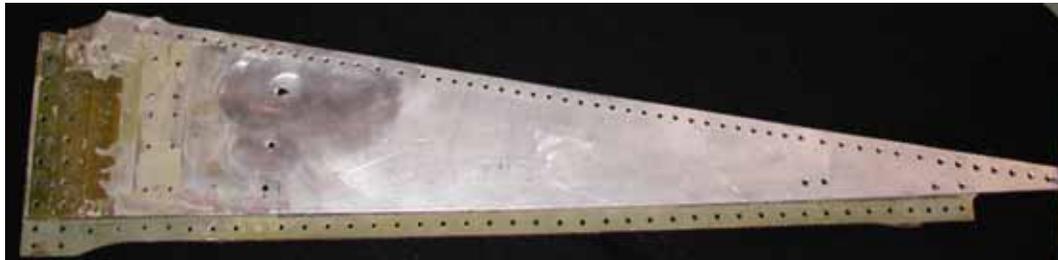
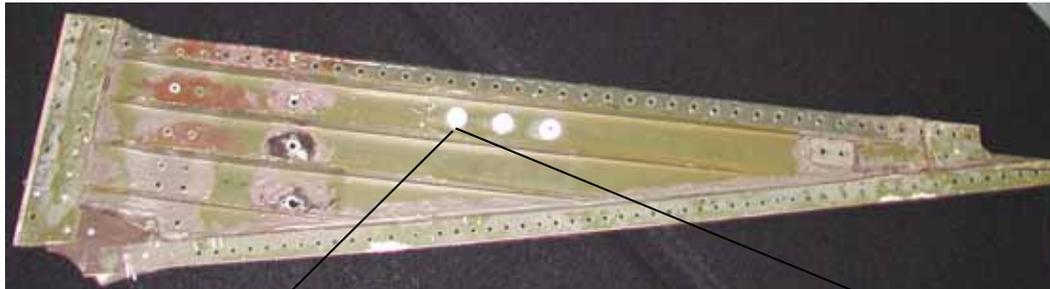
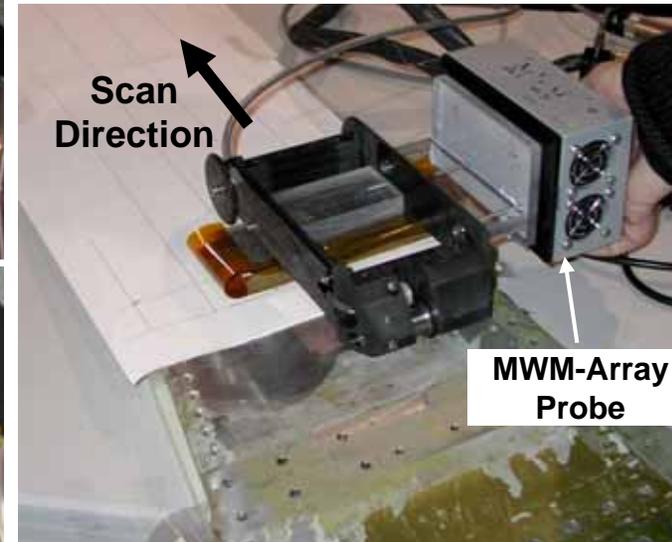
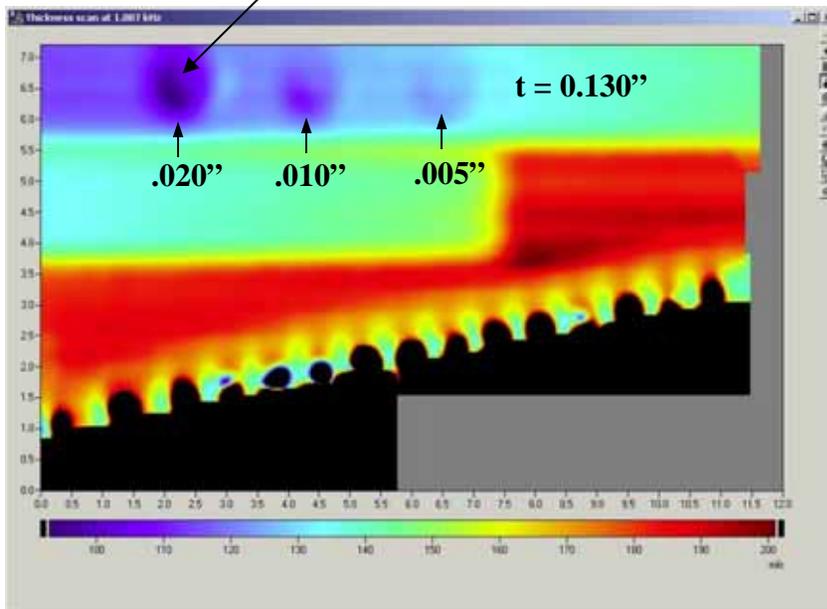
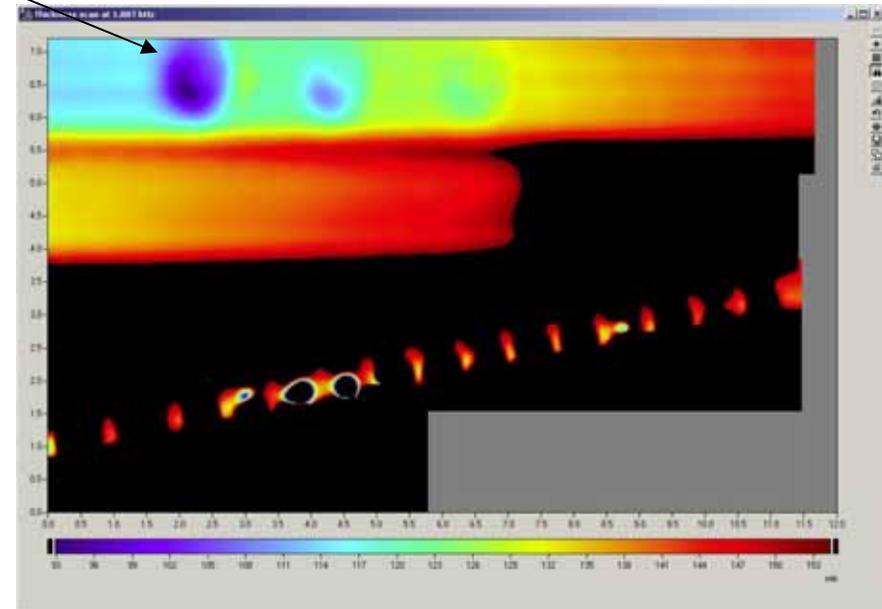
MWM-Array Scans of a Wing Plank from Navy P-3 Aircraft

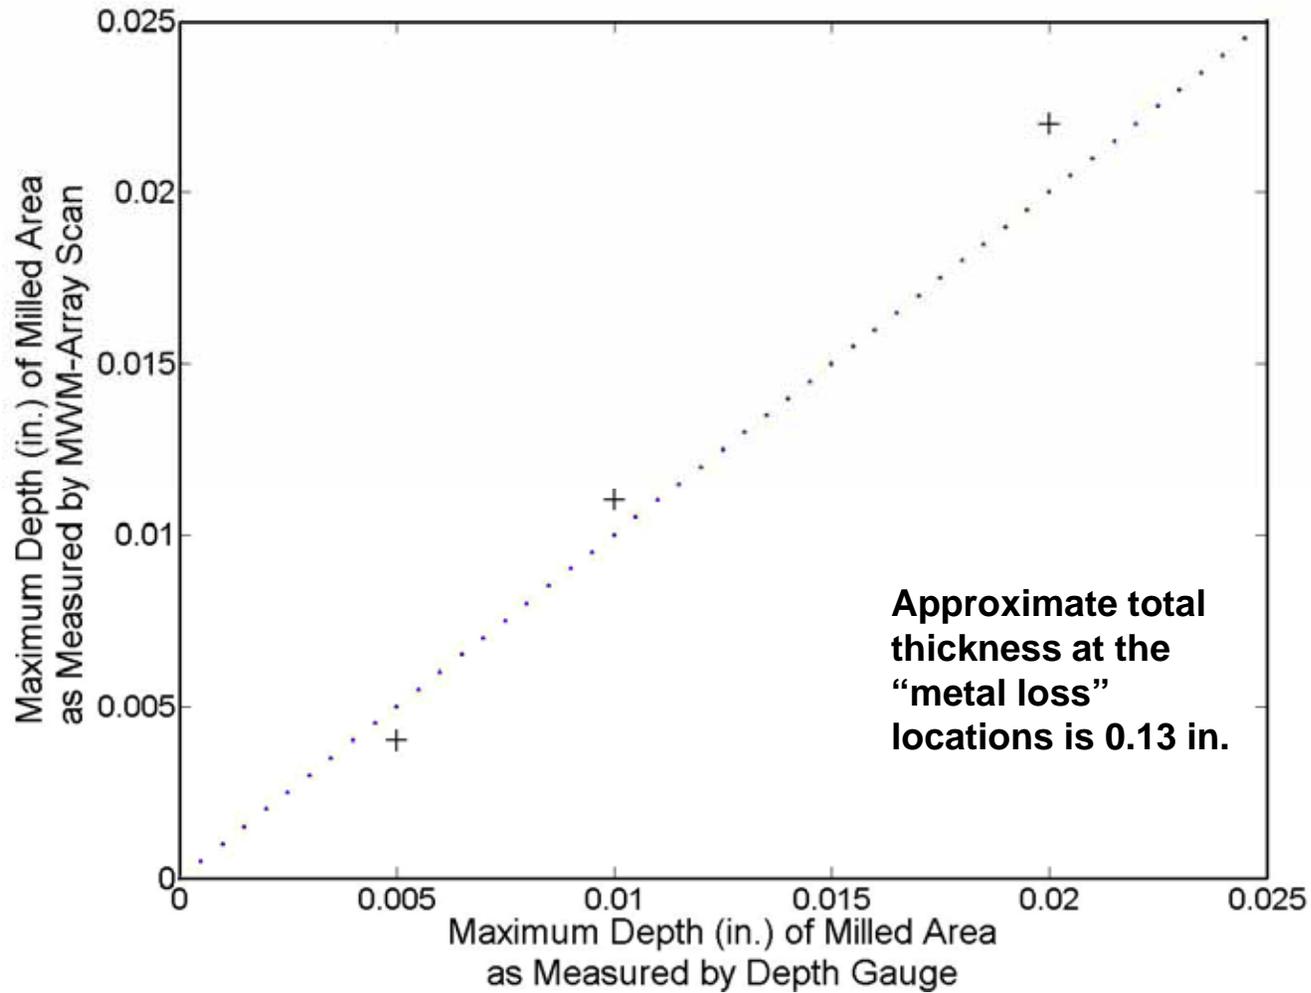
MWM-Array Hidden Metal Loss Estimates for the Three Milled Out Regions vs. the Actual Depth Measured with a Depth Gauge

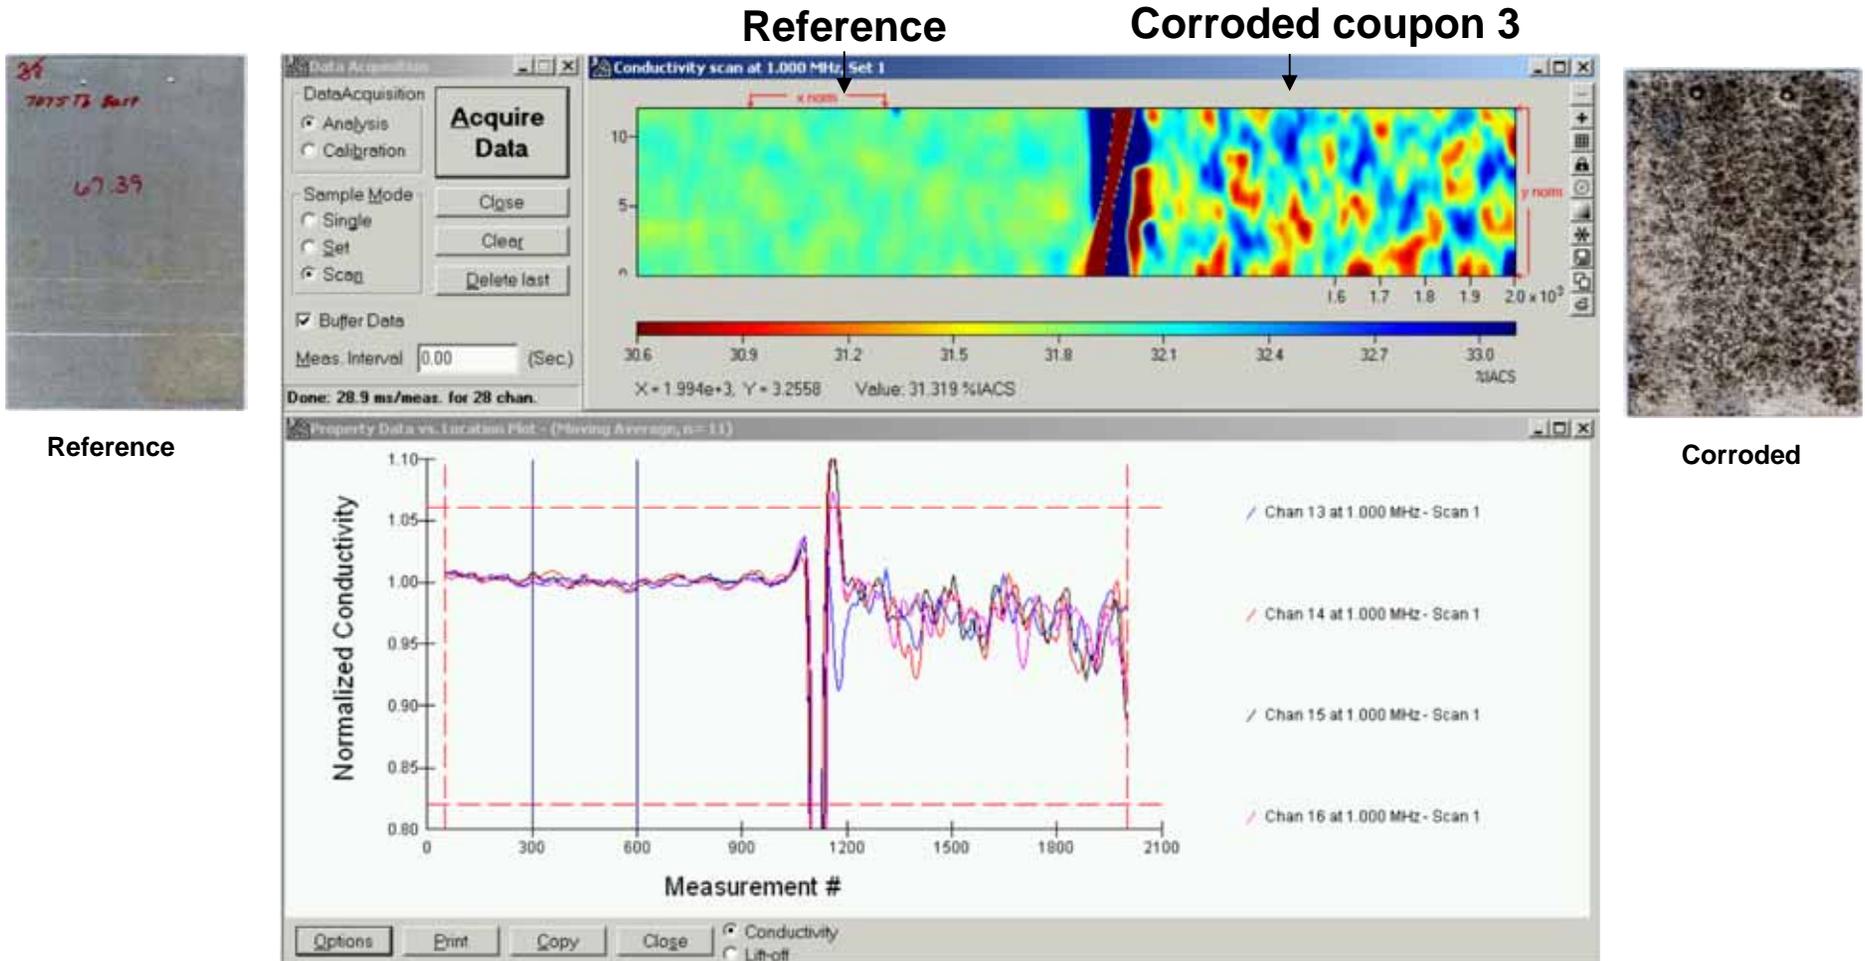
Corrosion Images without Paint Removal

Images of reference Al 7075-T6 coupon (left) and the more severely corroded Al 7075-T6 coupon (right) obtained at 1 MHz

Note: **0.004 in. insulating shim** used to simulate paint layer

Scan width 12 mm, scan length 100 mm

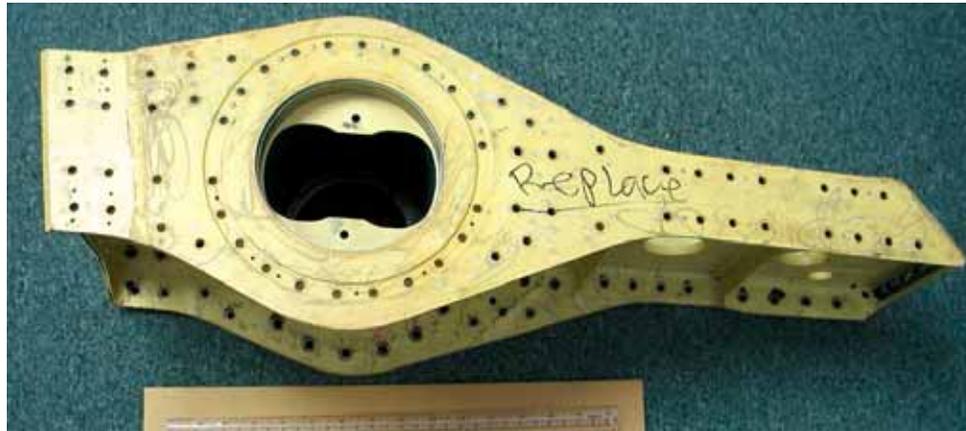
F-15 Wing Pylon Inspection

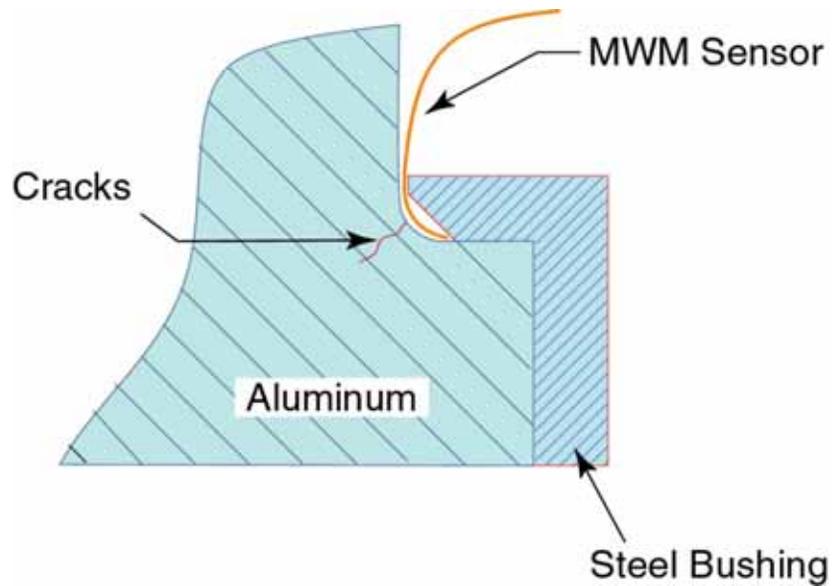
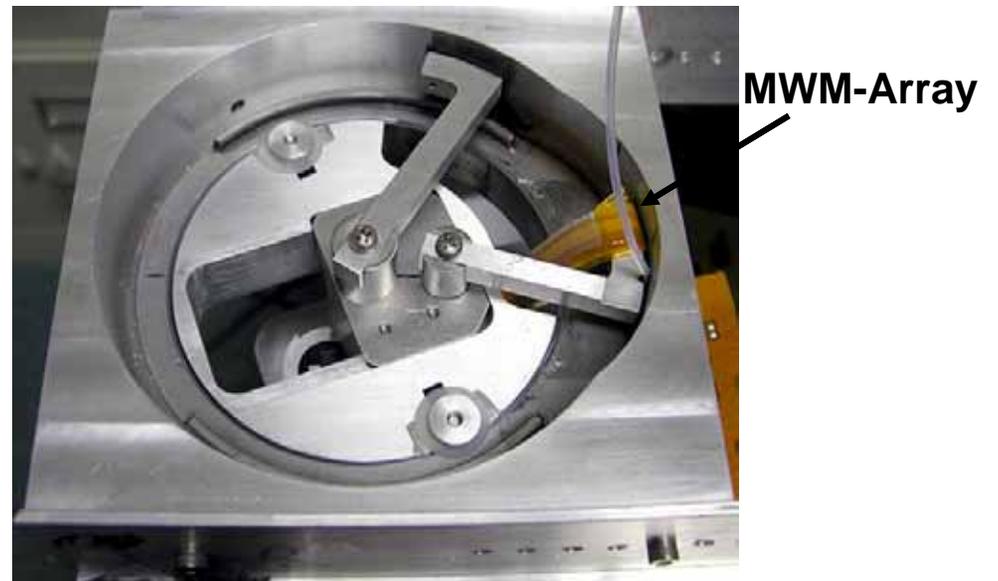
With Bushing in Place

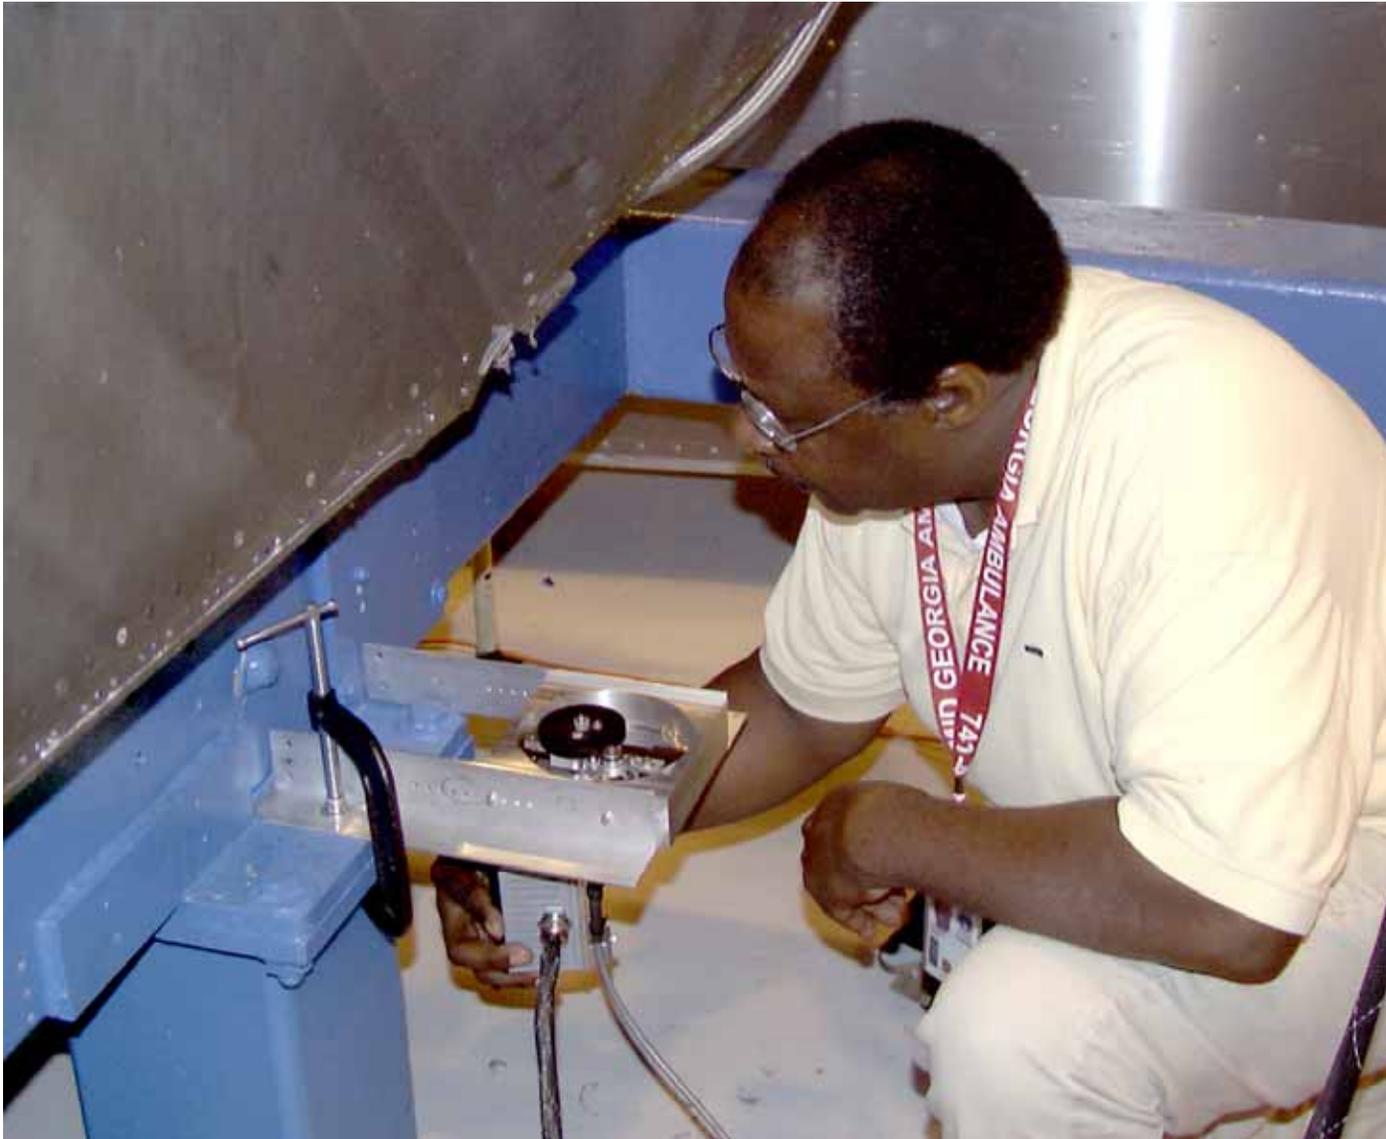
WR-ALC Training (on Mockup) with Bushing Removed

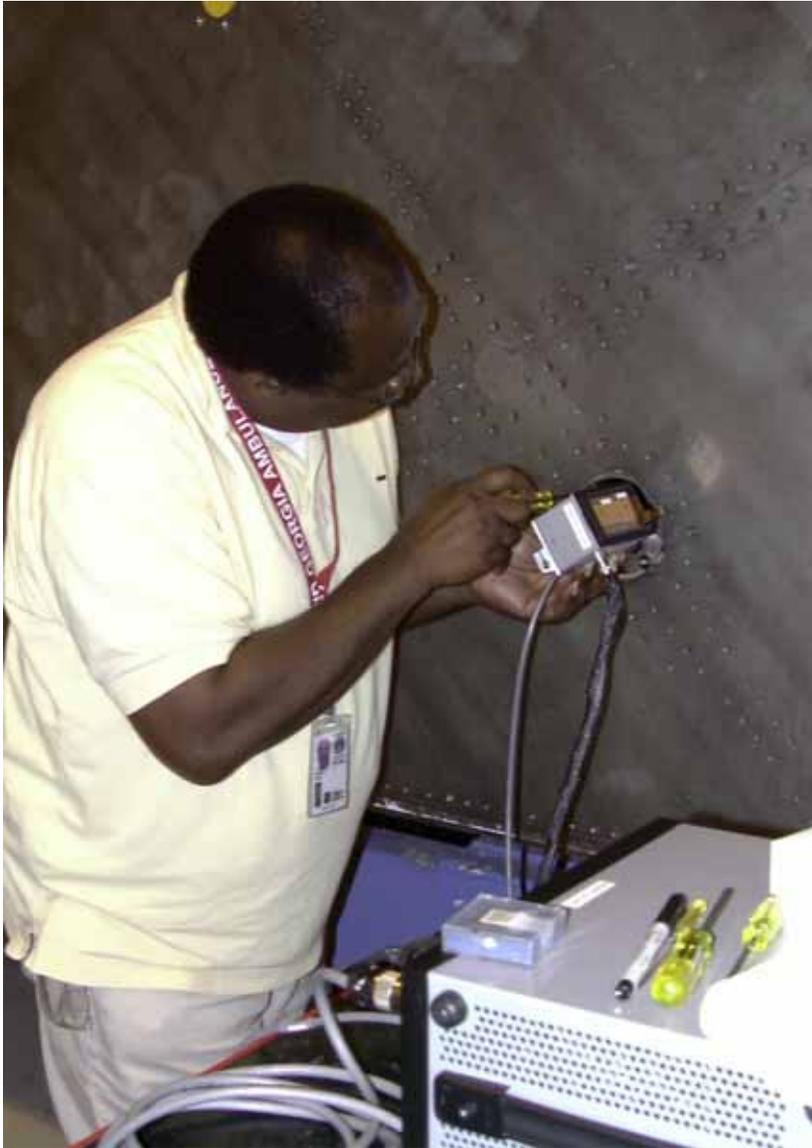
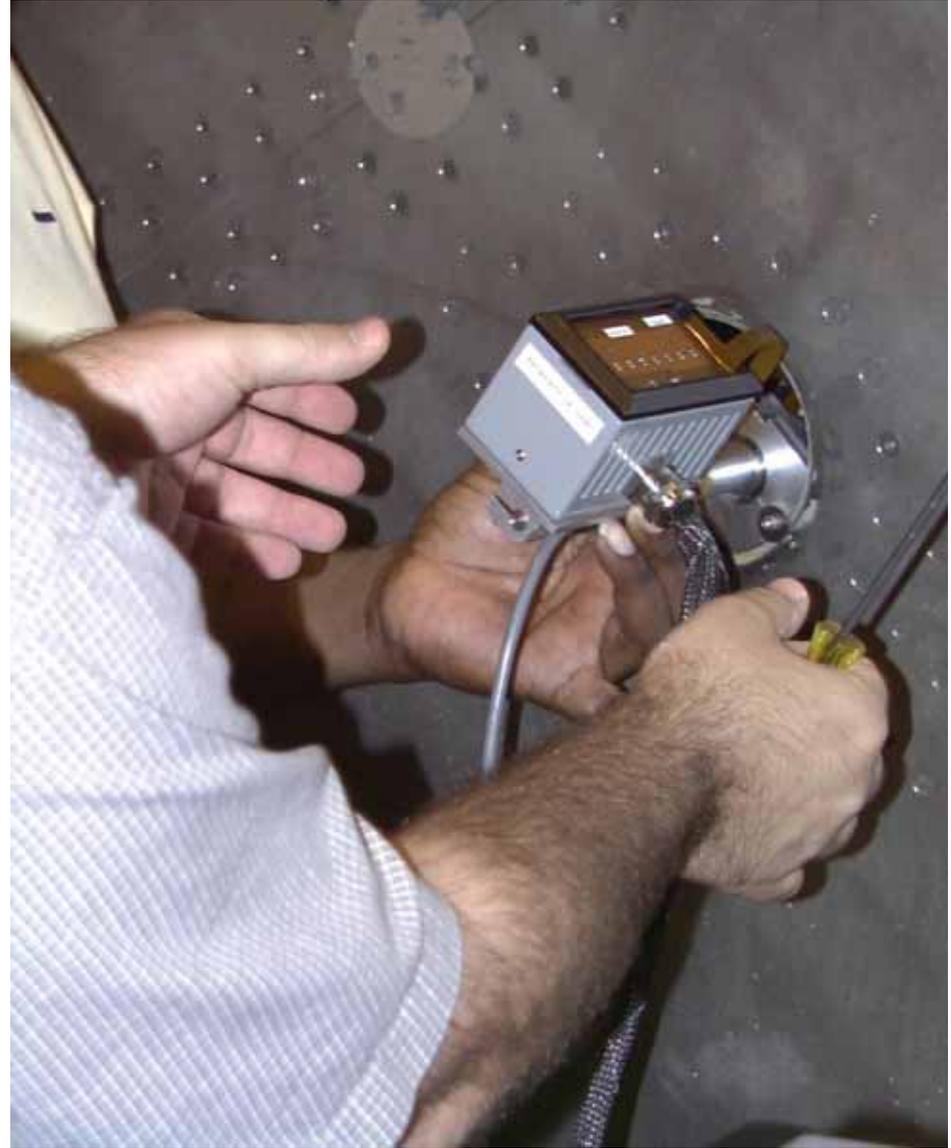
WR-ALC Training with Bushing Removed

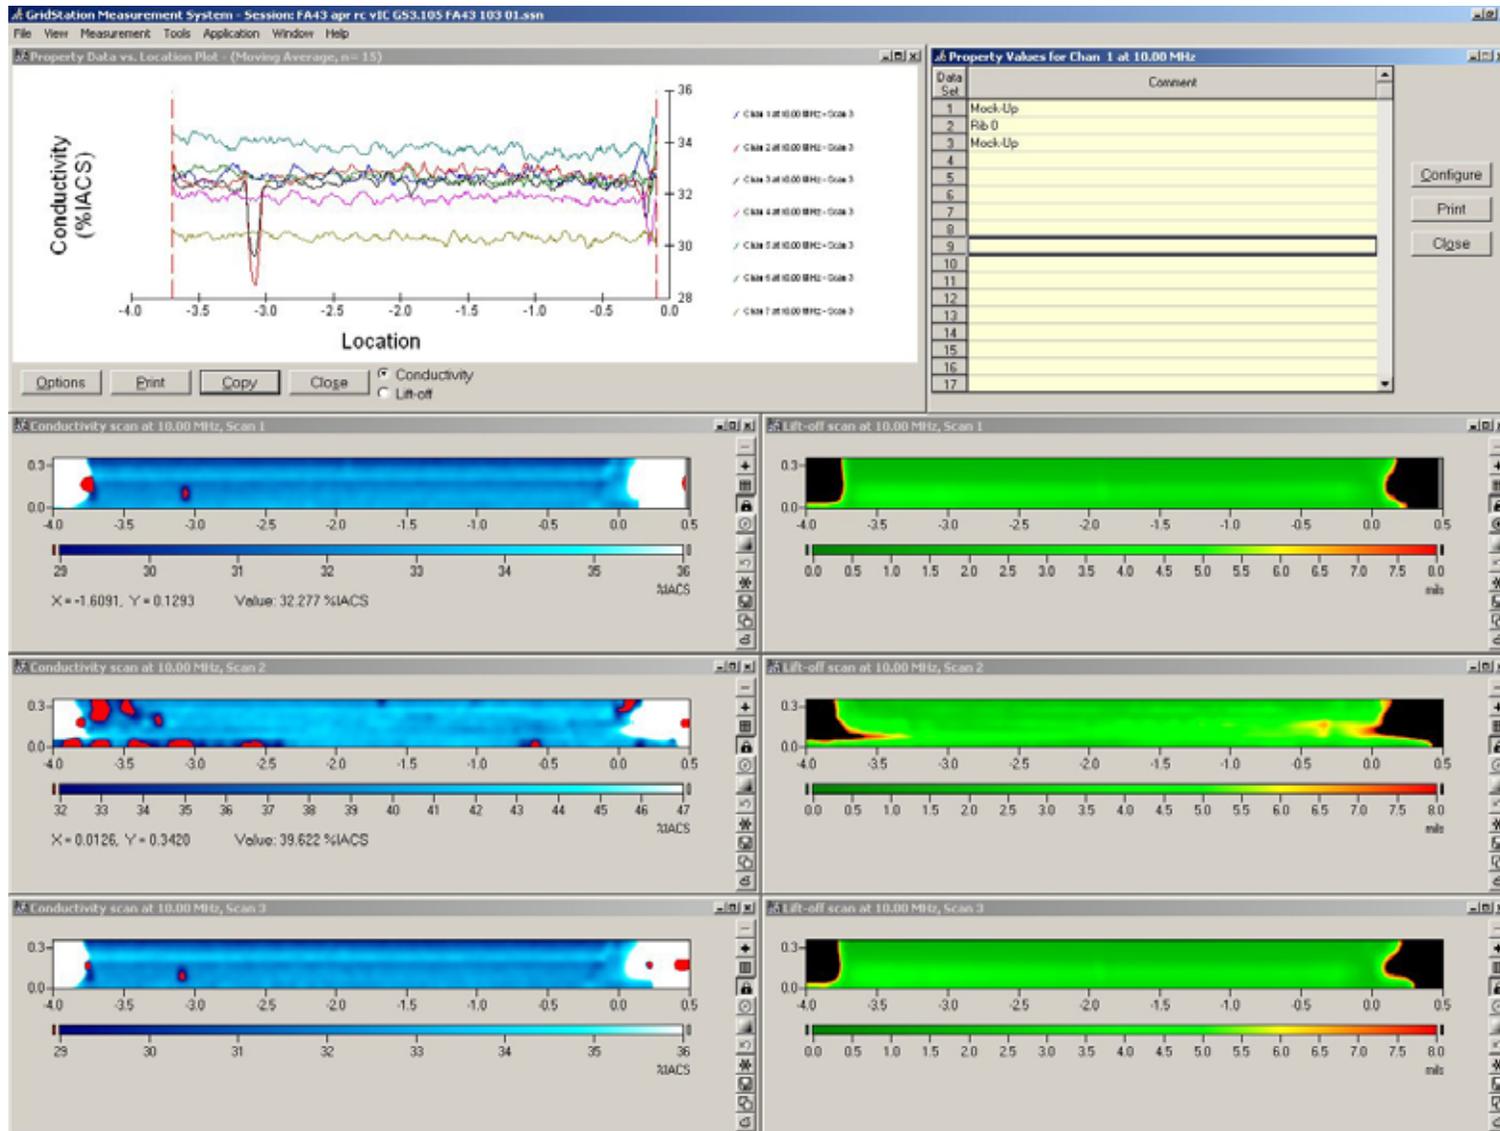
MWM-Array Corrosion Pitting/Crack Imaging
