Corrosion Imaging through Insulation using MR-MWM-Arrays

Neil Goldfine, Todd Dunford, Scott Denenberg, Yanko Sheiretov,
Shayan Haque, Brian Manning, and Andrew Washabaugh

JENTEK Sensors, Inc., 110-1 Clematis Avenue, Waltham MA 02453
Tel: 781-373-9700; www.jenteksensors.com

June 3, 2015

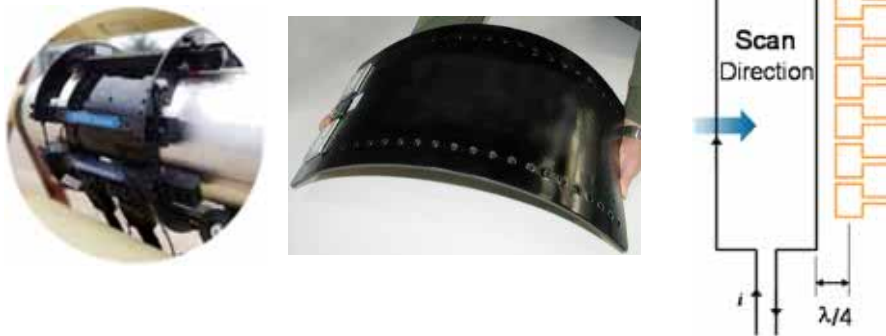
1. Sensors: MWM[®]-Arrays

- Paradigm shift in sensor design (first priority is predictable response based on physics-based modeling)

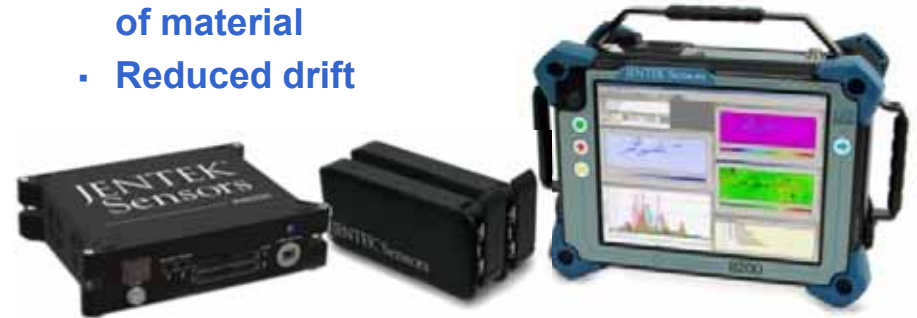
2. Next Generation 8200 GridStation[®] Electronics

- 10x signal-to-noise improvement
- Very low frequencies (deep penetration)
- Crack detection through up to 0.5 inches of material
- Reduced drift

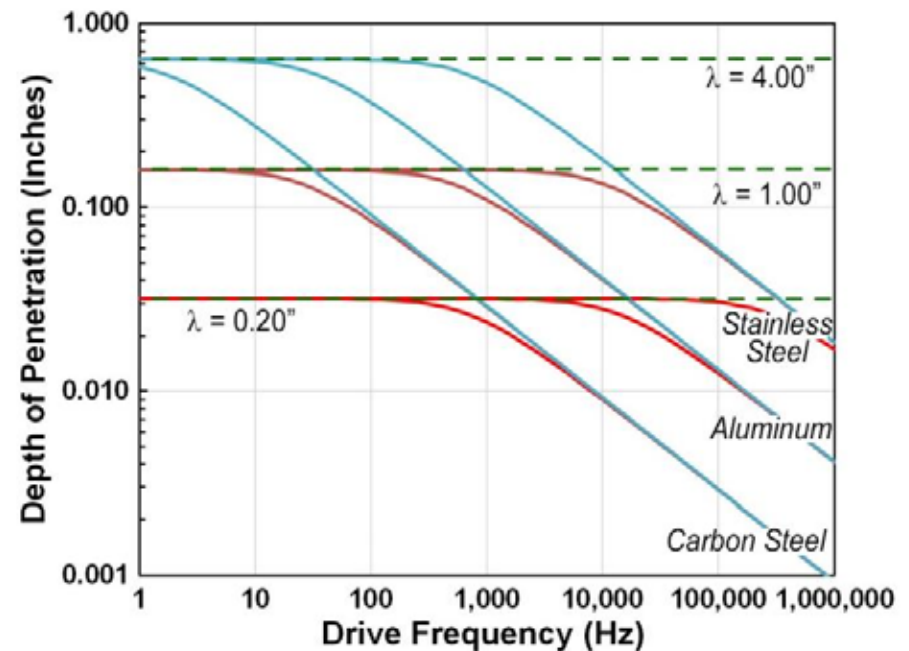
MR-MWM-Array

Depth of Penetration = $1/\text{Re}(\Gamma_n)$

Low Frequency Limit = $\frac{\lambda}{2\pi}$

$$\Gamma_n = \sqrt{(2\pi n / \lambda)^2 + j2 / \delta^2}$$

$$\text{Skin depth: } \delta = \sqrt{\frac{1}{\pi f \mu \sigma}}$$

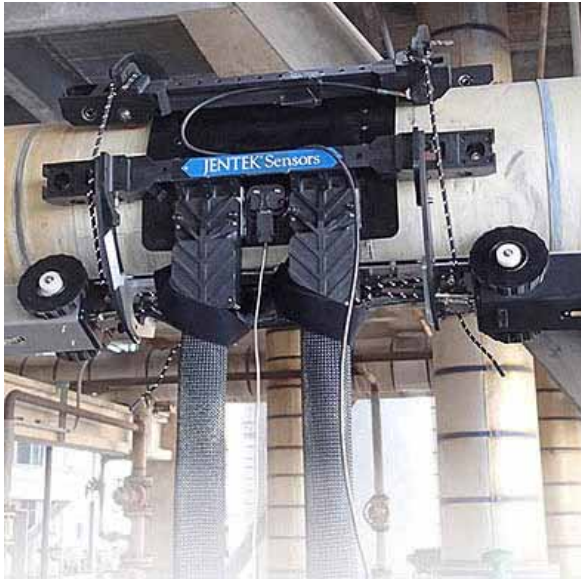
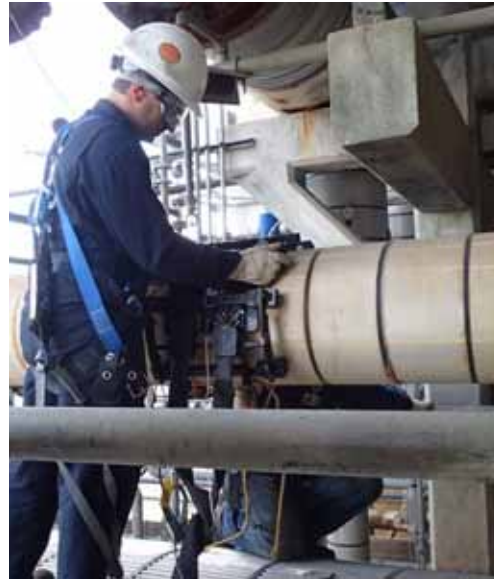
Problem Definition

$h, \Delta_{wj}, \Delta_i, \Delta_p, \mu_p$

h_o = distance between sensor & external surface of weather jacket

Δ_{wj} = weather jacket thickness

Δ_i = insulation thickness + external metal loss

Δ_p = remaining pipe wall thickness

μ_p = pipe magnetic permeability

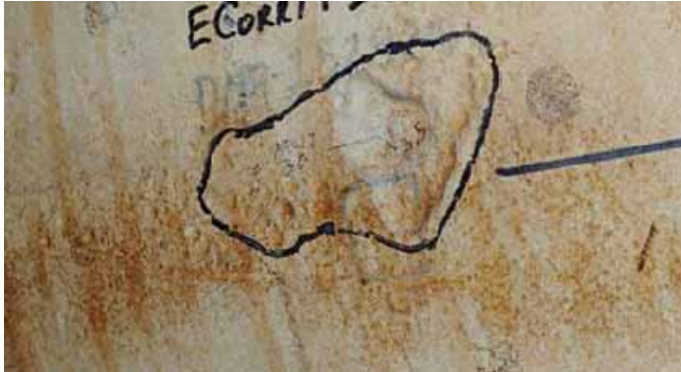
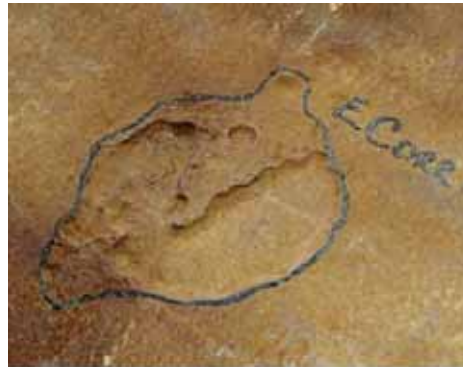
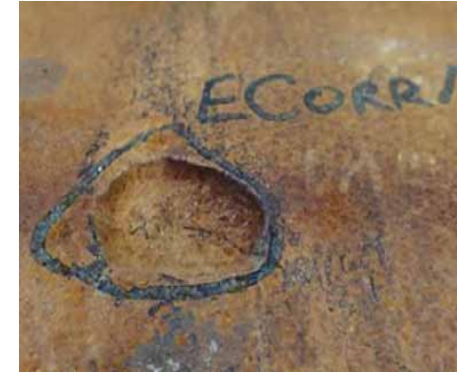
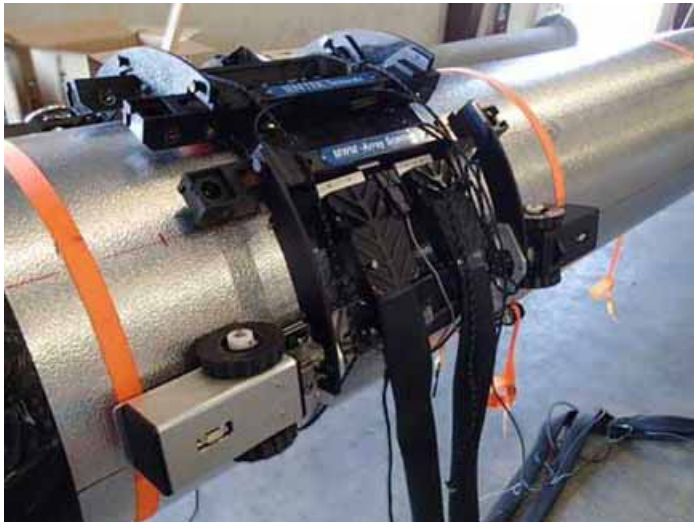
Performance Evaluation of Corrosion Imaging System

Results comparison with known natural corrosion defects on the OD (CUI)

Axial Length (inches/mm)	Circumferential Length (inches/mm)	Mean Depth (inches/mm)	Hit/Miss
1.5/38.1	1.5/38.1	0.12/3.0	Hit
9.0/228.6	1.5/38.1	0.06/1.5	Miss
2.0/50.8	1.5/38.1	0.08/2.0	Miss
4.0/101.6	1.25/31.75	0.12/3.0	Hit
4.0/101.6	4.0/101.6	0.08/2.0	Hit*
4.0/101.6	4.5/114.3	0.08/2.0	Hit*
1.75/44.45	2.75/69.85	0.1/2.5	Hit
2.75/69.85	2.5/63.5	0.12/3.0	Hit
1.0/25.4	0.75/19.05	0.16/4.0	Miss

*The defect produced two distinct indications in the scan data that were responsible for the indications were identified on a best-effort basis.

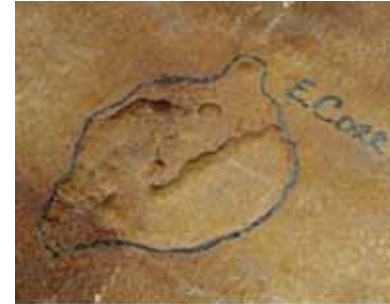
External Corrosion – Sample B

Performance Evaluation Results (December 2013)

Pipe Data:

20" Diameter, 0.250" wall

2" insulation with aluminum weather jacket

Flaw Data:

2.75" (Axial), 2.50" (Circumferential), 0.12 Deep (48%)

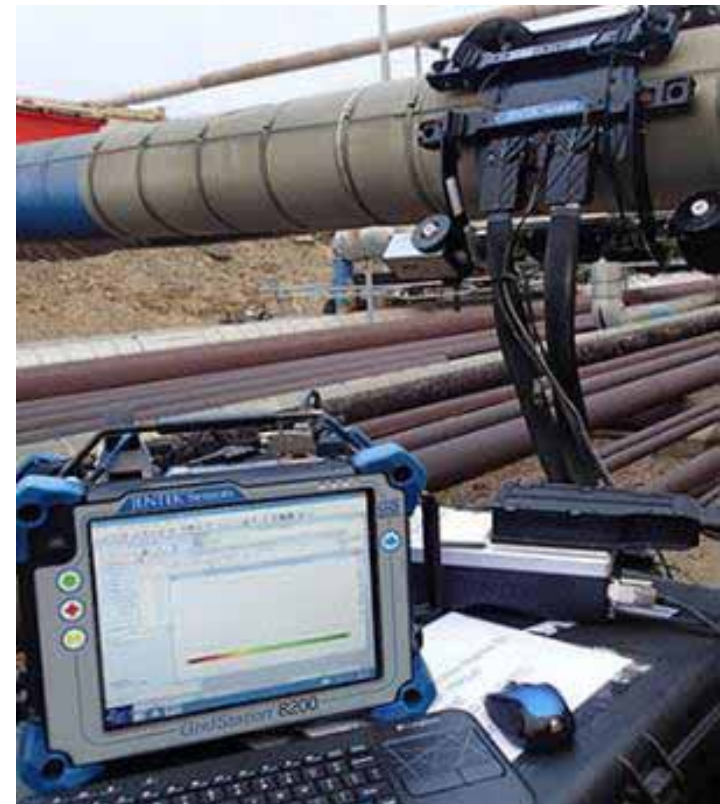
8200 Integrated System

- ❑ Longer, light-weight cables for increased operator ease-of-use
- ❑ More compact cable/PEU configuration
- ❑ Improved positioning encoder module

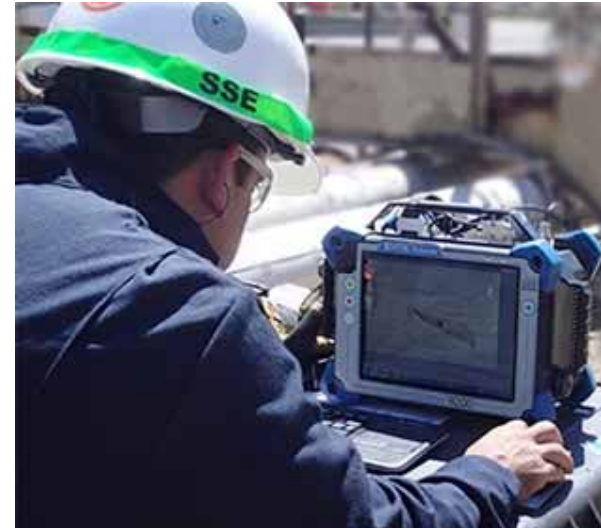
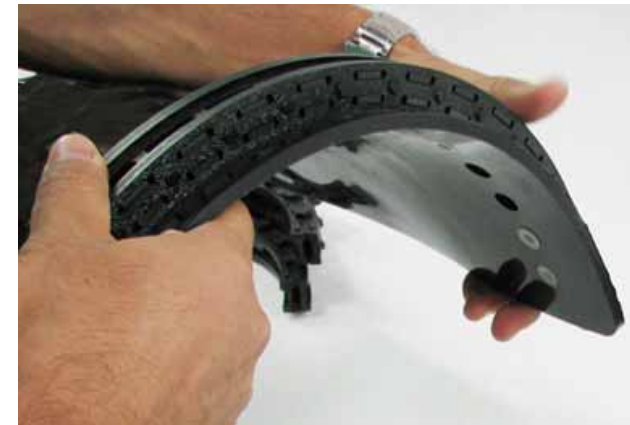
Corrosion Imaging Tool – Current Capability (1)

System capabilities:

- Carbon steel pipelines and piping (straight sections only) for a minimum of 8.5 in. total diameter (including insulation) and above
- Up to 0.5 in. thick pipe walls for internal and external corrosion imaging
- Up to 0.040 in. Aluminum and Stainless Steel weather jackets (**not suitable for galvanized weather jackets**)
- All (non-conducting) insulation materials, up to 3 in. thick
- Current focus is on pipelines and piping, but **method can be adapted for vessels or other carbon steel structures**

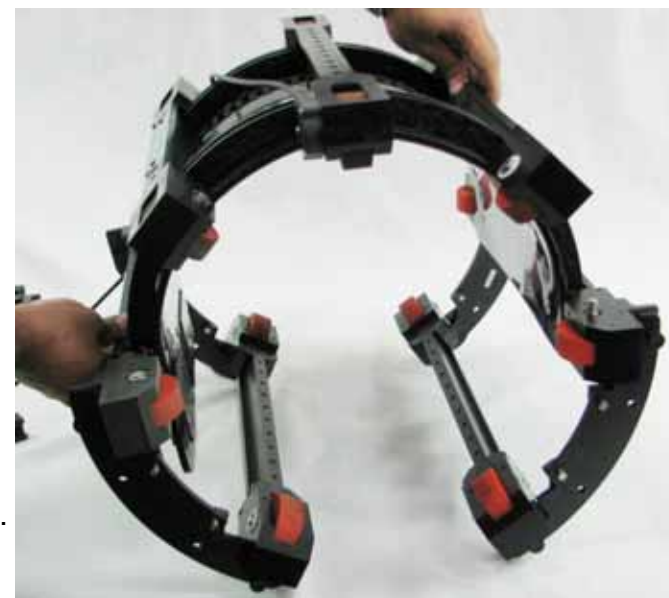
Corrosion Imaging Tool – Current Capability (2)

Areas of corrosion with dimensions exceeding the following numbers will have a high probability for detection:

- **1 in. diameter @ 65% wall loss (average)**
- **2 in. diameter @ 50% wall loss (average)**
- **3 in. diameter @ 30% wall loss (average)**

Note: This evaluation was performed on 20 in. pipes with natural corrosion, 0.250 in. wall, 2 in. insulation, and 0.020 in. aluminum weather jacket. The system performance is expected to vary with different pipe configurations.

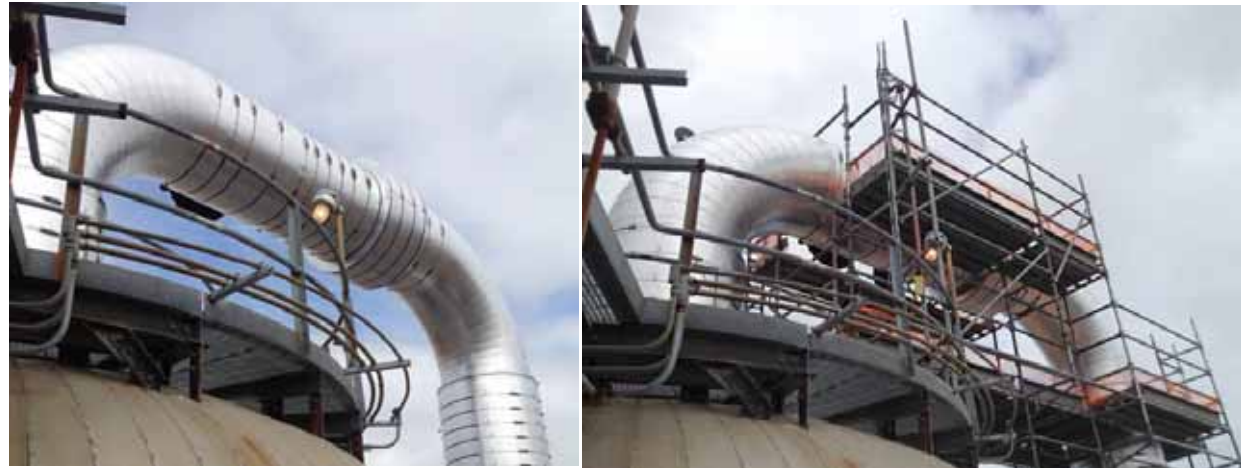
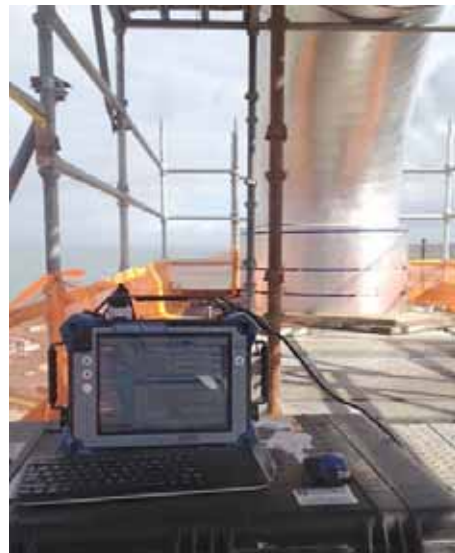
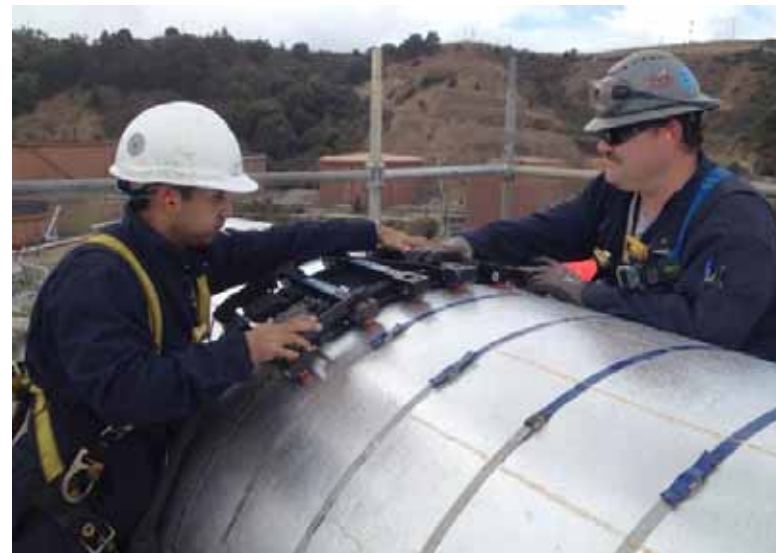
Case Study I - Corrosion Imaging on Refinery Piping

Inspection was performed with the pipe in production at high temperature

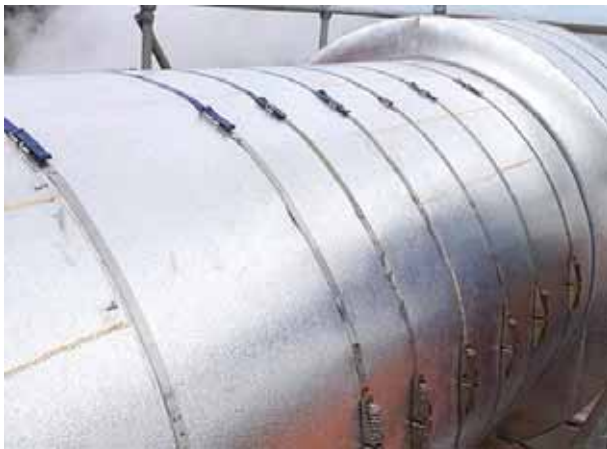
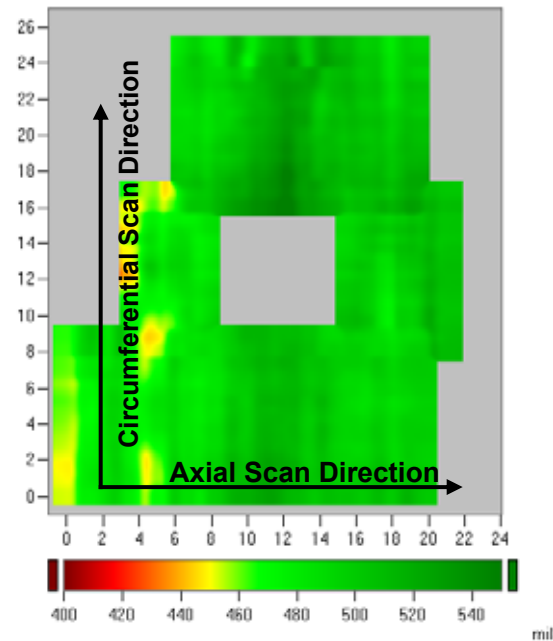
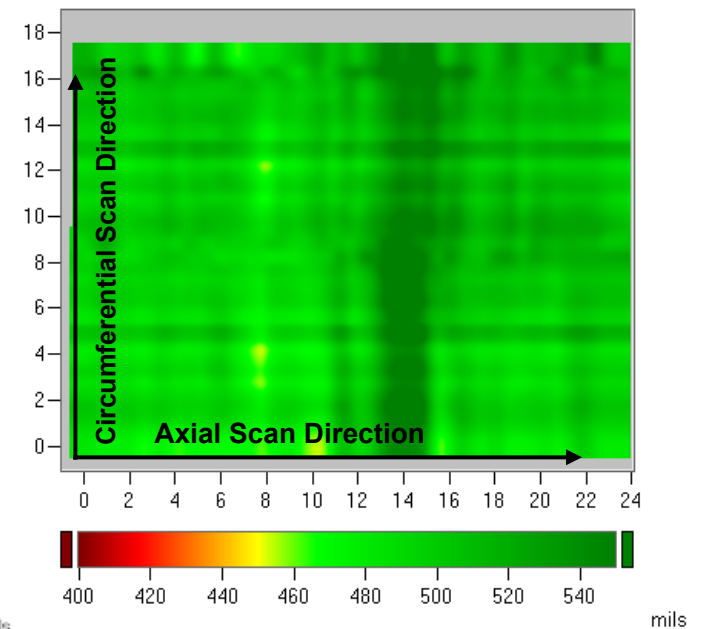
Case Study I - Corrosion Imaging on Refinery Piping

Multiple Unknowns Meas. Steel Thickness Scans

Inspection was performed with the pipe in production
at high temperature

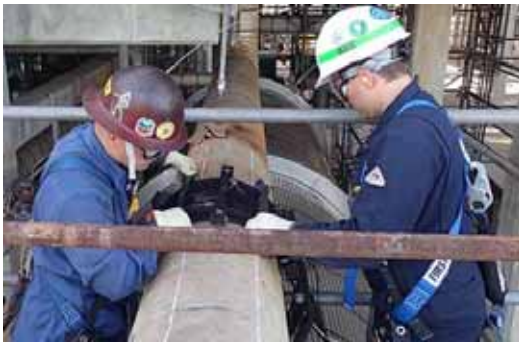
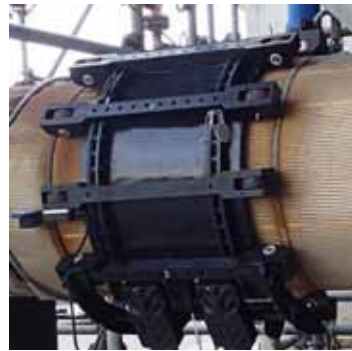
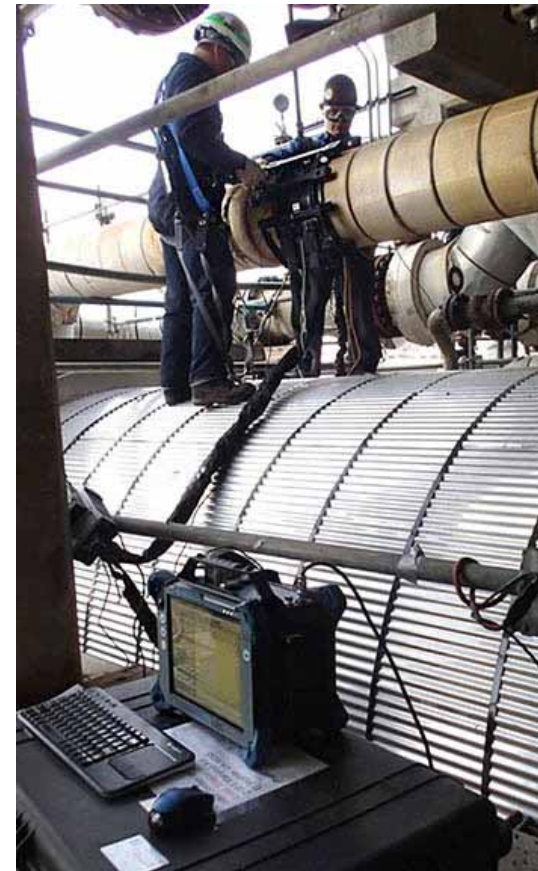
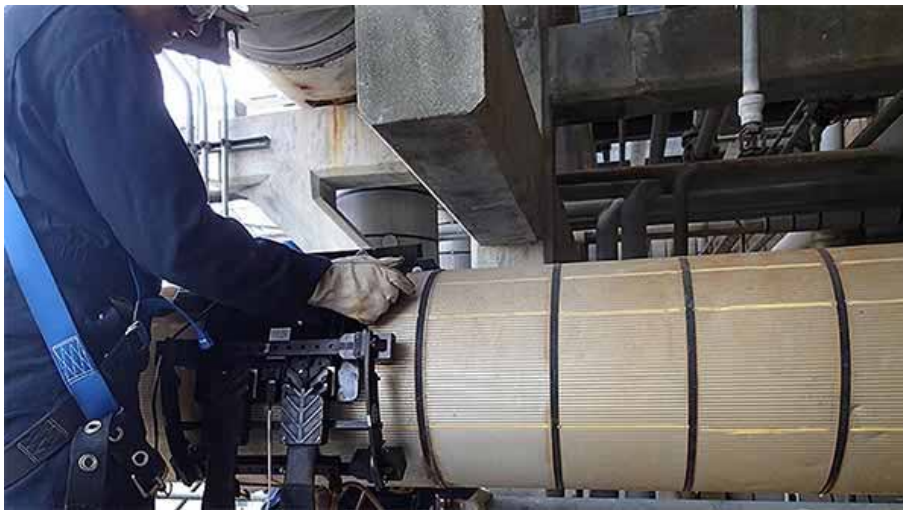
Case Study II - Corrosion Imaging on Refinery Piping

- JENTEK engineers provided service support to field service technicians performing inspection for internal and external corrosion on a pipe at a major U.S. refinery.
- Technicians are using system with magnetoresistive array sensing technology capable of imaging corrosion in weather jacketed pipe.

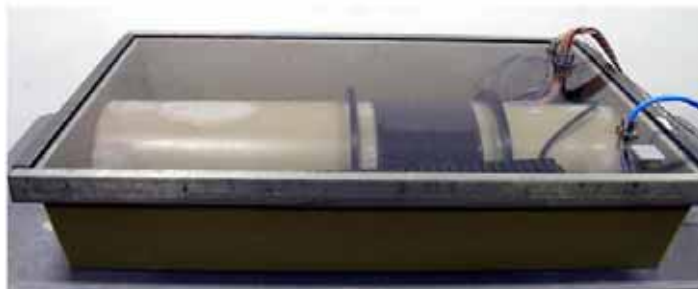
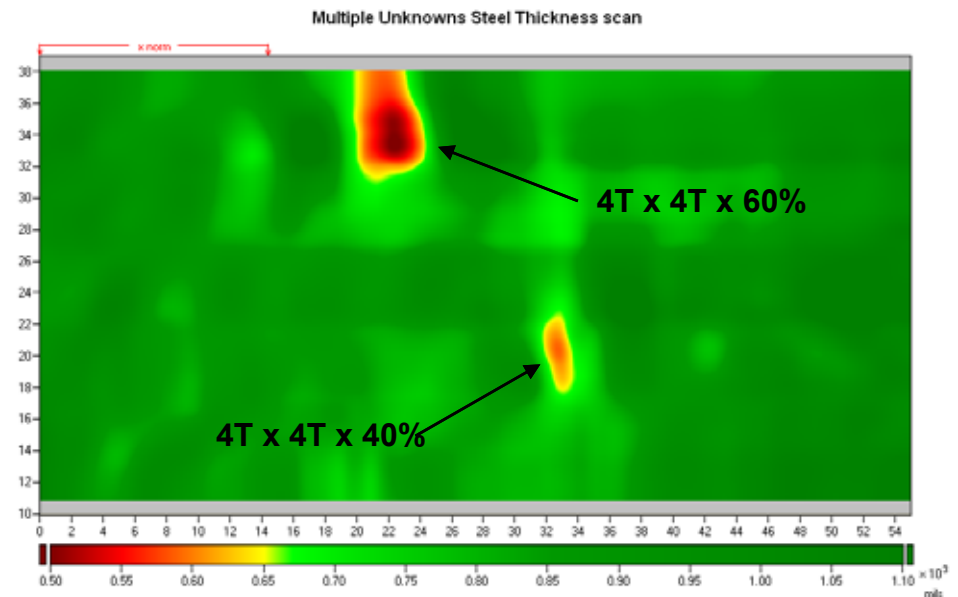
Internal Corrosion in Heavy Wall Pipe

▪ Completed demonstration of MR-MWM-Array

- Performed scans with the 8200α prototype system and the low frequency MR-MWM-Array on the new sample (with fabricated internal defects) through 2-in. insulation
- Performed measurement and calibration adaptation procedure and algorithm development (under JENTEK IR&D funding)
- Completed evaluation of GridStation 8200α system (under JENTEK IR&D funding)

▪ Completed fabrication and testing of the deep water scanner

- Fabrication of the scanner is complete
- Integrated with our new GridStation 8200α system
- Completed preliminary testing of the sensor
- Addressed cabling and connectivity issues
- Completed pressure testing of scanner components
