Imaging Corrosion under Insulation and under Fireproofing, using MR-MWM-Arrays

Neil Goldfine, Brian Manning, Zachary Thomas, Yanko Sheiretov, Scott Denenberg,
Todd Dunford, and Shayan Haque
JENTEK Sensors, Inc., 110-1 Clematis Avenue, Waltham, MA 02453-7013

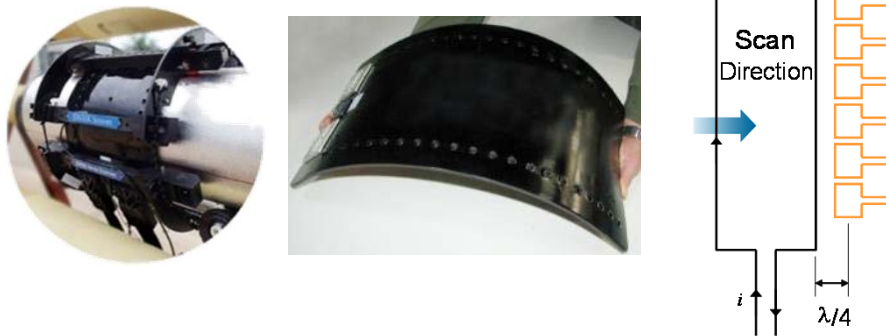
1. Sensors: MWM[®]-Arrays

- Paradigm shift in sensor design (first priority is predictable response based on physics-based modeling)

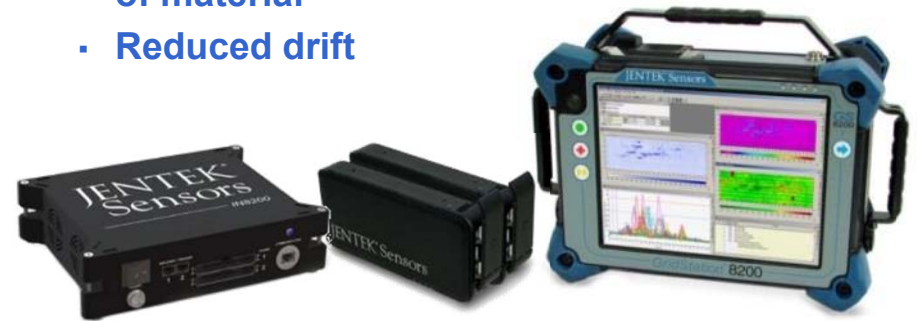
2. Next Generation Electronics

- 10x signal-to-noise improvement
- Very low frequencies (deep penetration)
- Crack detection through up to 0.5 inches of material
- Reduced drift

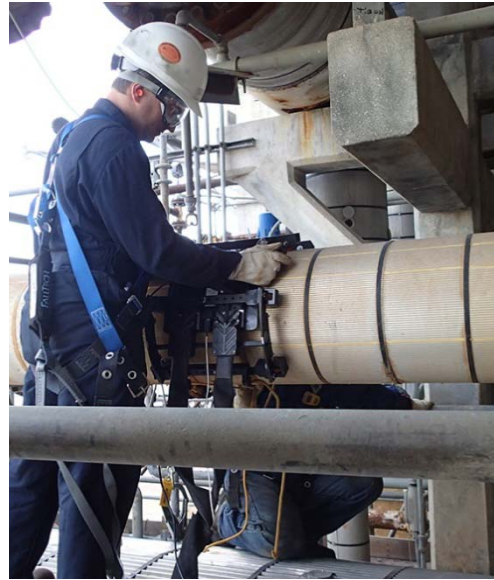
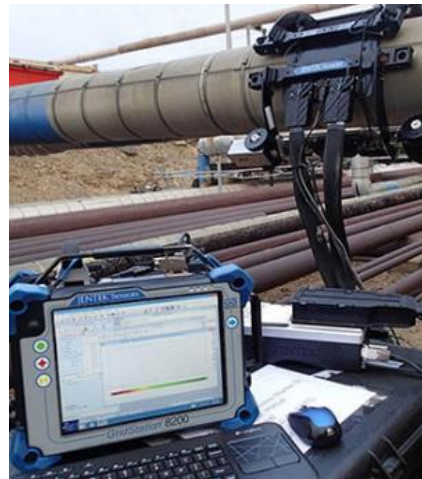
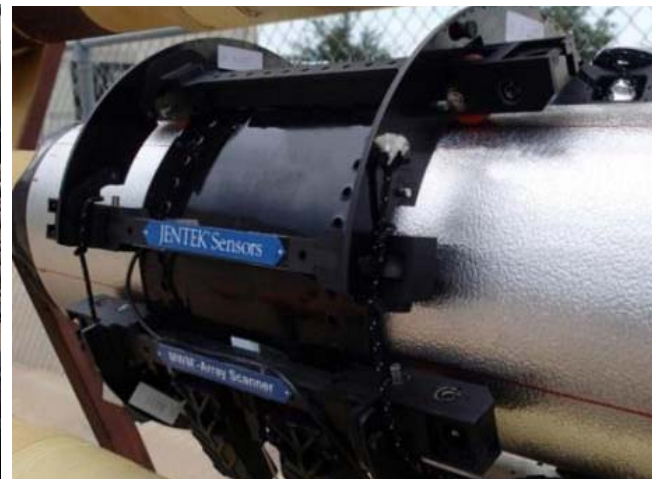
Problem Definition

$h, \Delta_{wj}, \Delta_i, \Delta_p, \mu_p$

h_o = distance between sensor & external surface of weather jacket

Δ_{wj} = weather jacket thickness

Δ_i = insulation thickness + external metal loss

Δ_p = remaining pipe wall thickness

μ_p = pipe magnetic permeability

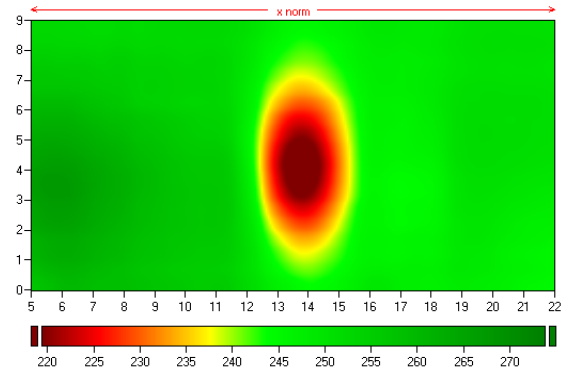
Lab Demonstration of ID/OD Discrimination

External Wall Loss

Internal Wall Loss

Thickness

Lift-Off

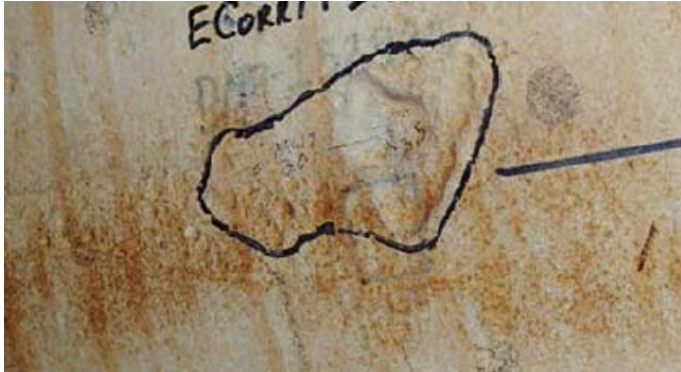
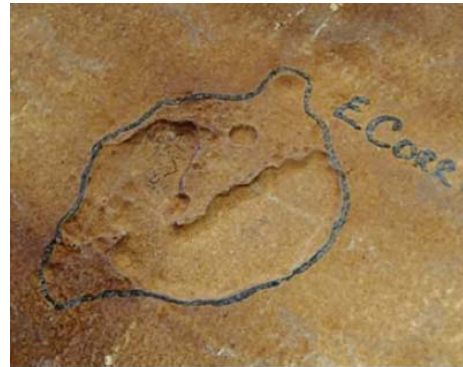
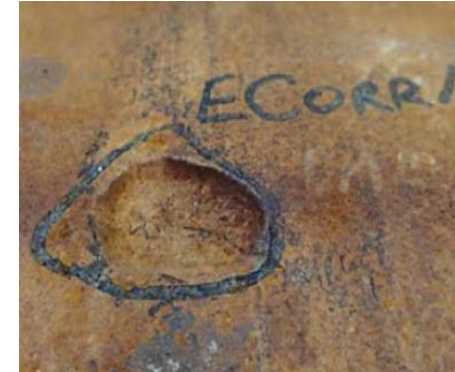
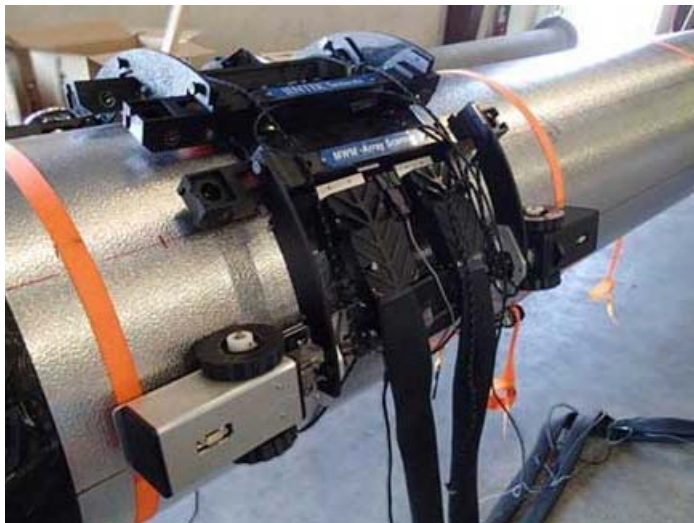
Performance Evaluation of Corrosion Imaging System

Results comparison with known natural corrosion defects on the OD (CUI)

Axial Length (inches/mm)	Circumferential Length (inches/mm)	Mean Depth (inches/mm)	Hit/Miss
1.5/38	1.50/38	0.12/3.0	Hit
9.0/228	1.50/38	0.06/1.5	Miss
2.0/50	1.50/38	0.08/2.0	Miss
4.0/101	1.25/32	0.12/3.0	Hit
4.0/101	4.00/101	0.08/2.0	Hit*
4.0/101	4.50/114	0.08/2.0	Hit*
1.75/44	2.75/70	0.10/2.5	Hit
2.75/69	2.50/63	0.12/3.0	Hit
1.0/25	0.75/19	0.16/4.0	Miss

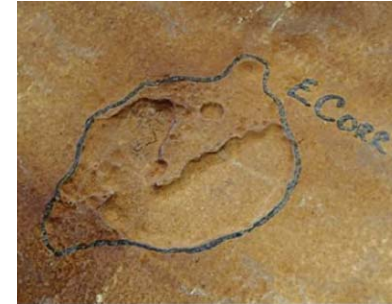
External Corrosion – Sample B

Pipe Data:

20" Diameter, 0.250" wall

2" insulation with aluminum weather jacket

Flaw Data:

2.75" (Axial), 2.50" (Circumferential), 0.12 Deep (48%)

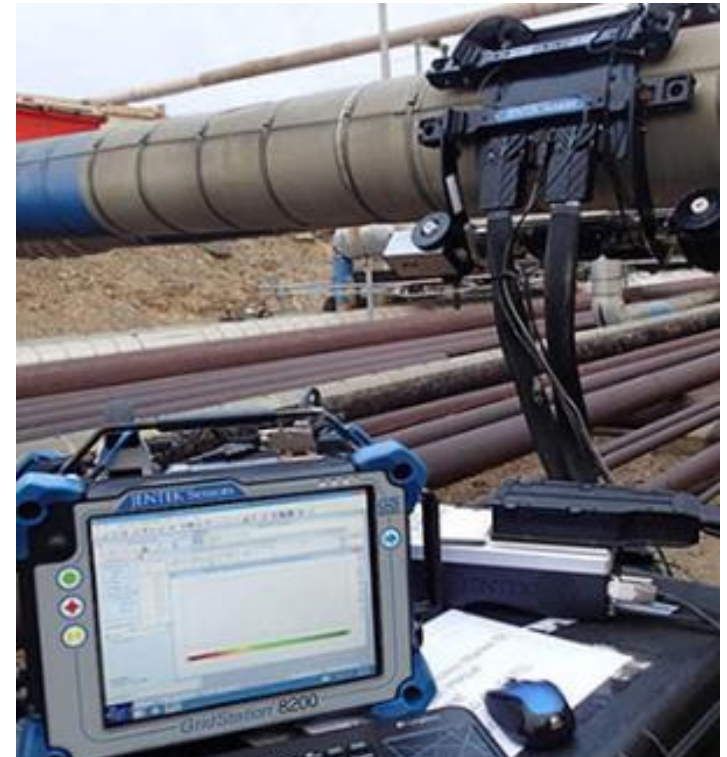
Integrated System

- Longer, light-weight cables for increased operator ease-of-use
- More compact cable/PEU configuration
- Improved positioning encoder module

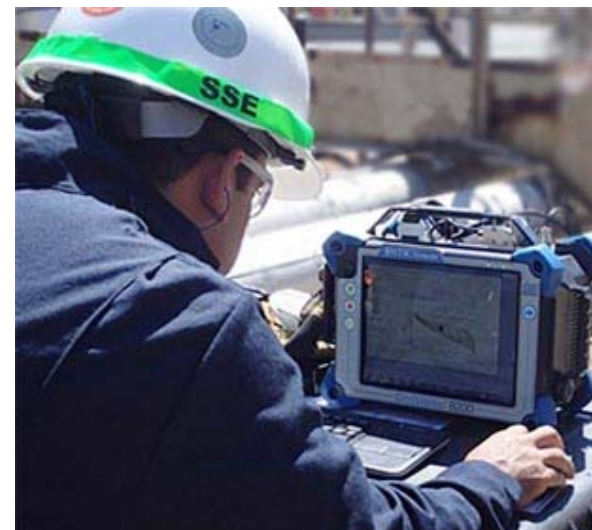
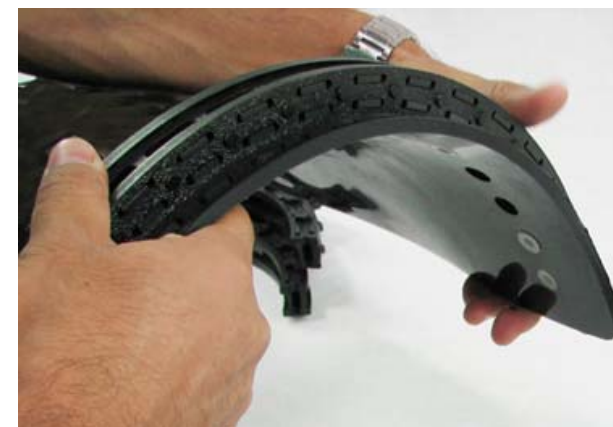
Corrosion Imaging Tool – Current Capability (1)

- Carbon steel pipelines and piping (straight sections only) for a minimum of 8.5 inch total diameter (including insulation) and above
- Up to 0.5 inch thick pipe walls for internal and external corrosion imaging
- Up to 0.040 inch Aluminum and Stainless Steel weather jackets (**not suitable for galvanized weather jackets**)
- All (non-conducting) insulation materials, up to 3 inch thick
- Current focus is on pipelines, piping and vessels. Can be adapted for other steel structures

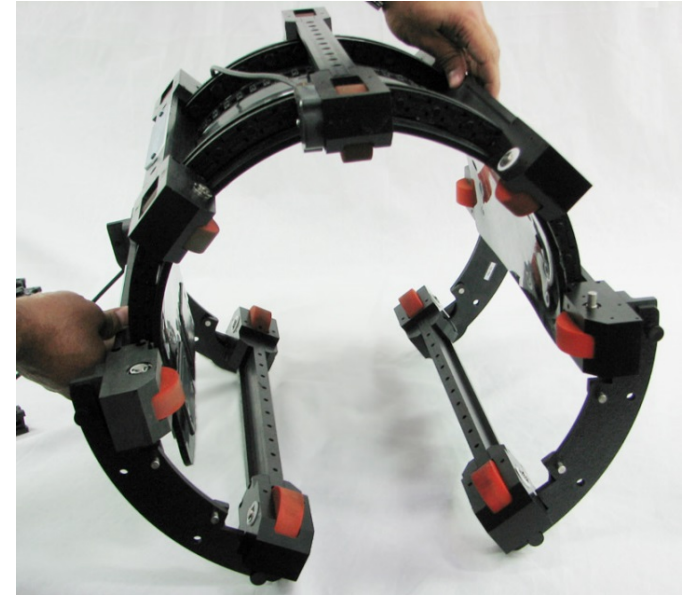
Corrosion Imaging Tool – Current Capability (2)

Areas of corrosion with dimensions exceeding the following numbers will have a high probability for detection:

- **1 in. diameter @ 65% wall loss (average)**
- **2 in. diameter @ 50% wall loss (average)**
- **3 in. diameter @ 30% wall loss (average)**

Note: This evaluation was performed on 20 in. pipes with natural corrosion, 0.250 in. wall, 2 in. insulation, and 0.020 in. aluminum weather jacket. The system performance is expected to vary with different pipe configurations.

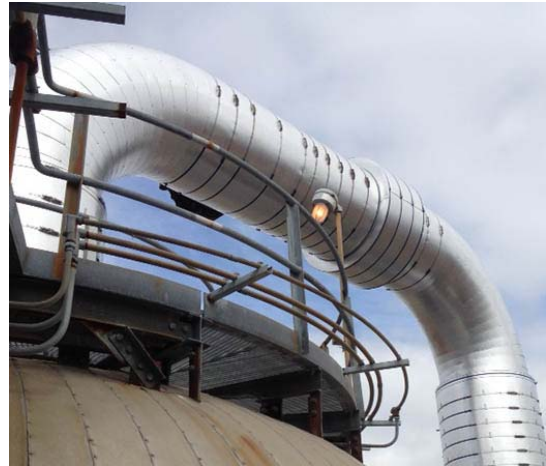
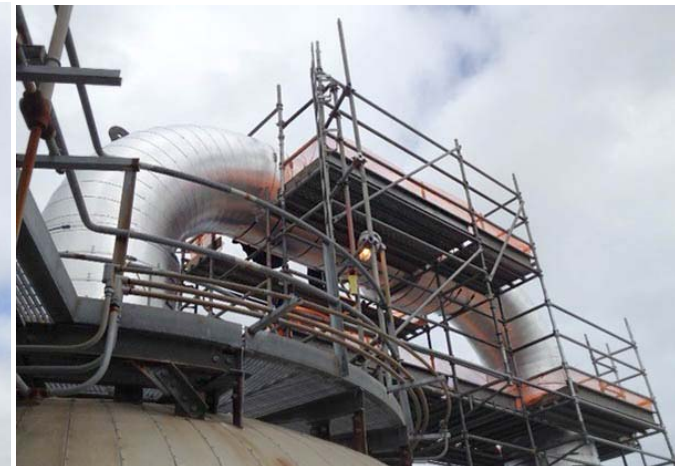
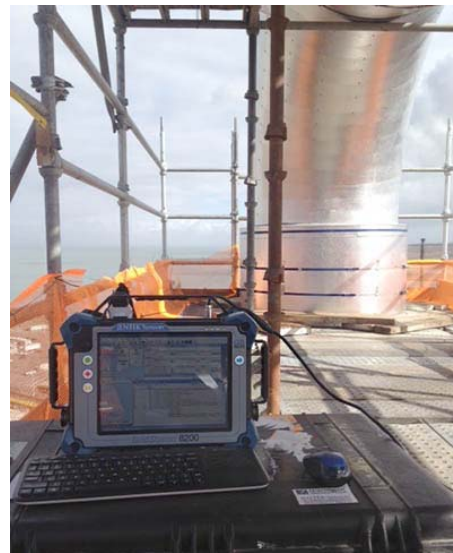
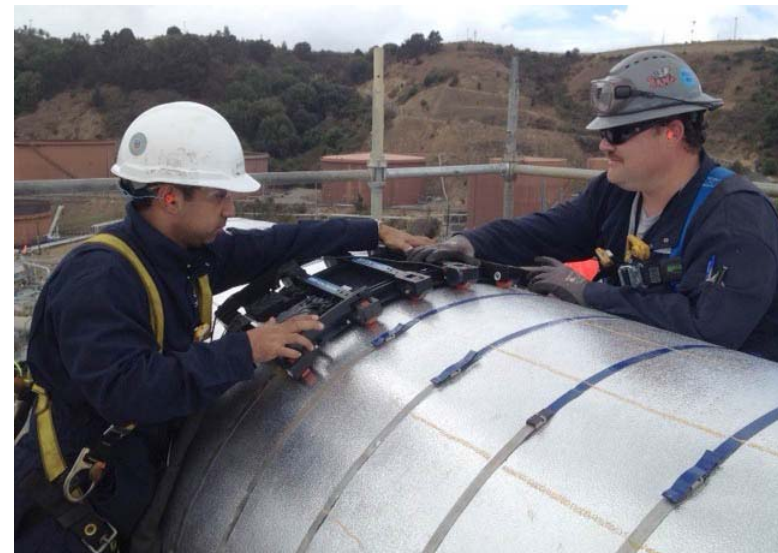
Case Study I - Corrosion Imaging on Refinery Piping

Inspection was performed with the pipe in production at high temperature

Multiple Unknowns Meas. Steel Thickness Scans

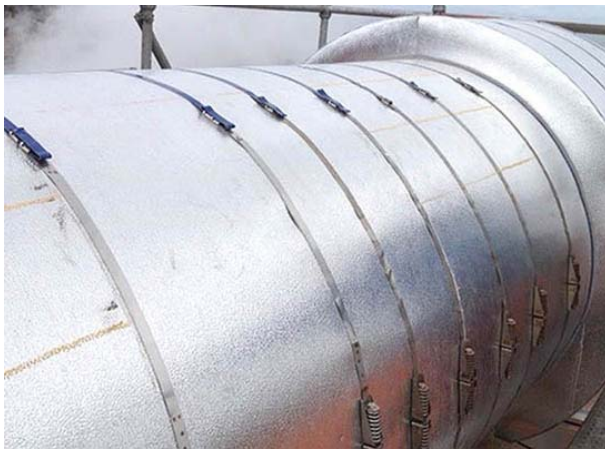
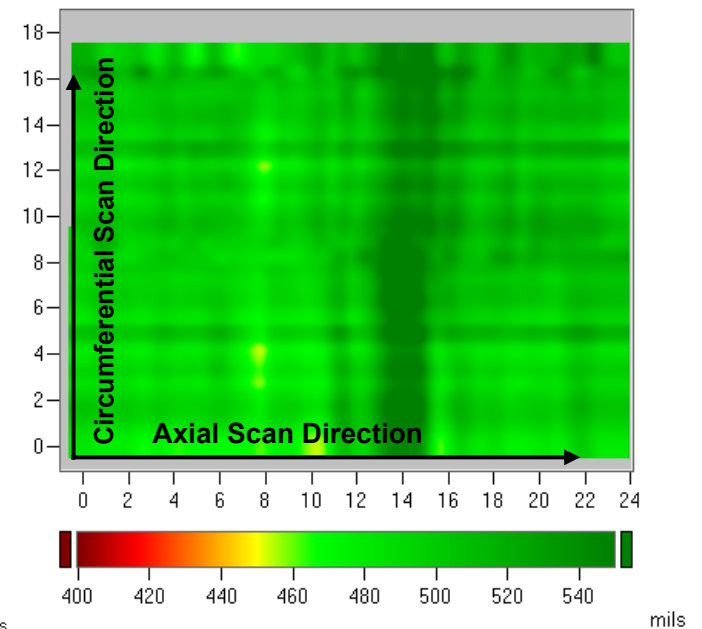
Case Study I - Corrosion Imaging on Refinery Piping

Inspection was performed with the pipe in production
at high temperature

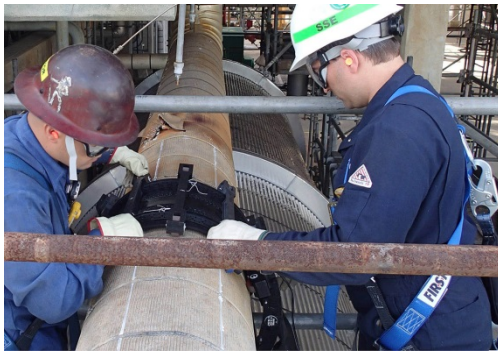
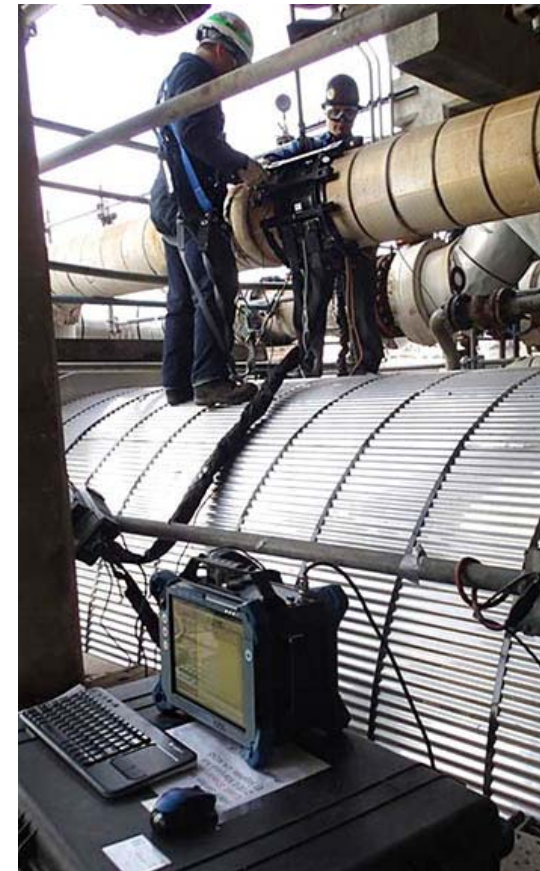
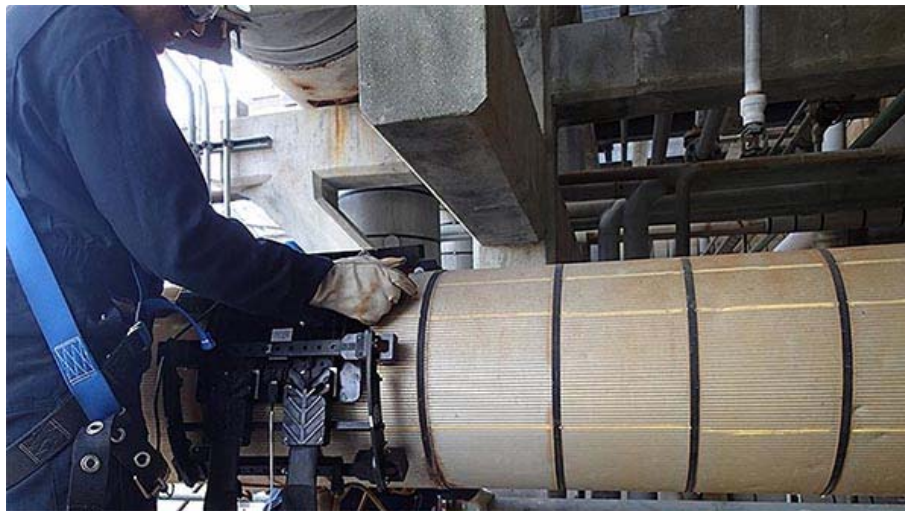
Case Study II - Corrosion Imaging on Refinery Piping

- Engineers provided service support to field service technicians performing inspection for internal and external corrosion on a pipe at a major U.S. refinery.
- Technicians are using system with magnetoresistive array sensing technology capable of imaging corrosion in weather jacketed pipe.
